## Culcairn Closeout - Dilapidation Report - WSC December - 2025

Re: Dilapidation Inspection and report - Culcairn Solar Farm Surrounding roads:

- Benambra road "A" to "B", 3.8KM
- Weeamera road "B" to "C", 3.5KM

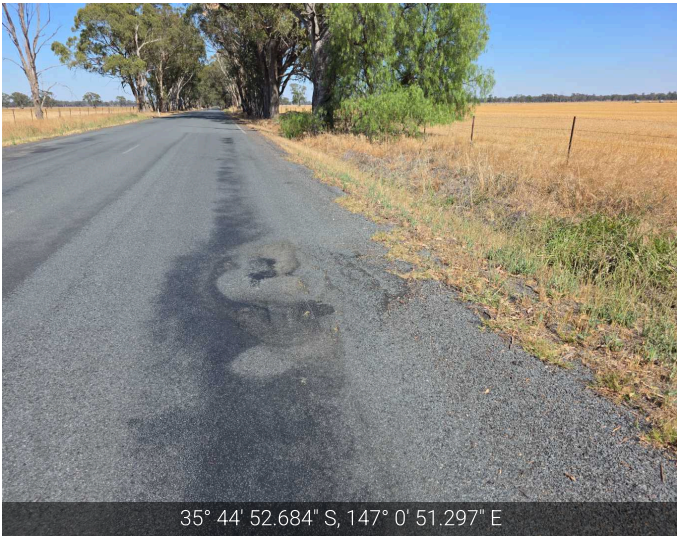
Patching to road with further heaving

Break-up of surface

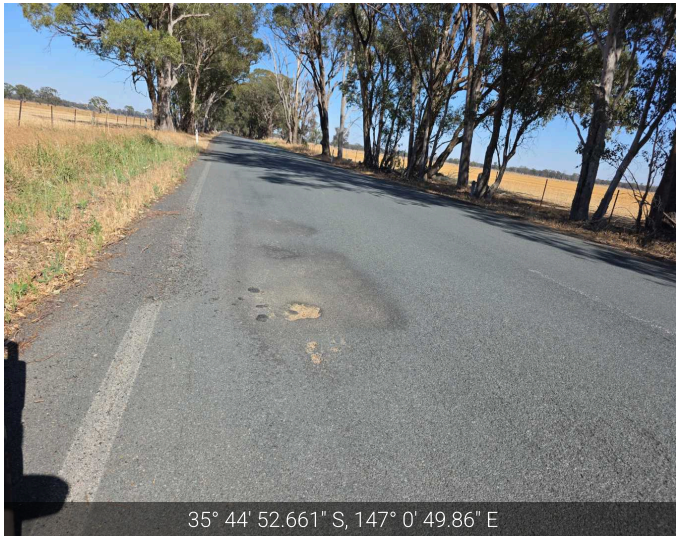
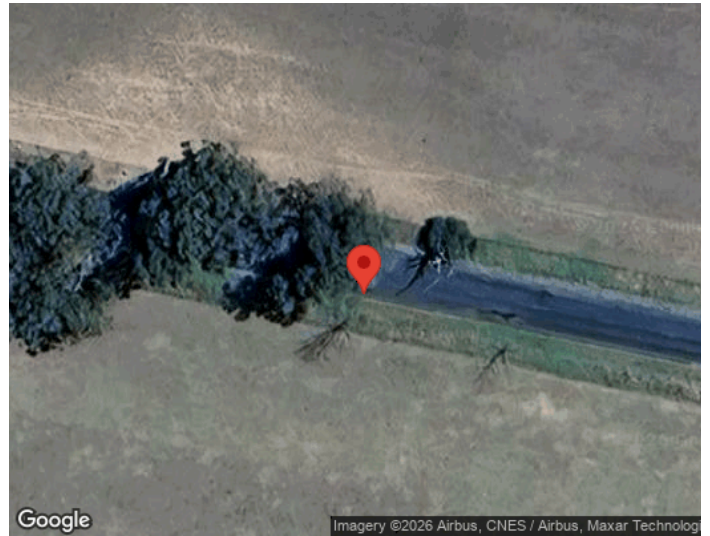
Patching with further cracking exposing the road base

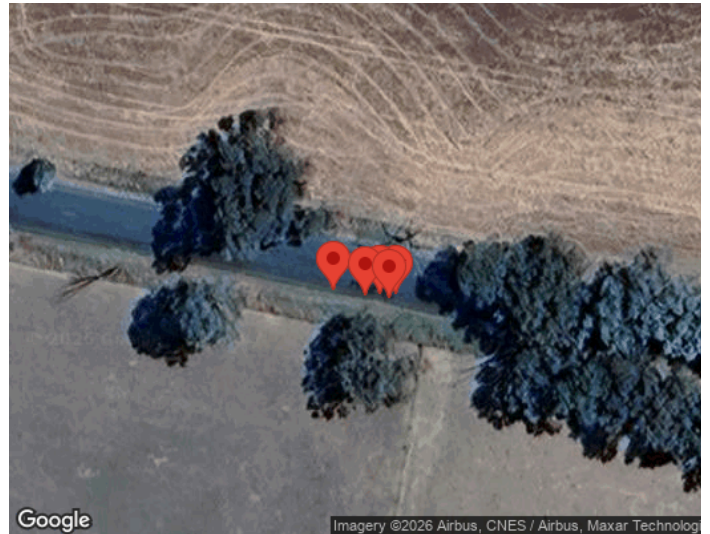
Patching with further settlement and surface break-up exposing roadbase

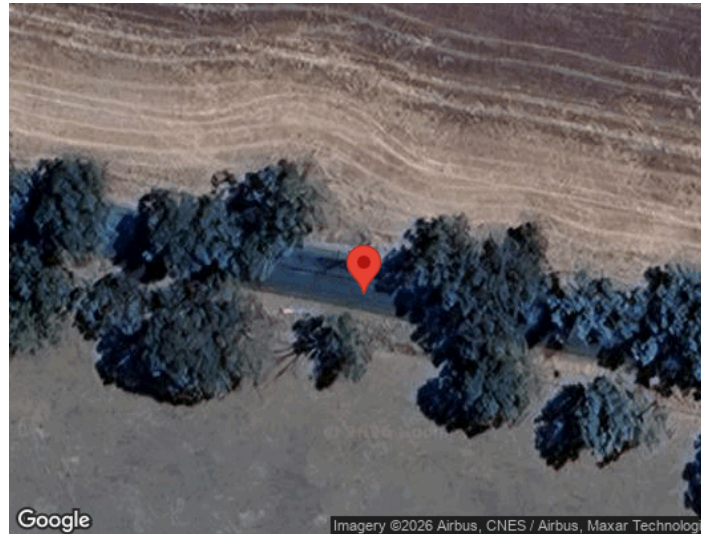
**Item 14****ID: A015**

Folder: Benambra Rd    Record type: Dilapidation    Tags: Repairs  
Repairs to Road

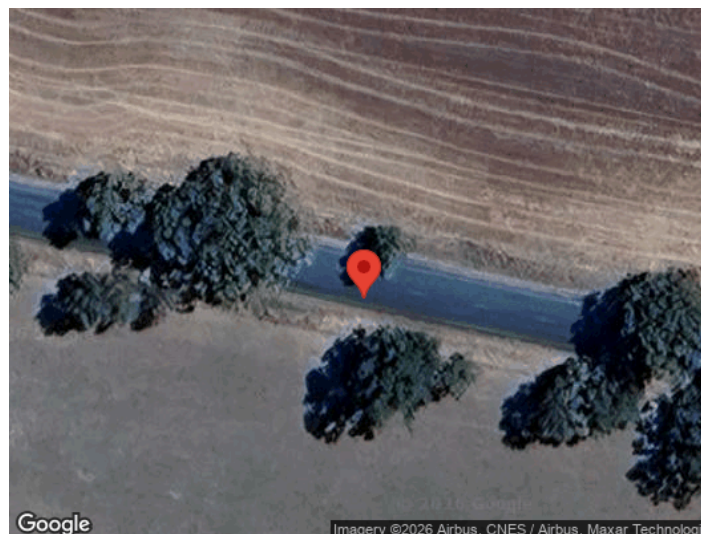
**Item 15****ID: A016**

Folder: Benambra Rd    Record type: Dilapidation    Tags: Repairs  
Repairs to Road

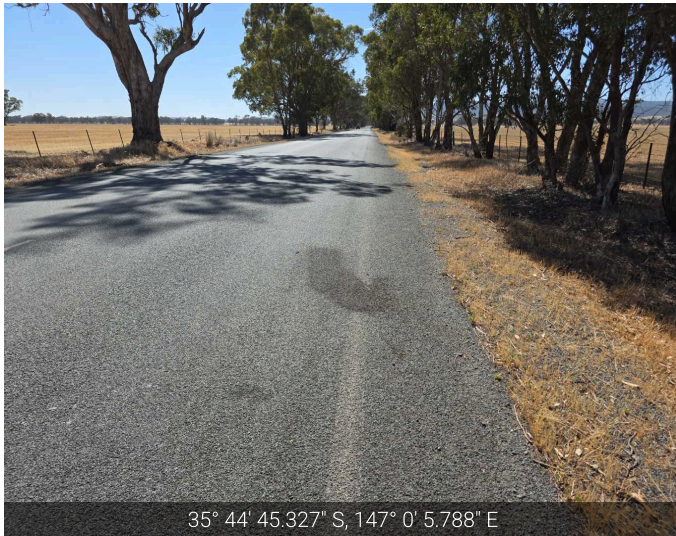
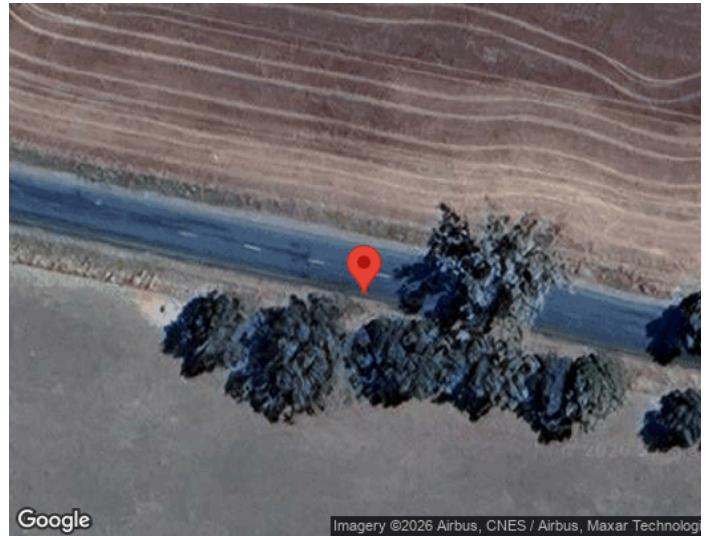
Repairs to Road

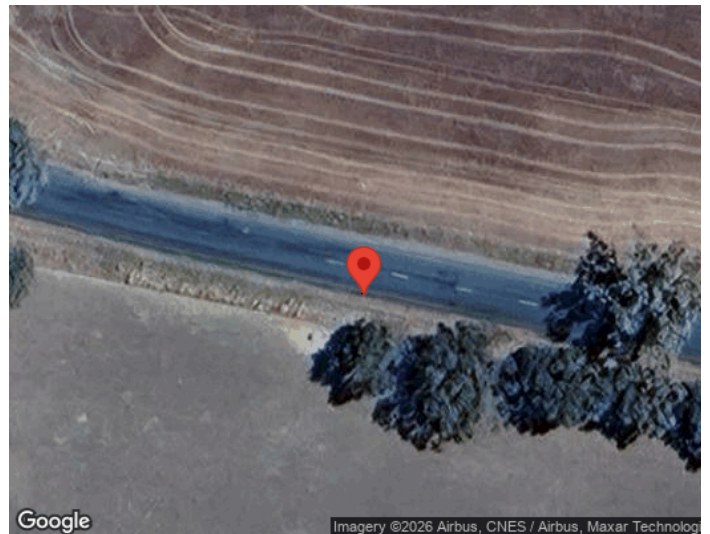
Cracking to Road Surface

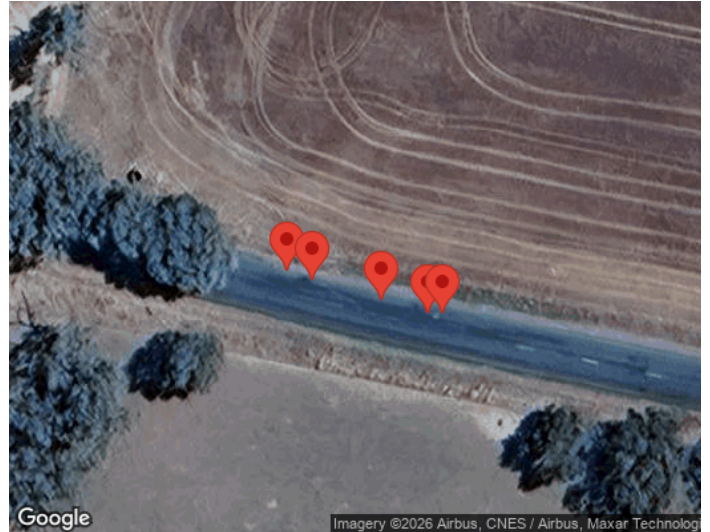
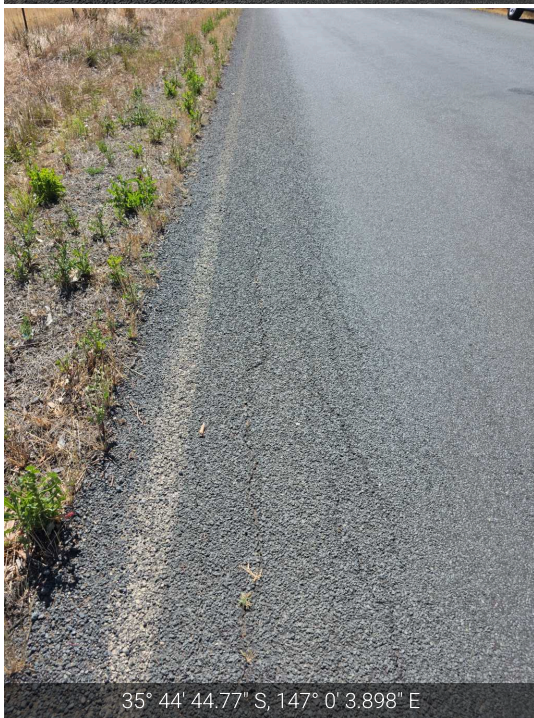
Repairs to Road

Cracking to surface

Exposed road base

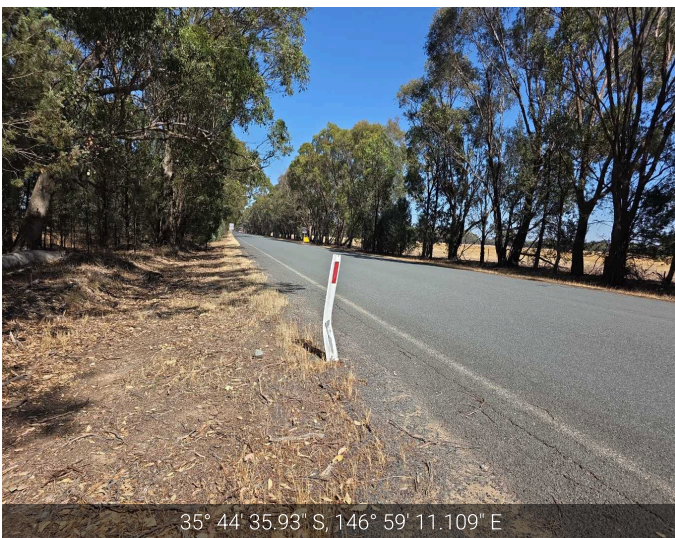
#### Item 19

Damage to Guide Marker

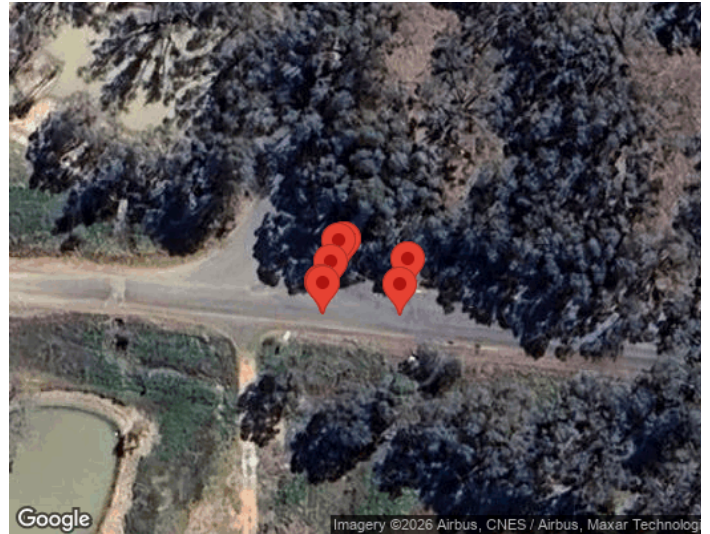
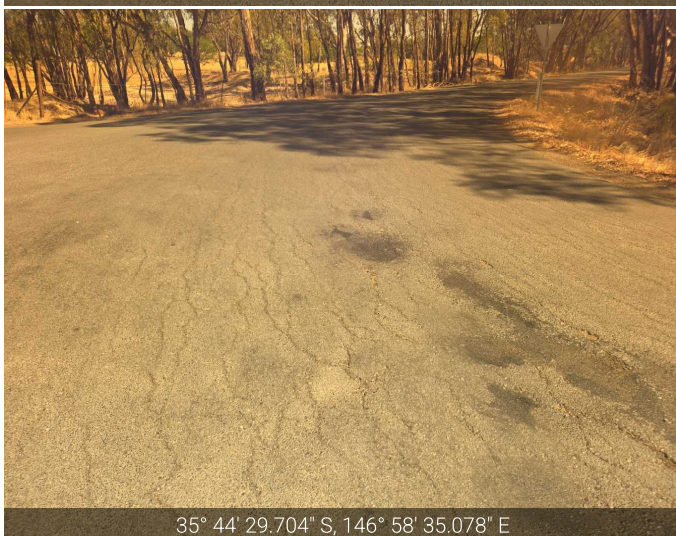
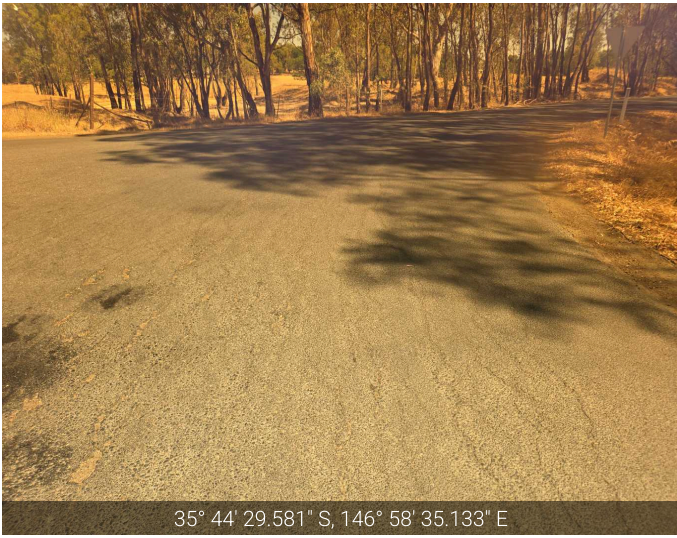
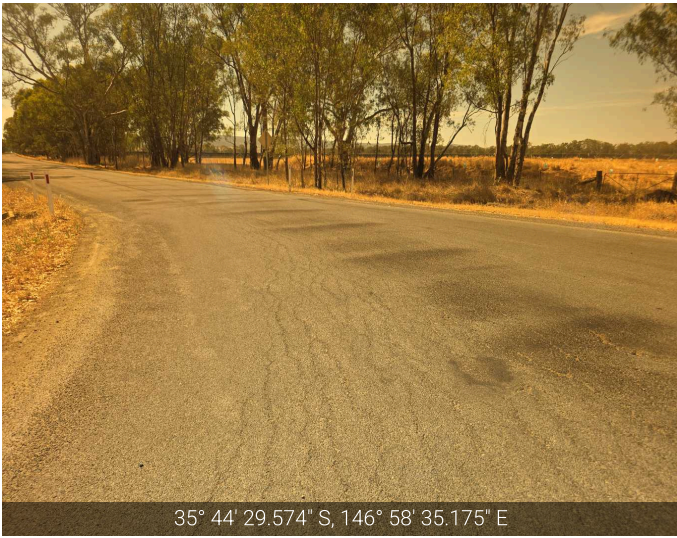
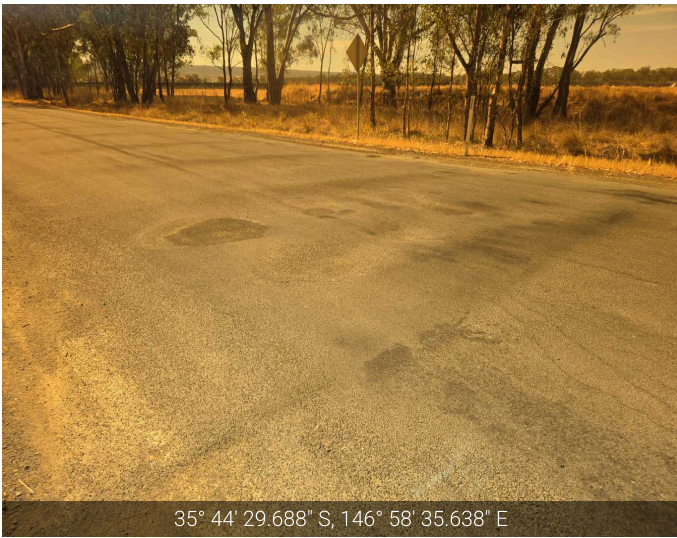
Uneven surface to Road finish

Cracking to Road finish

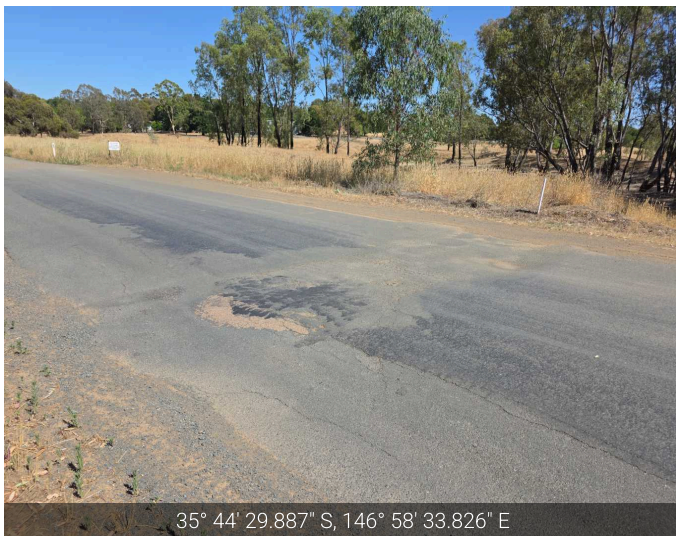
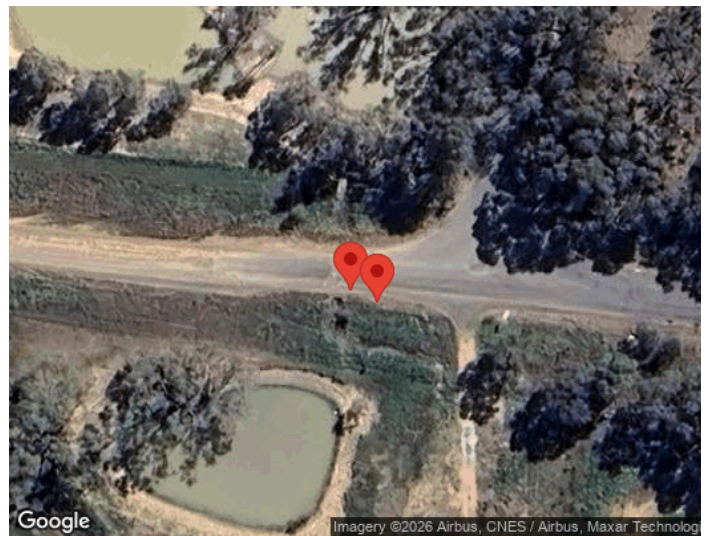
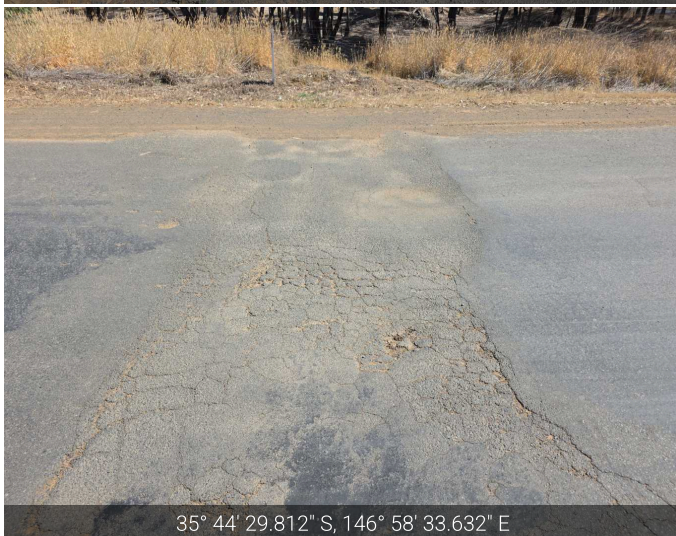
## Item 24

Uneven finish to road surface over stormwater culvert  
Cracking to Road Finish

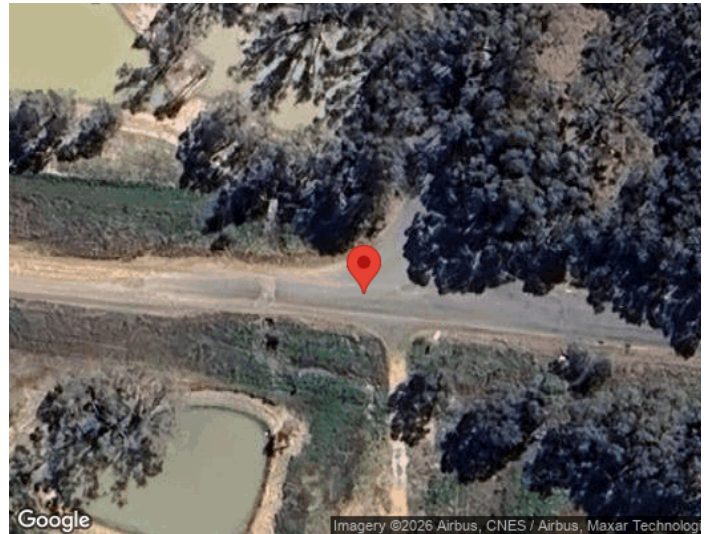
Cracking to Road finish

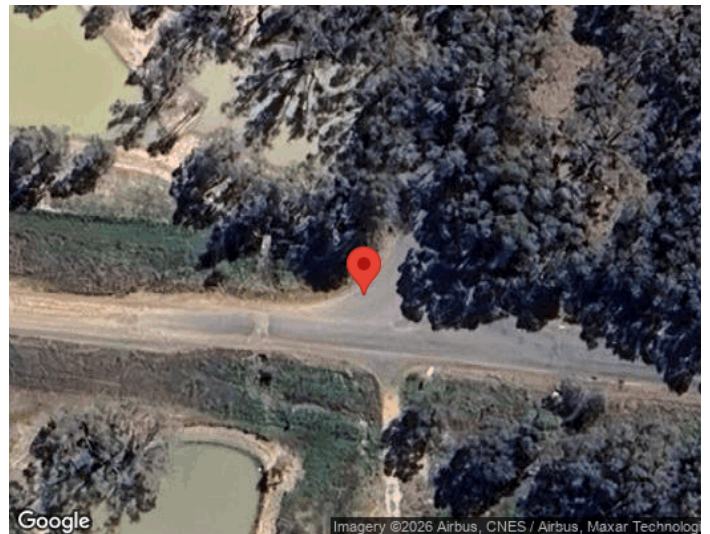
Break-up to edge

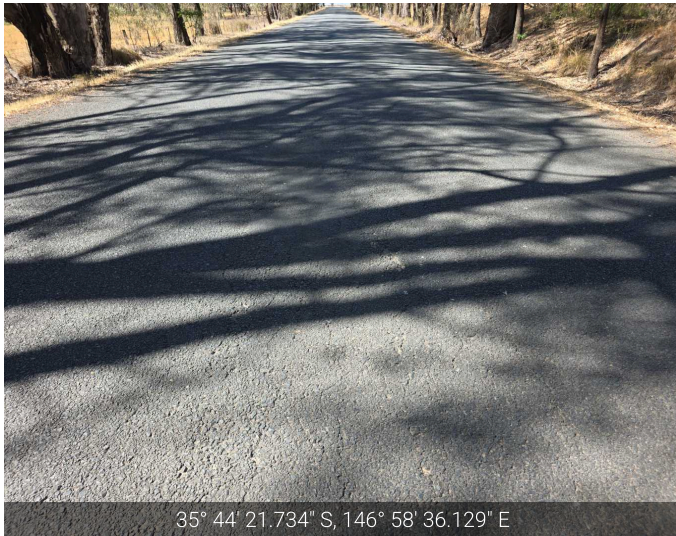
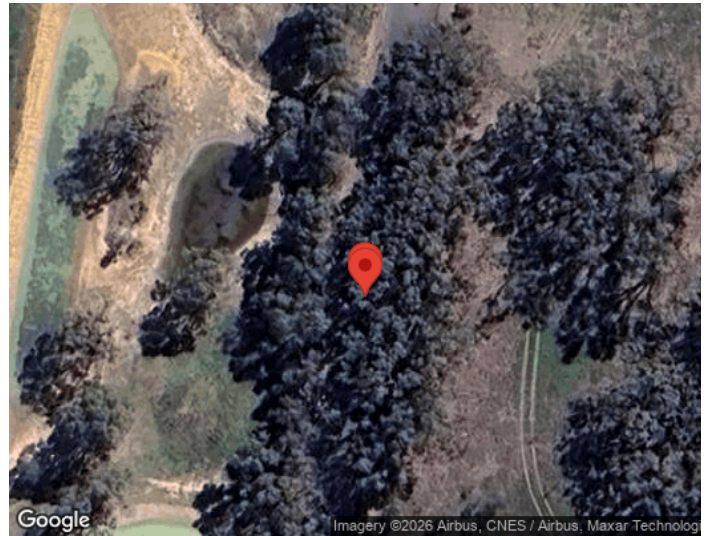
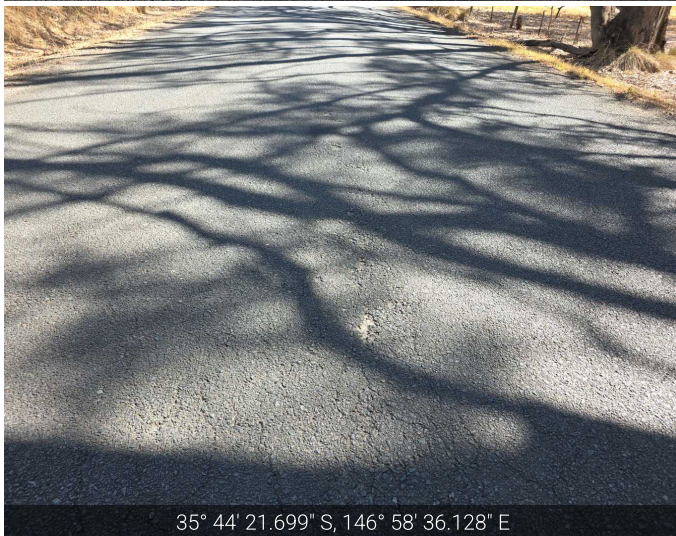
Cracking to Road Surface

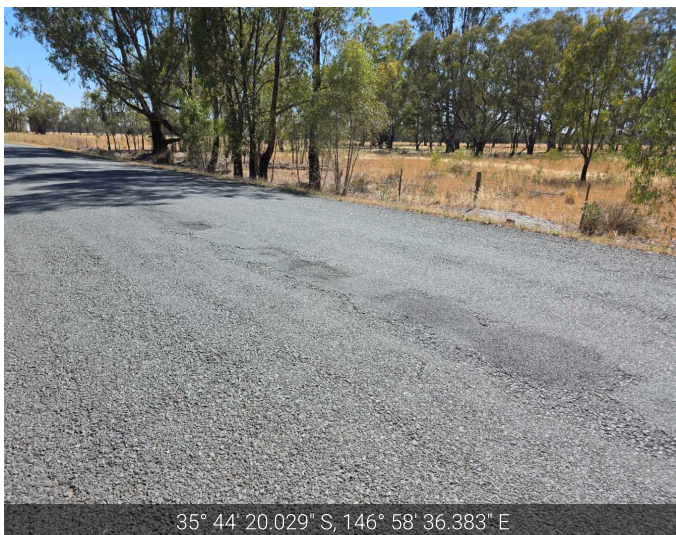
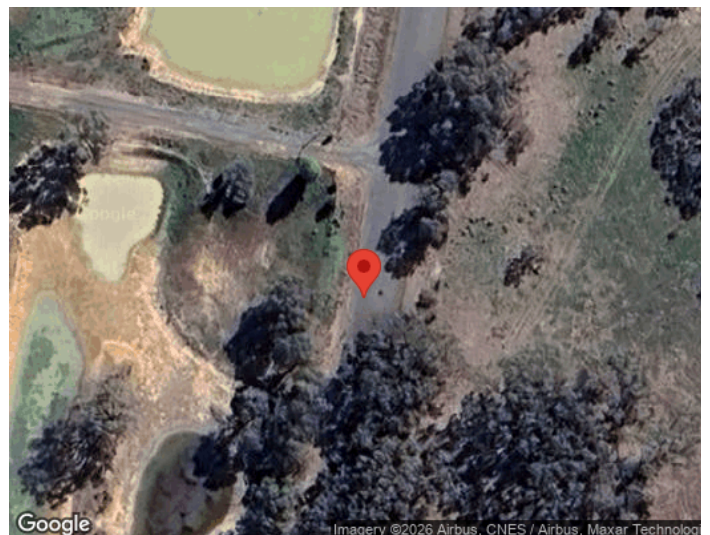
Patching to Road Surface

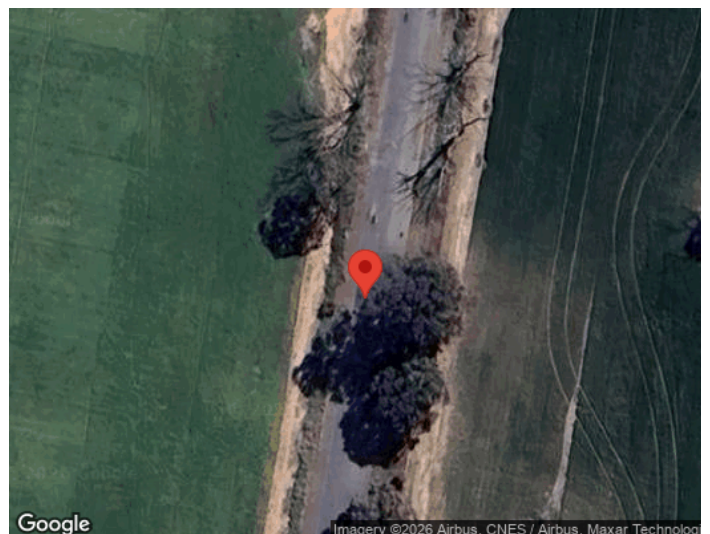
**Item 30**

Repairs to Road

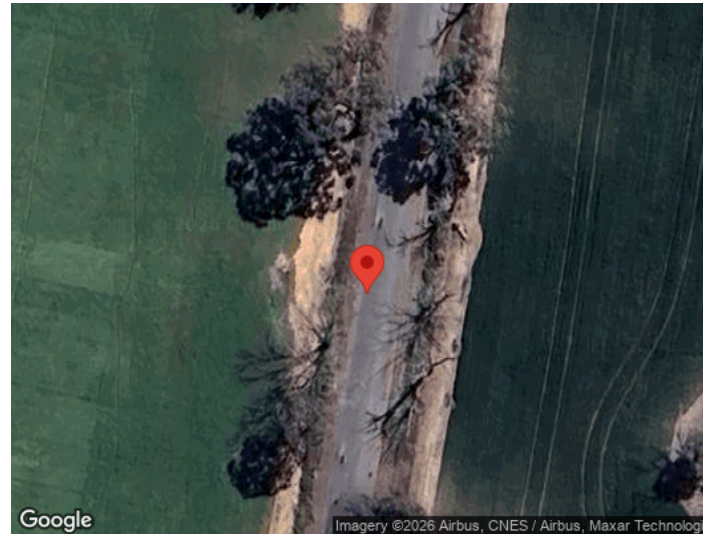
**Item 31**

Repairs to Road

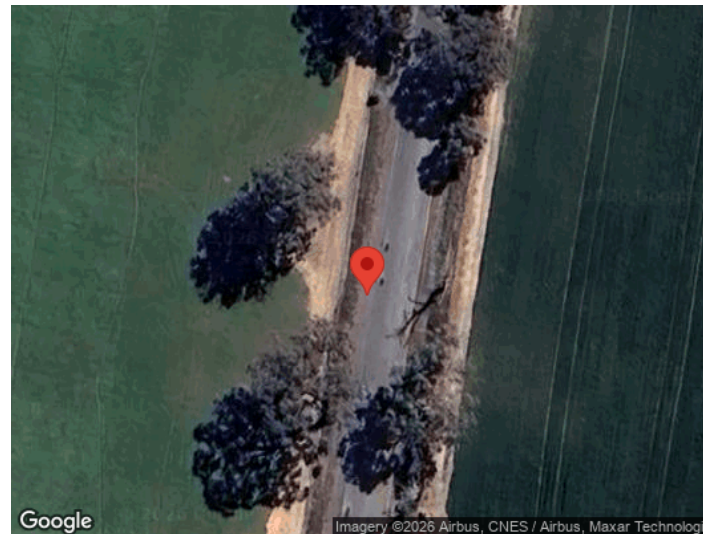
**Item 32**

Repairs to Road

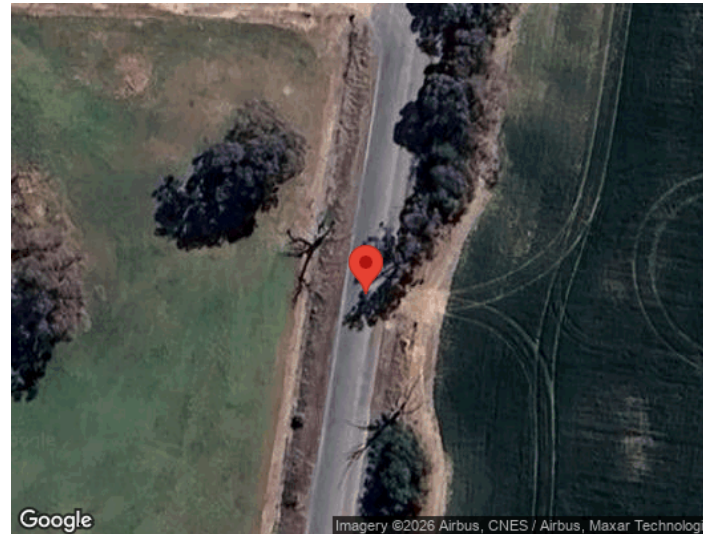
**Item 33**

Patching and Gouging to Road at private entry

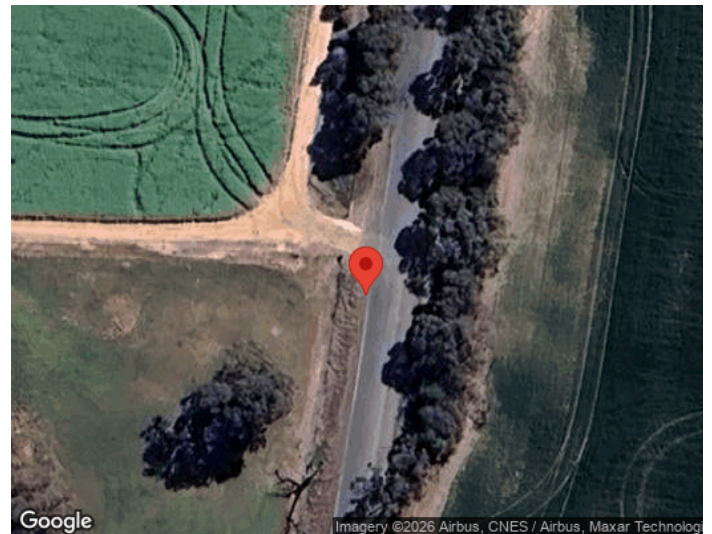
**Item 34**

Edge Break-up at private entry

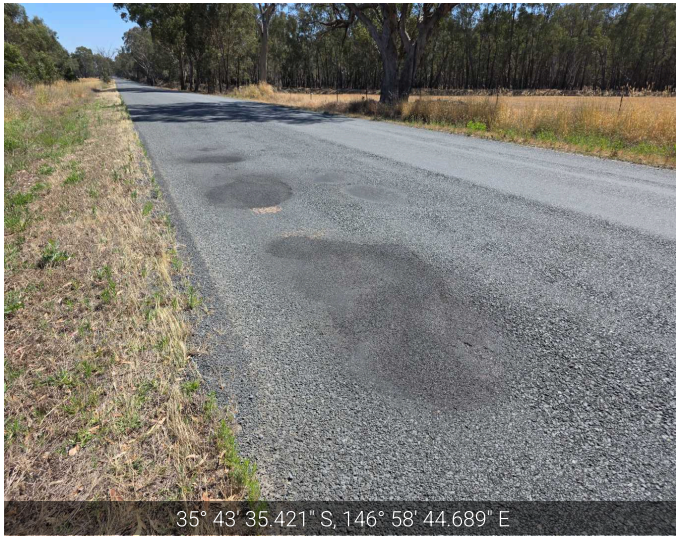
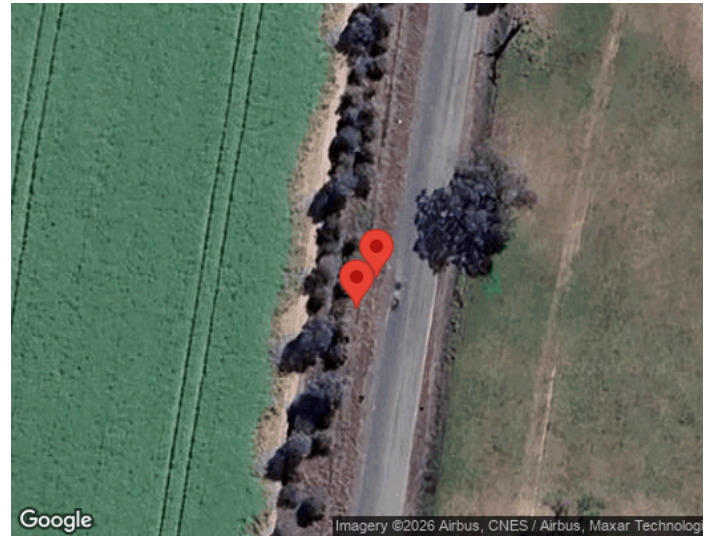
Repairs to Road

Cracking to Surface exposing roadbase

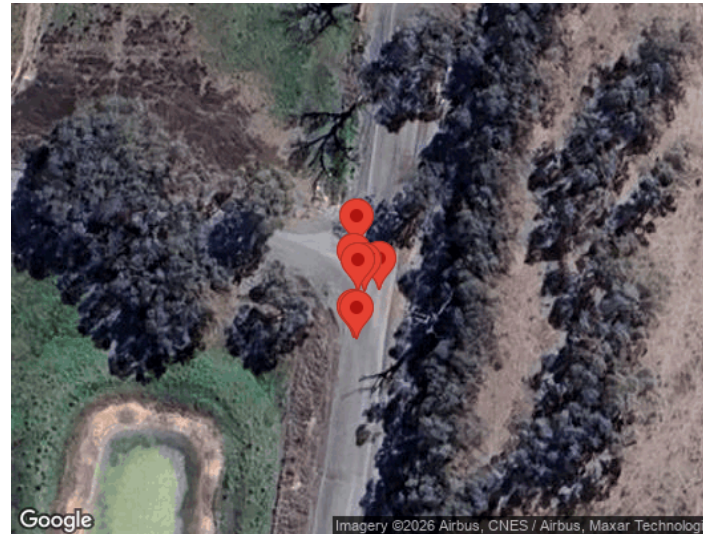
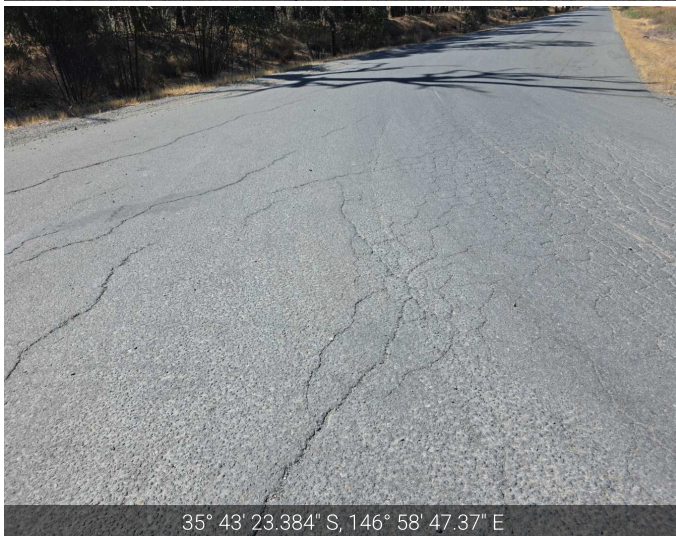
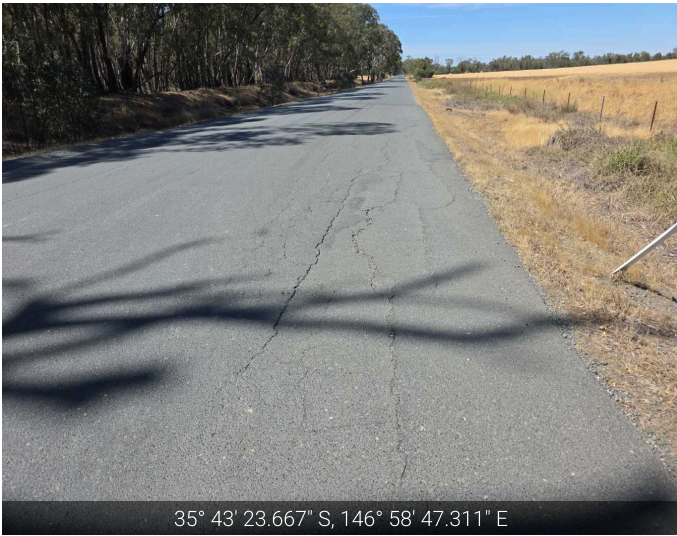
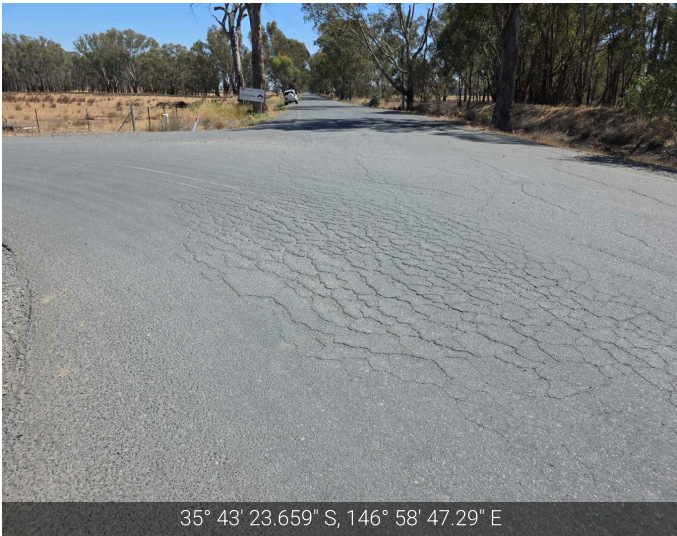
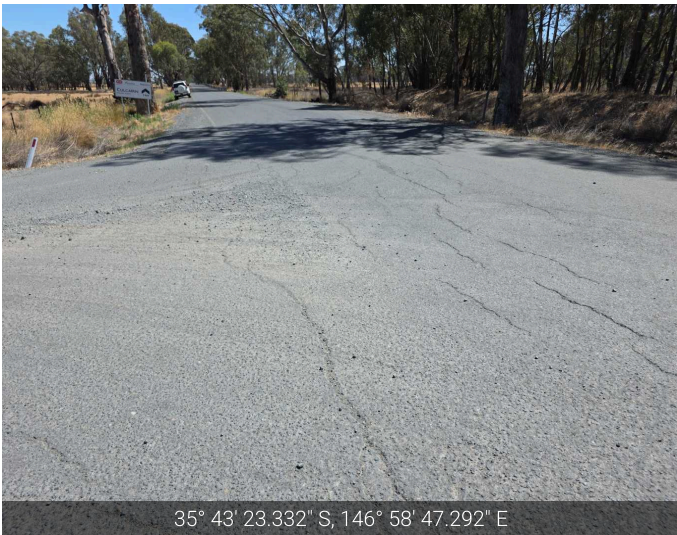
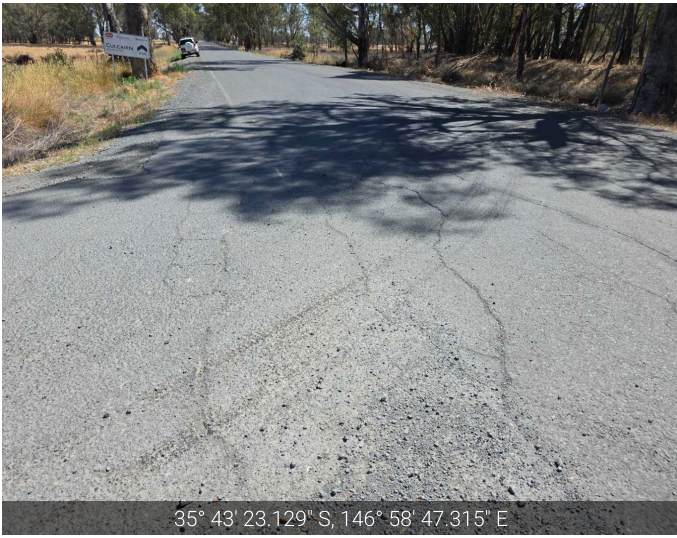
Cracking to Road Surface

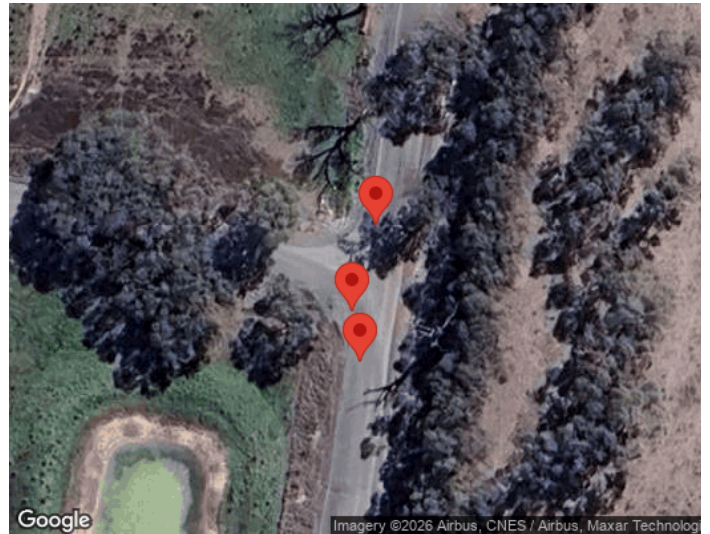
Damage to Road Markers

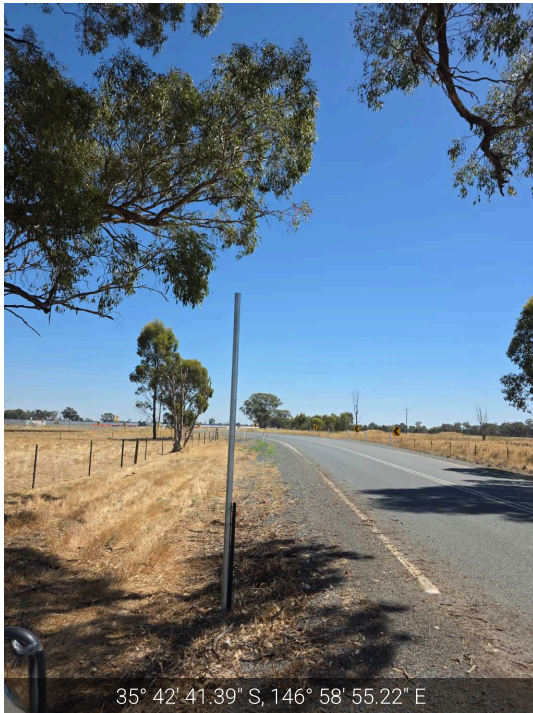
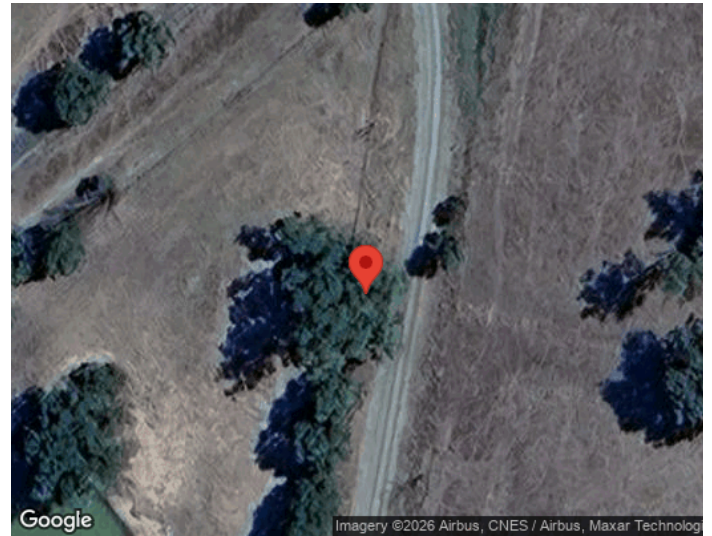
Folder: Weeamera Rd    Record type: Dilapidation    Tags: Damage To Signage  
Missing Signage

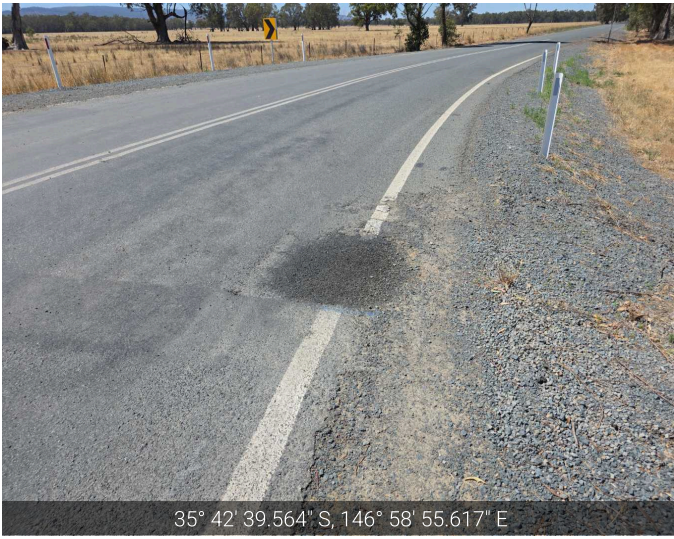
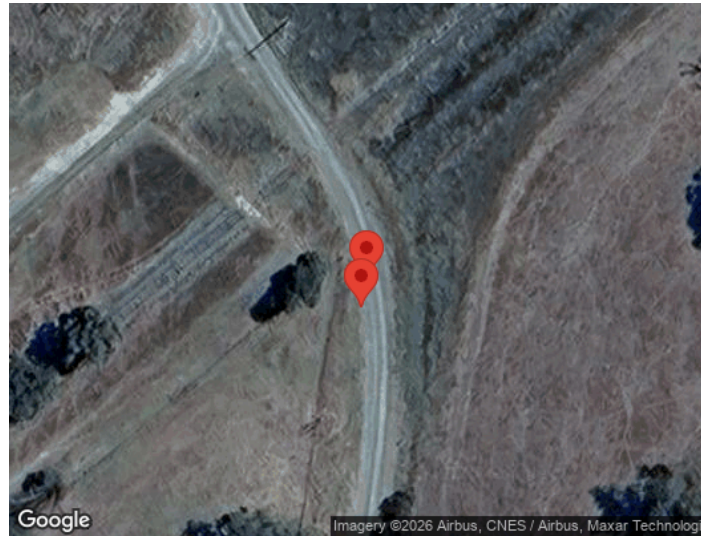
Repairs to Road

Uneven finish to Road

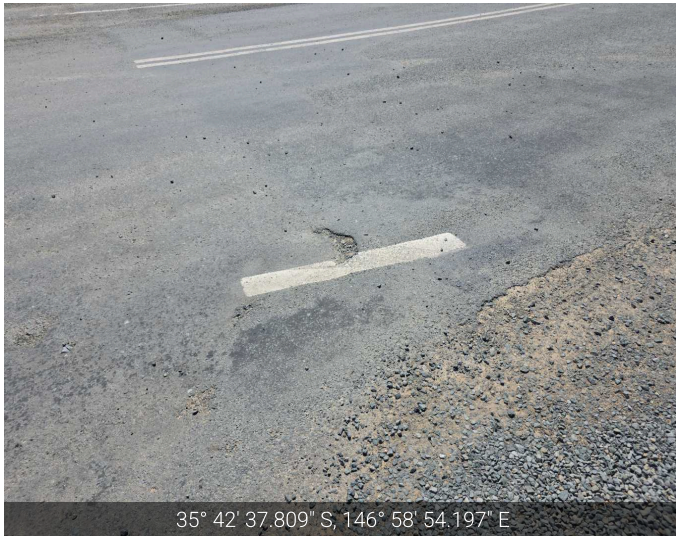
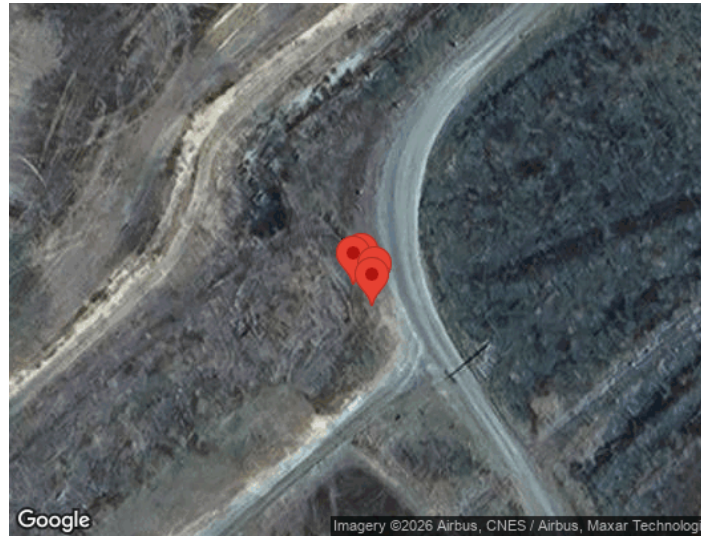
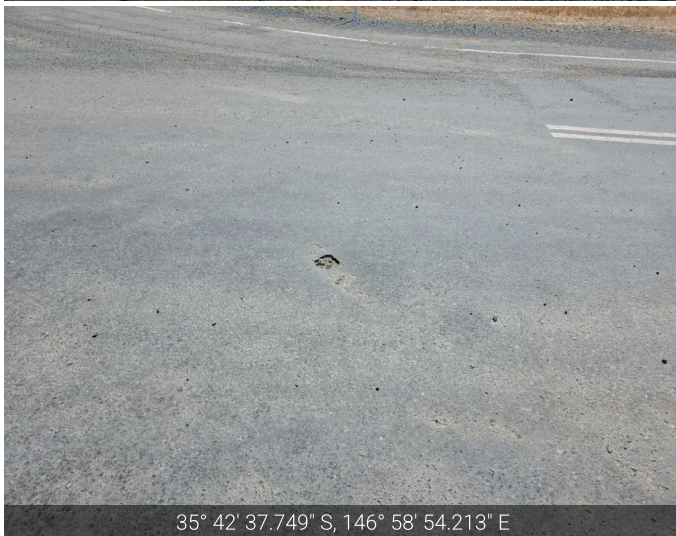
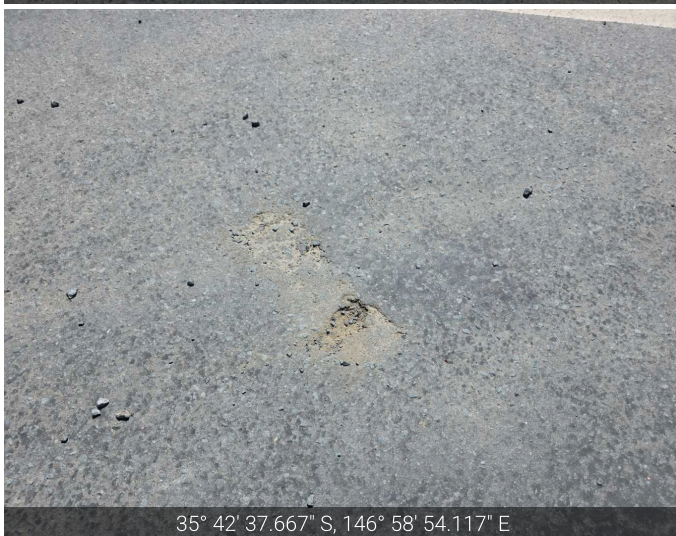
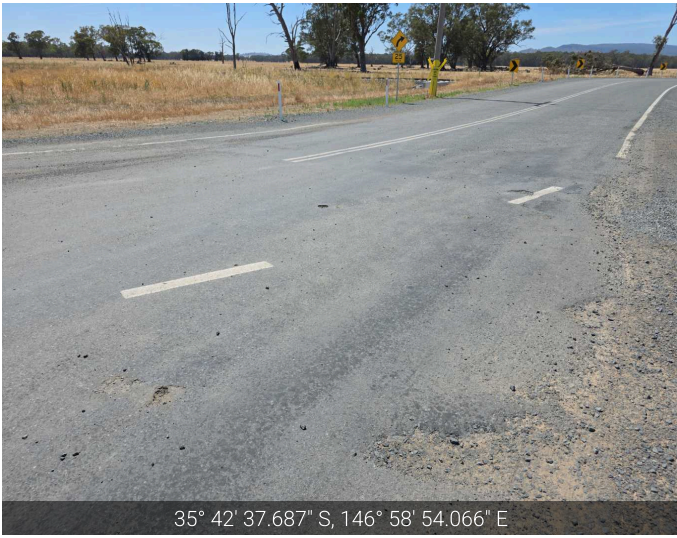
Damage to Road Surface exposing the Road Base

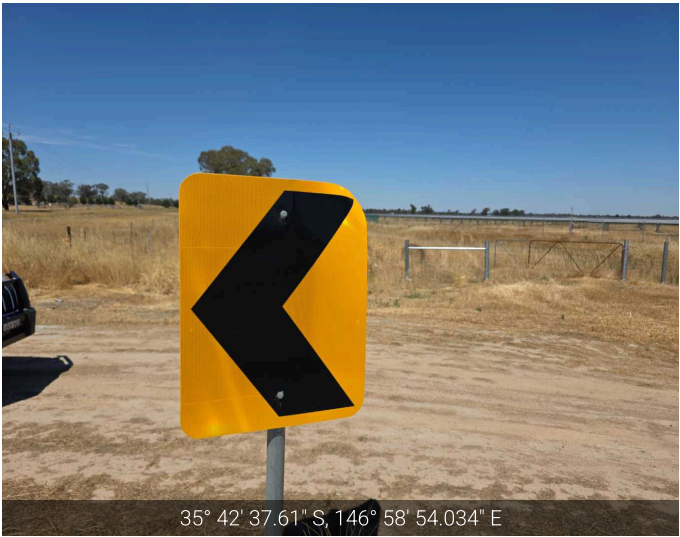
Item 43

Damage to Signage

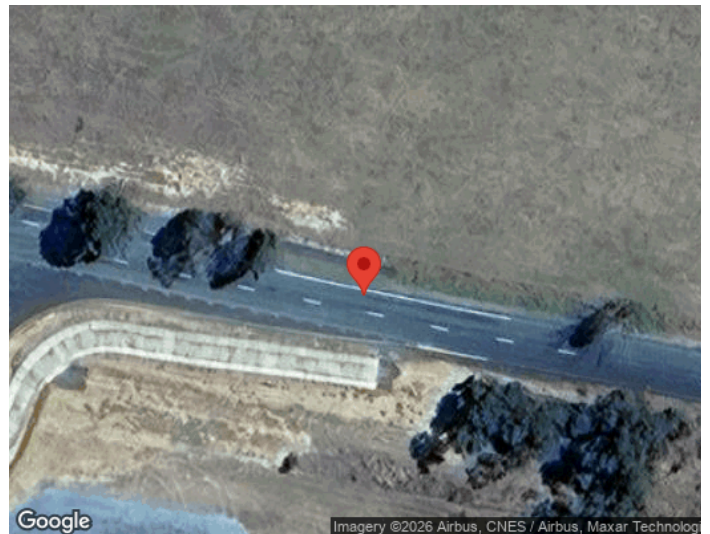
**Item 45**

Folder: Benambra Rd    Record type: Dilapidation    Tags: Heaving of the road surface from heavy vehicle access, Repairs  
Patching and Heaving to Road finish

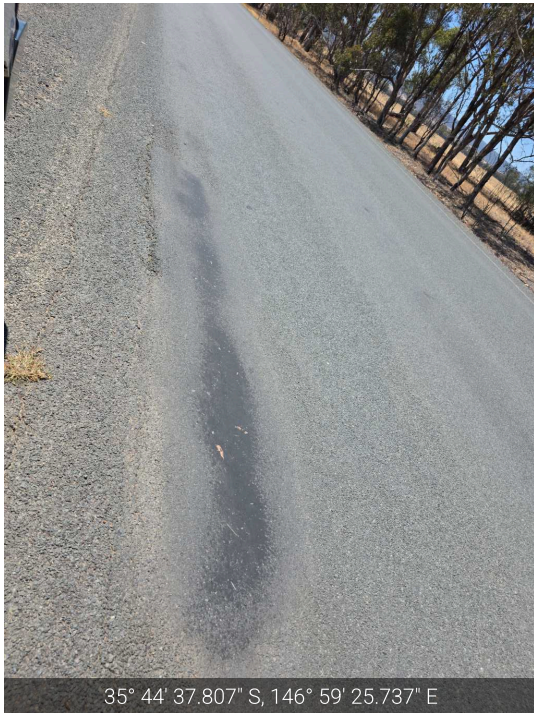
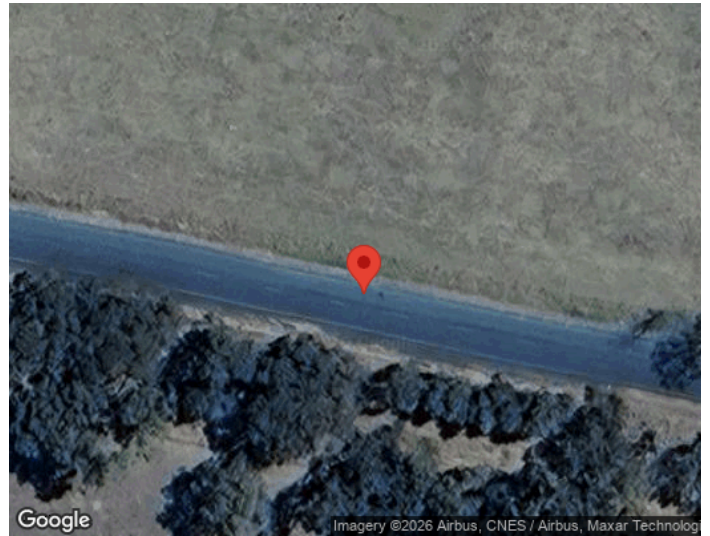
Patching to Road Surface

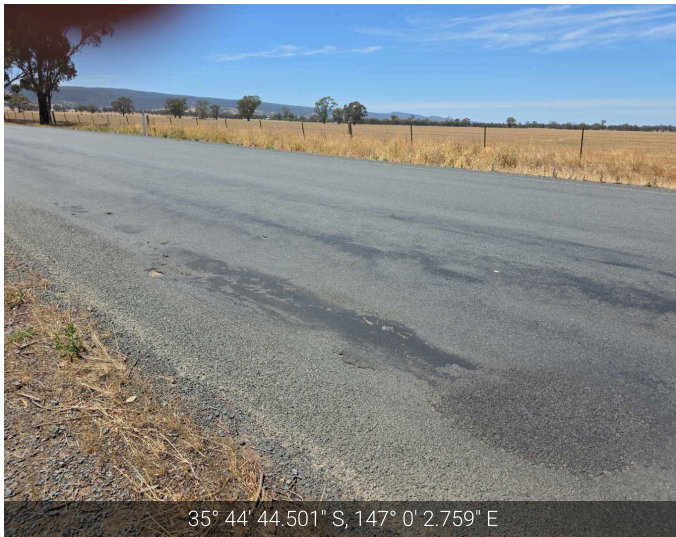
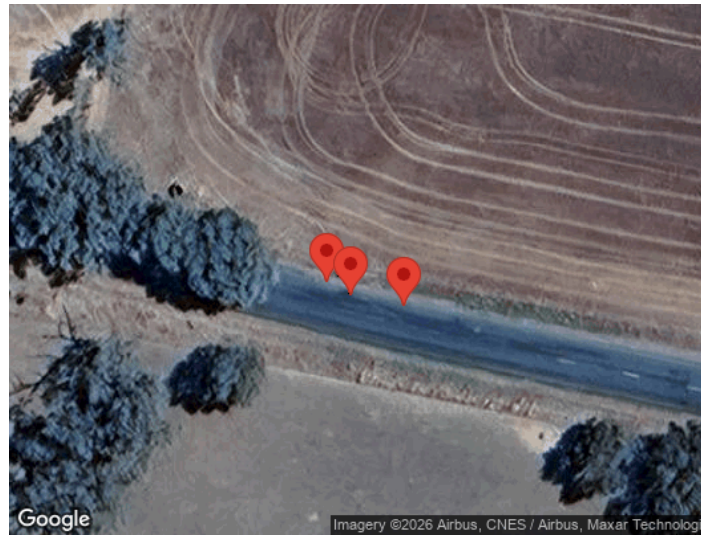
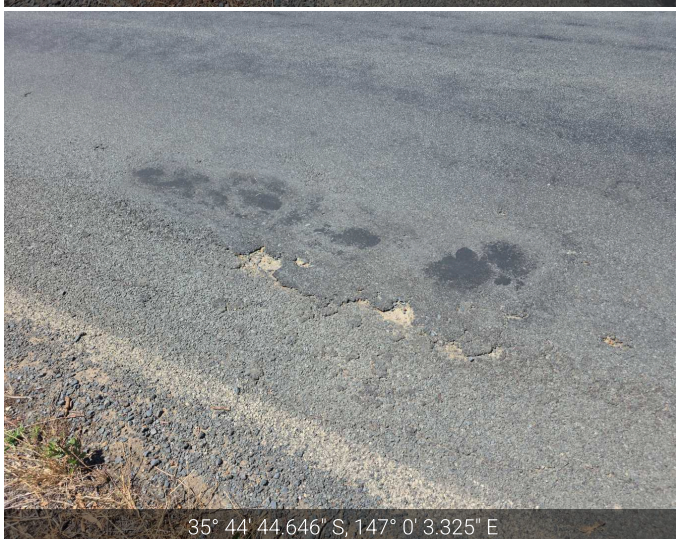
Patching to Road Surface

Exposed Road Base

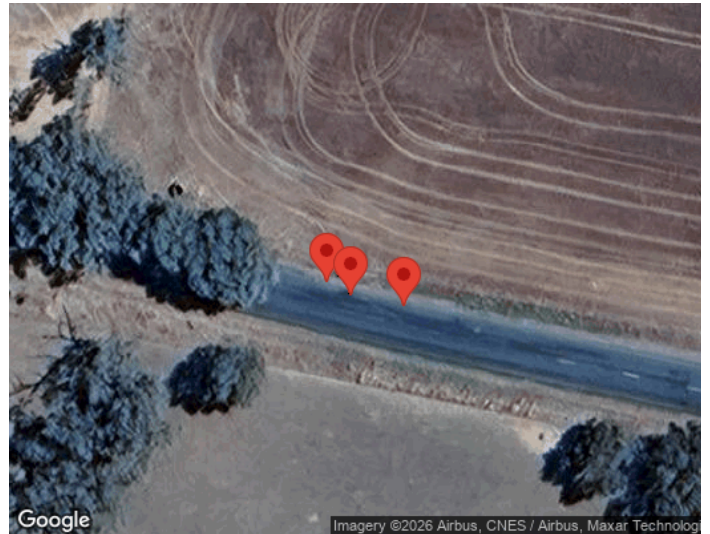
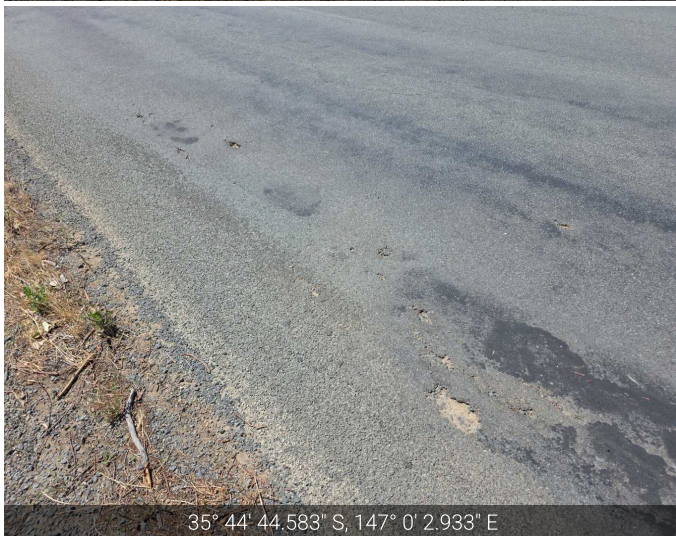
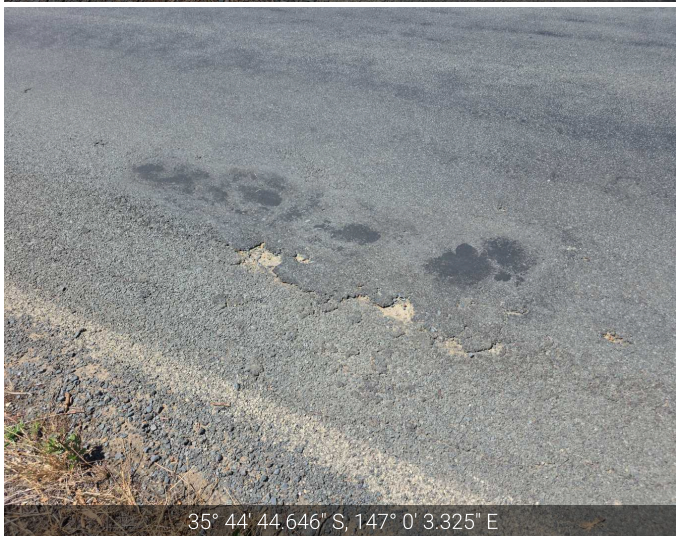
Patching to Road Surface
