# CULCAIRN BESS

## Access Road Dilapidation report August 2026

| Design Phase : N/A | | Document no: NEO-CUBS-CV-REP-2707 | Number of pages : 43 | | |

### RE: Dilapidation Inspection and report - Culcairn BESS Solar Farm Surrounding roads:

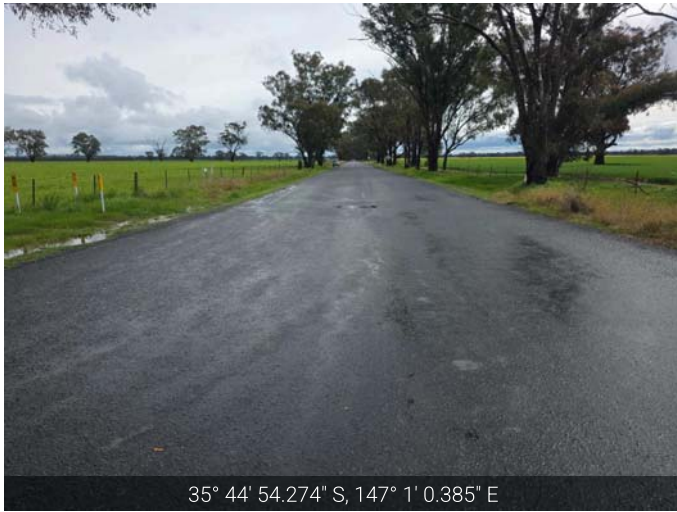
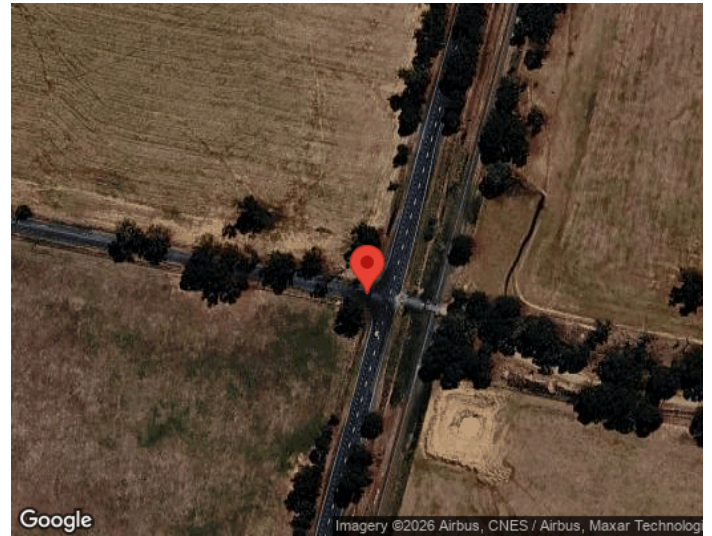
Benambra Road Intersection

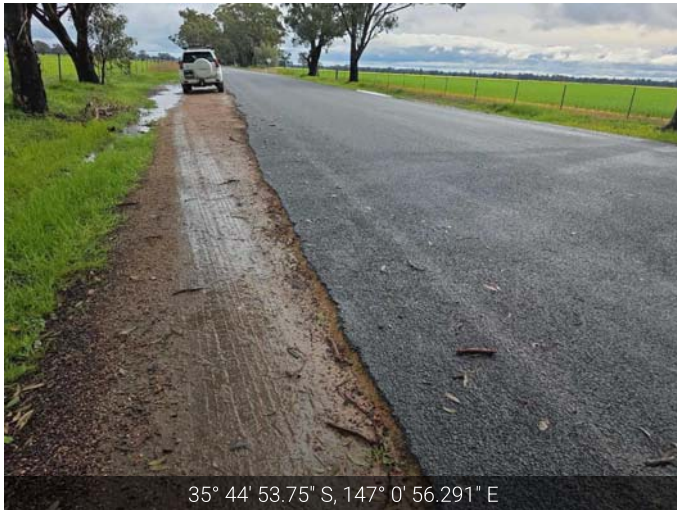
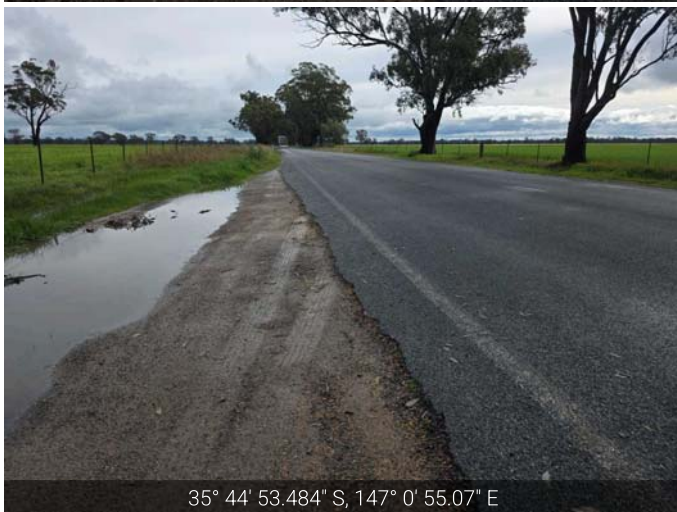
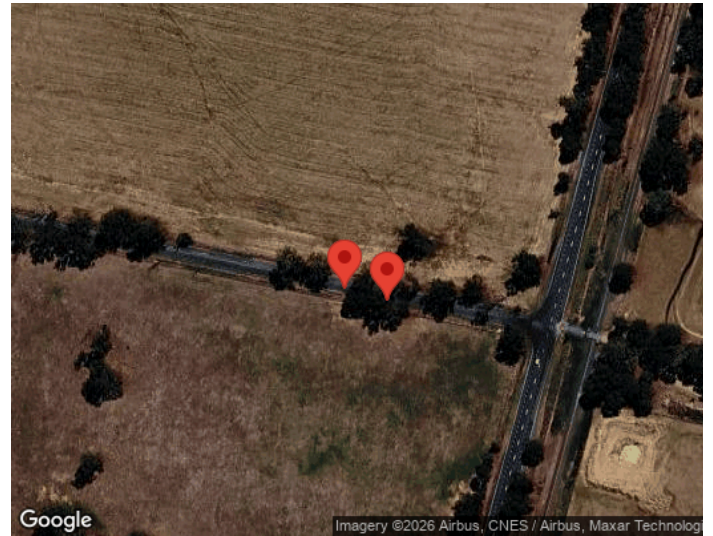
Edge Break-up to road

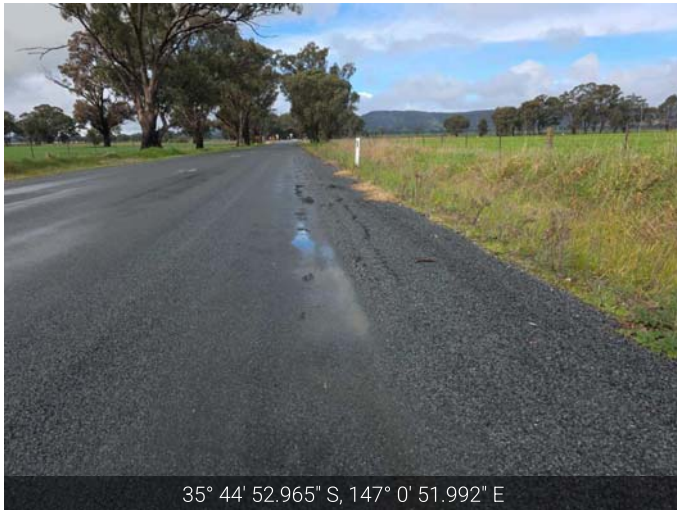
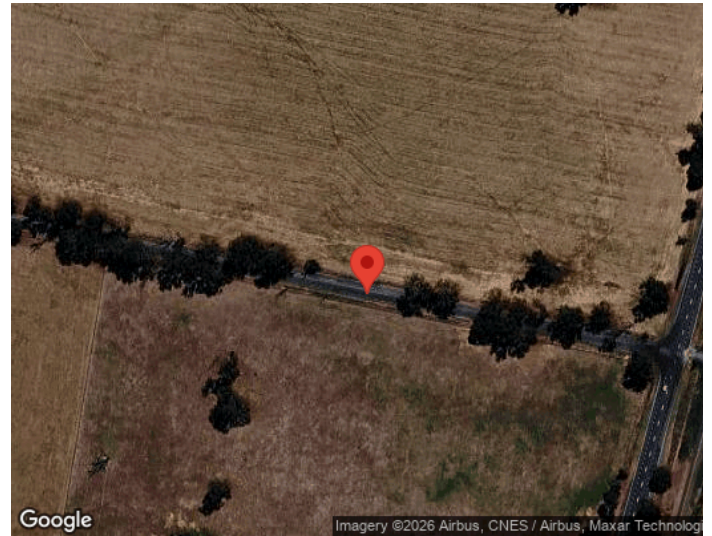
Heaving of road edge

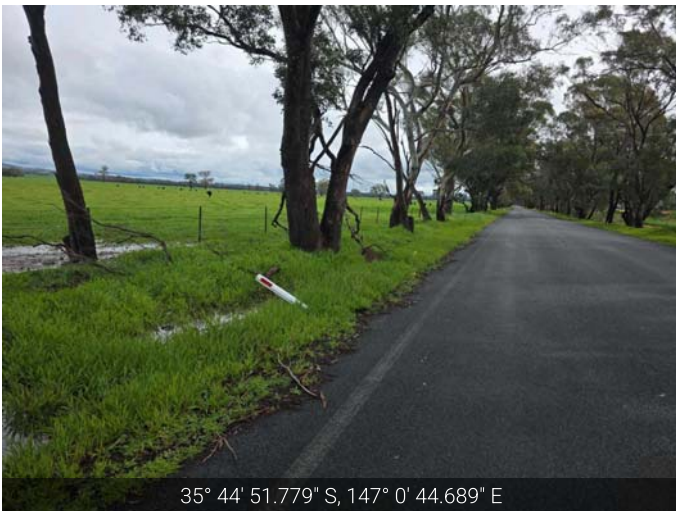
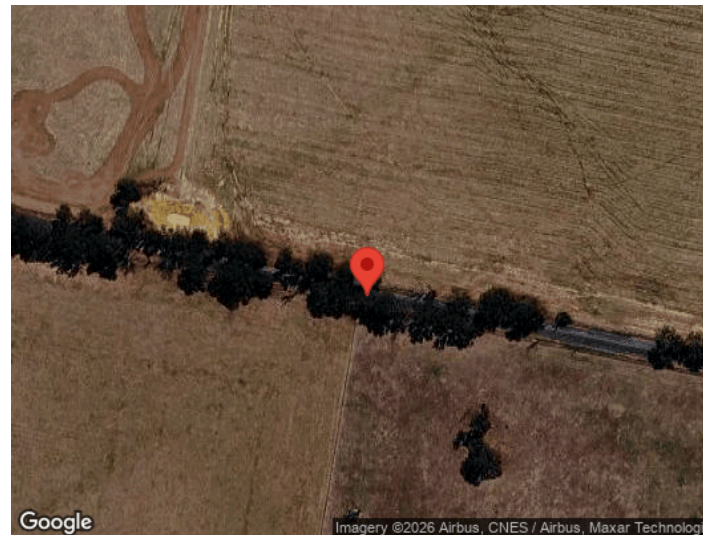
Damage to Road Marker

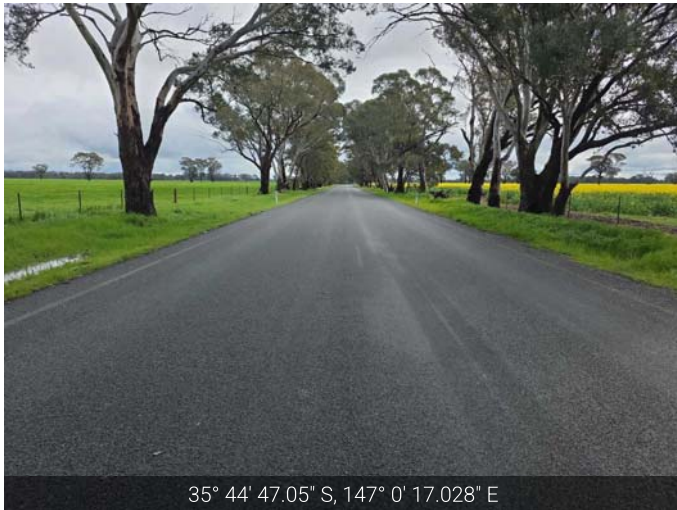
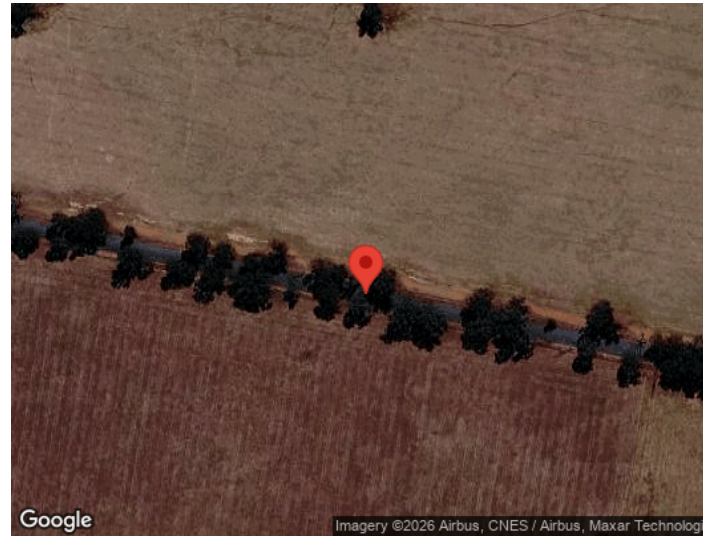
Heaving to road surface

Small break-up to road surface

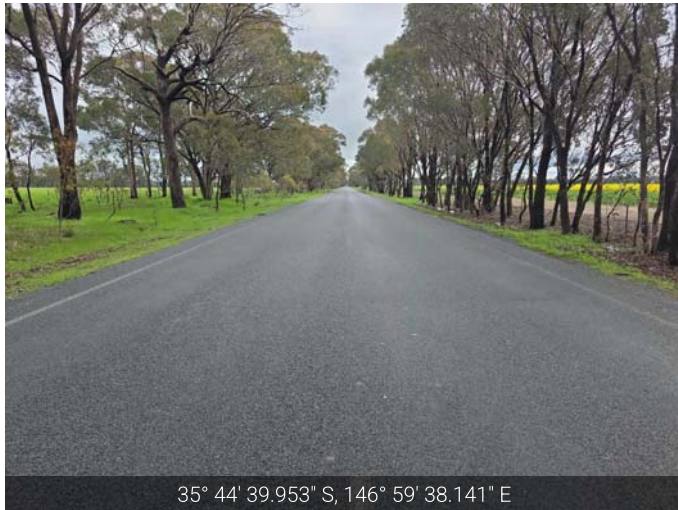
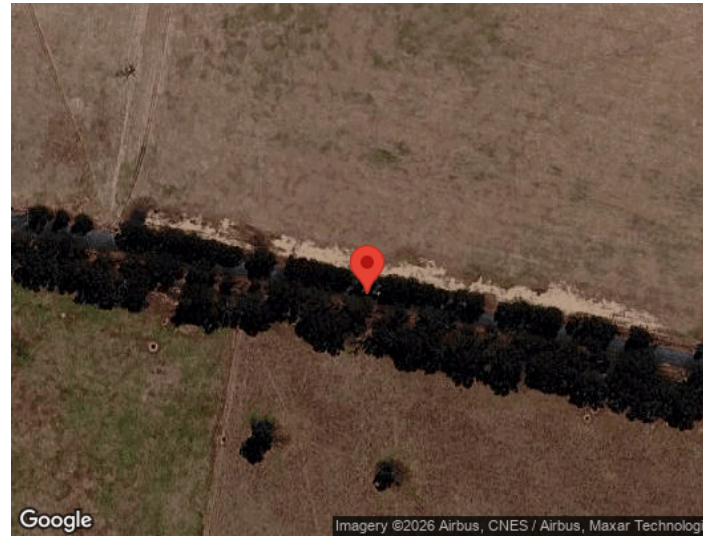
Water on road over surface break-up

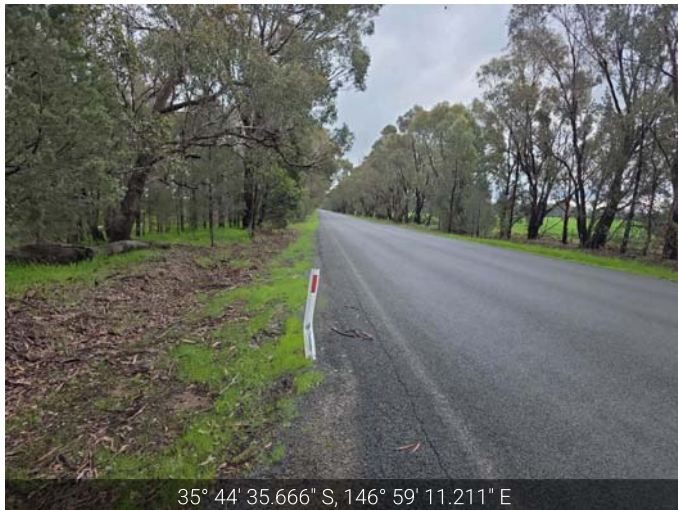
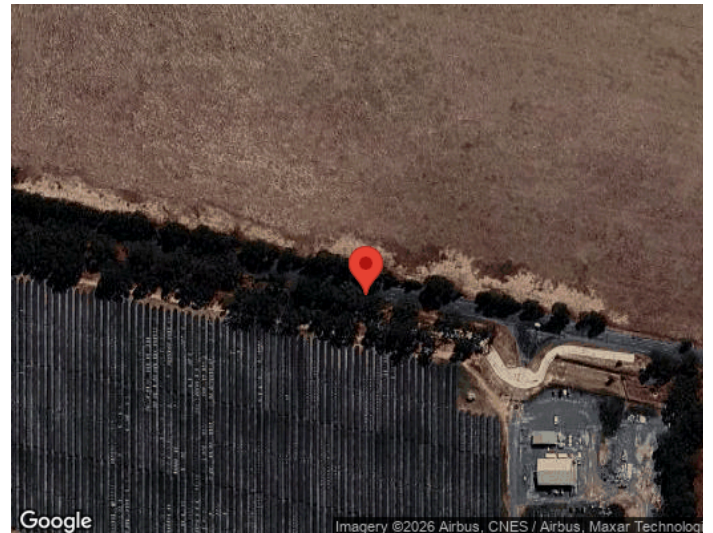
Damage to Road Marker

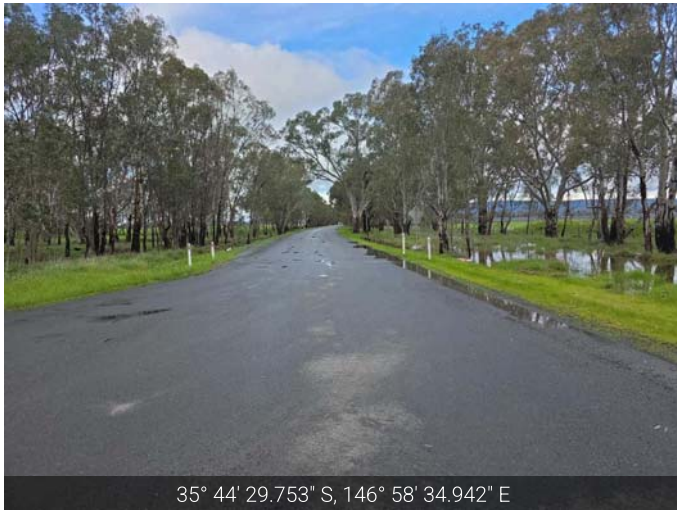
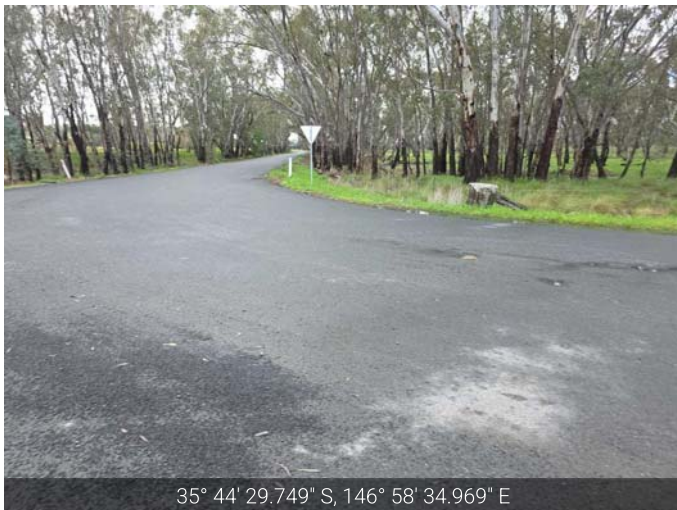
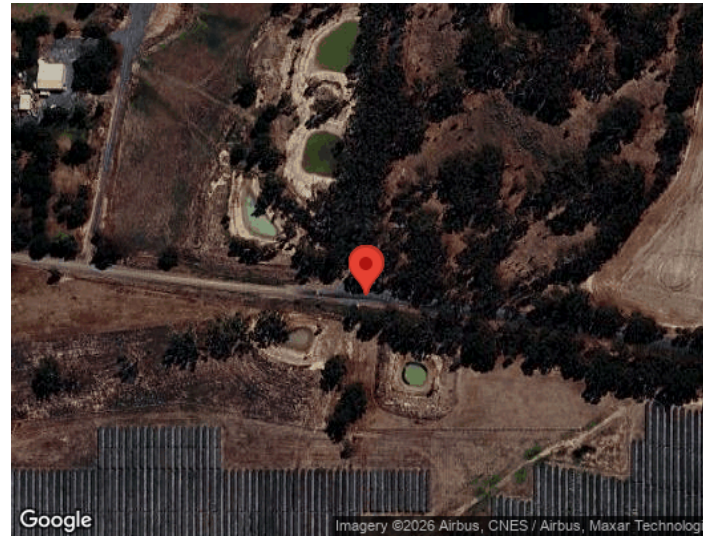
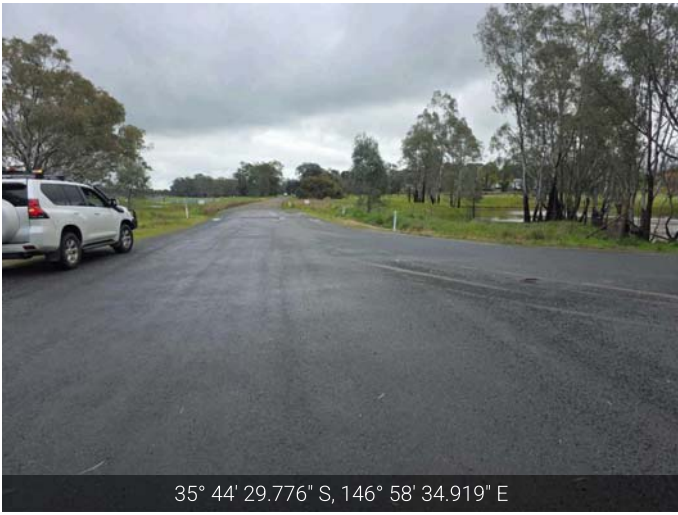
Benambra Rd / Weeamera Rd Intersection

Potholing

Crocodile Cracking

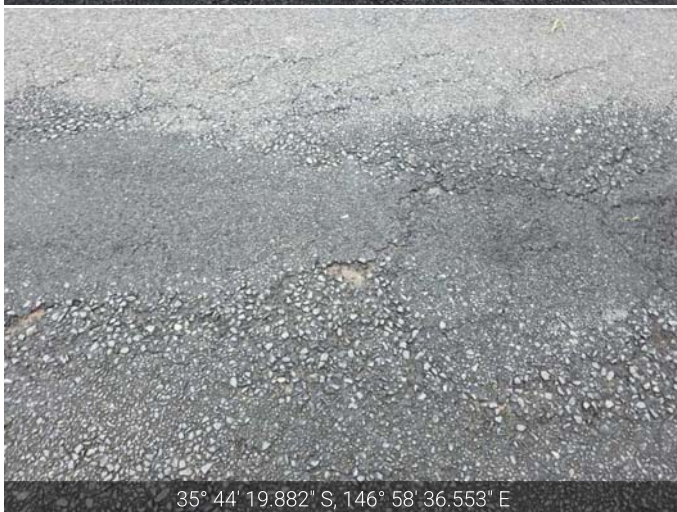
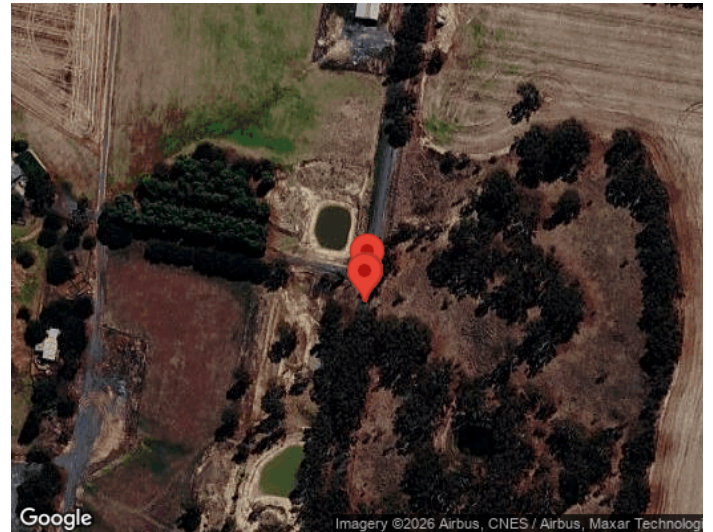
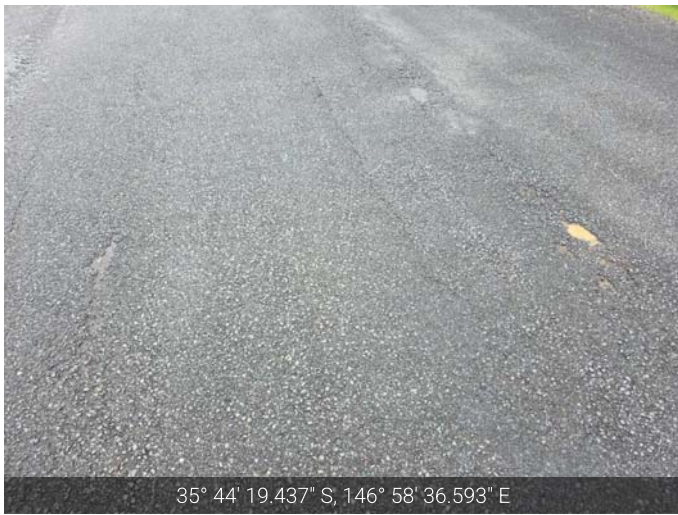
Surface Break-up

Patch sealing Repairs

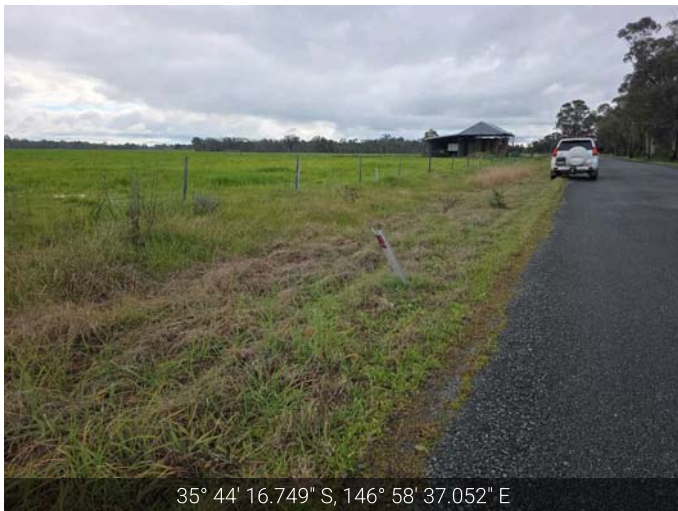
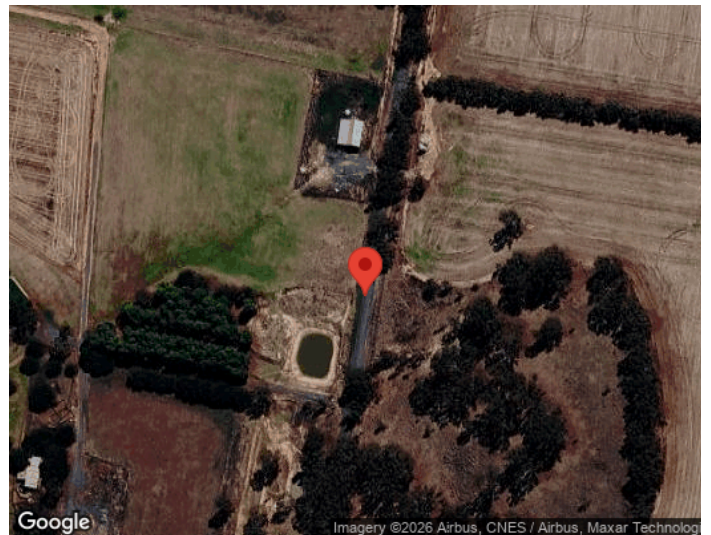
Damage to Road Marker

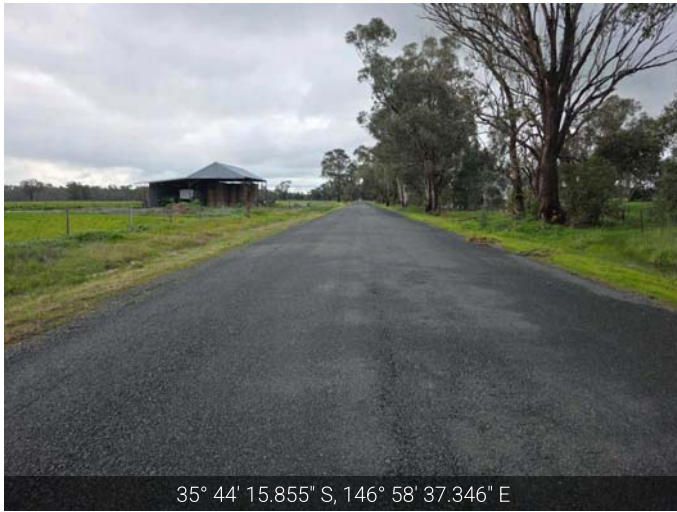
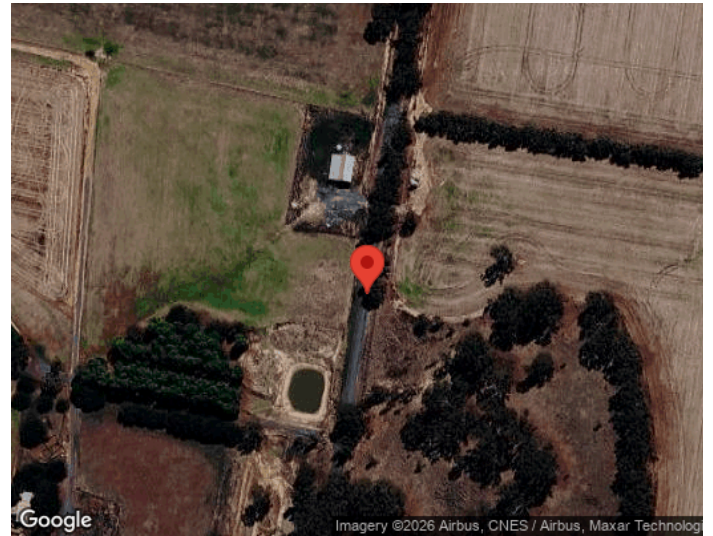
Foliage Growth through road base

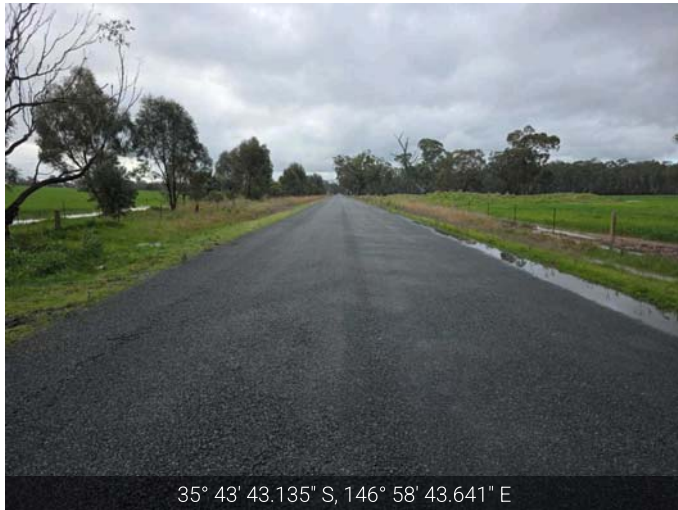
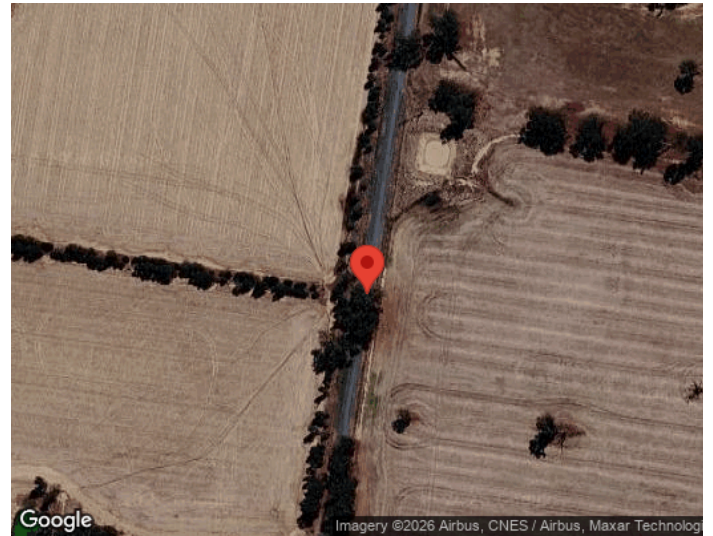
Damage to Road Marker

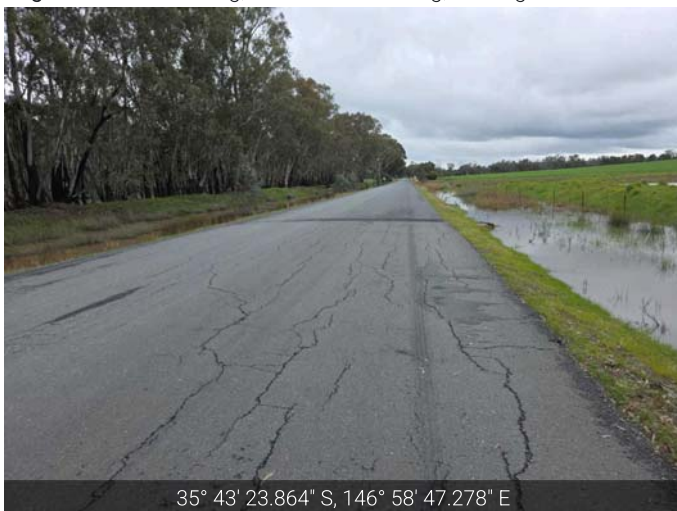
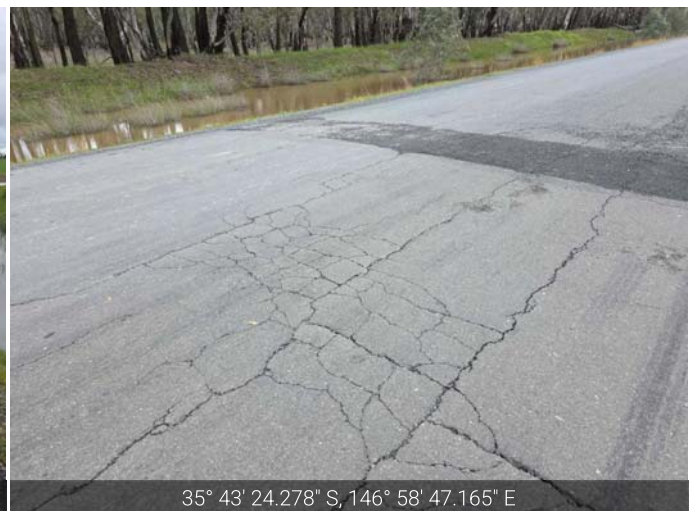
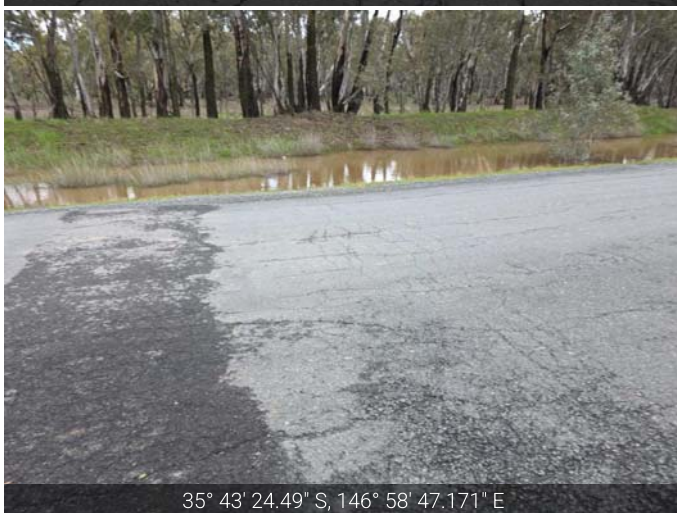
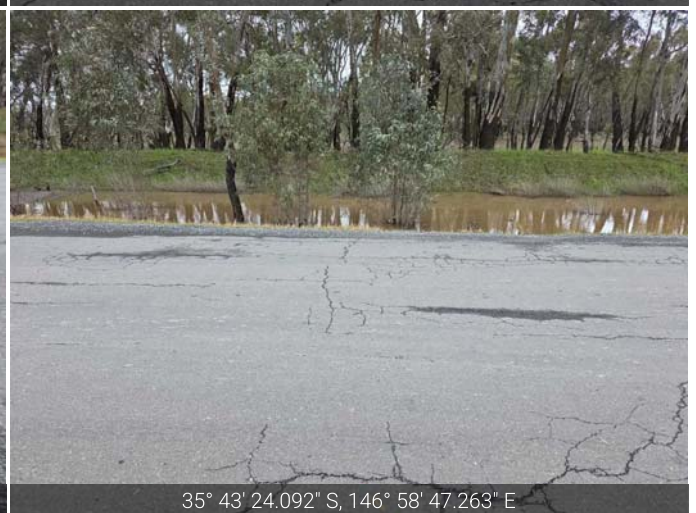
Longitudinal Cracking

Crocodile Cracking

Damage to Road Markers

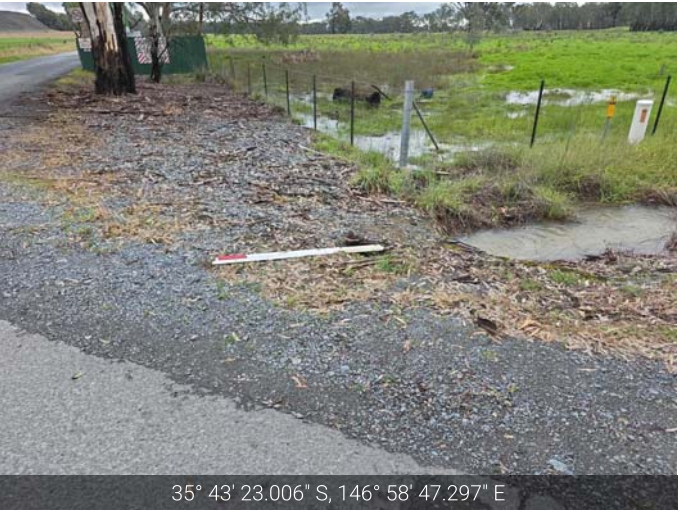
10 Aug 2026  
Damage to Road Marker

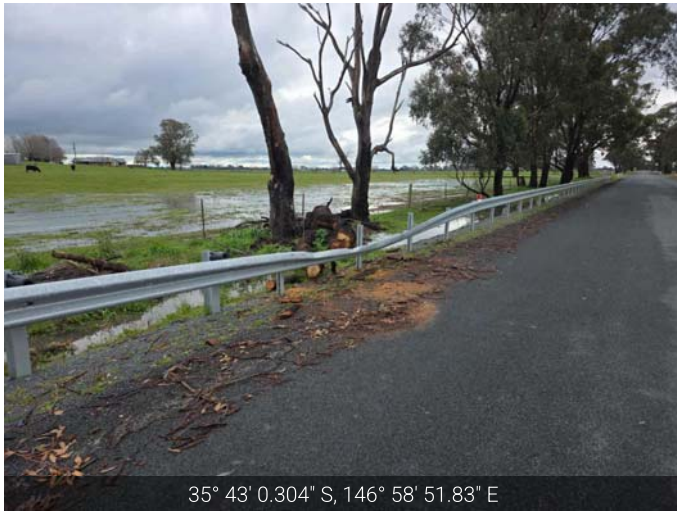
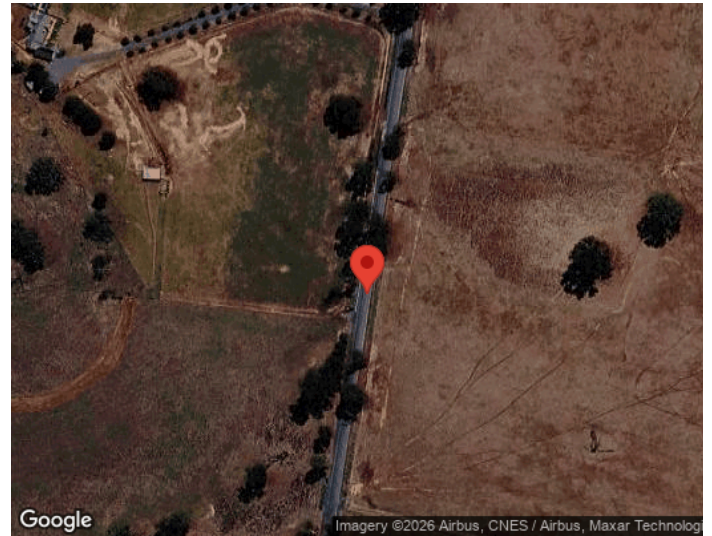
Damage to Guardrail

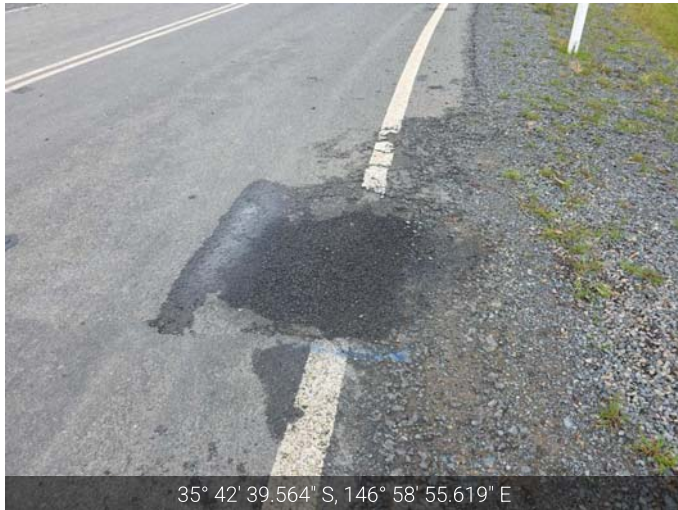
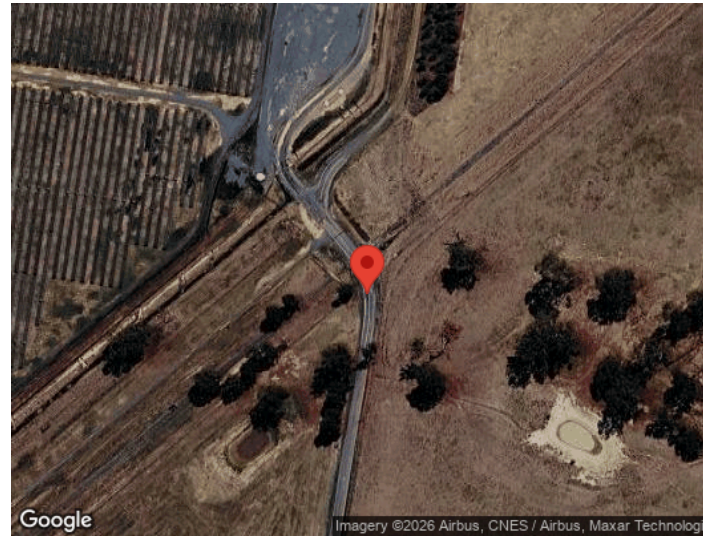
Slight Heaving to surface

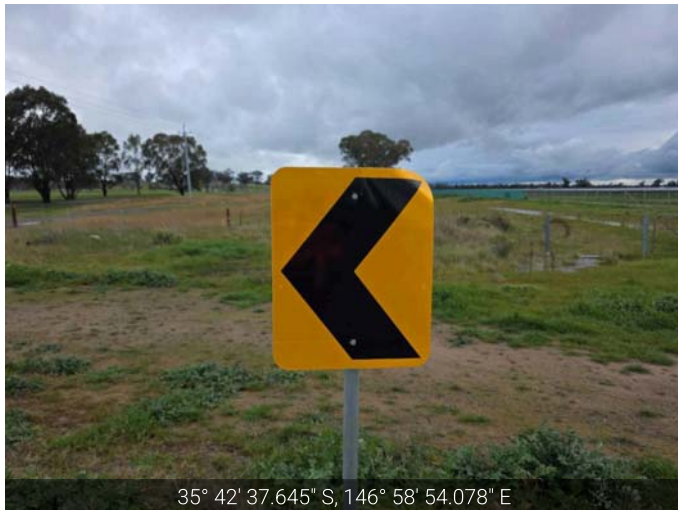
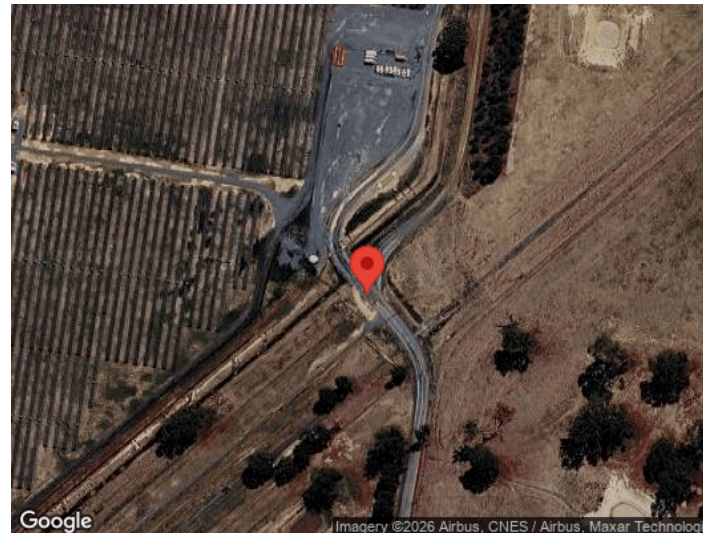
Damage tp signage adjacent to site entry

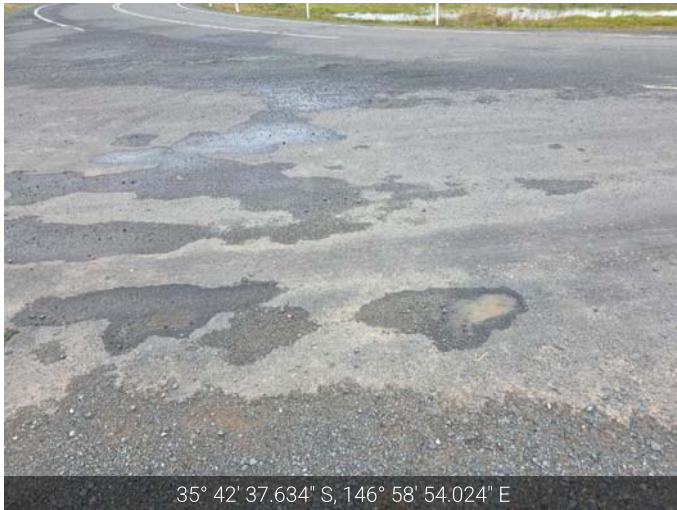
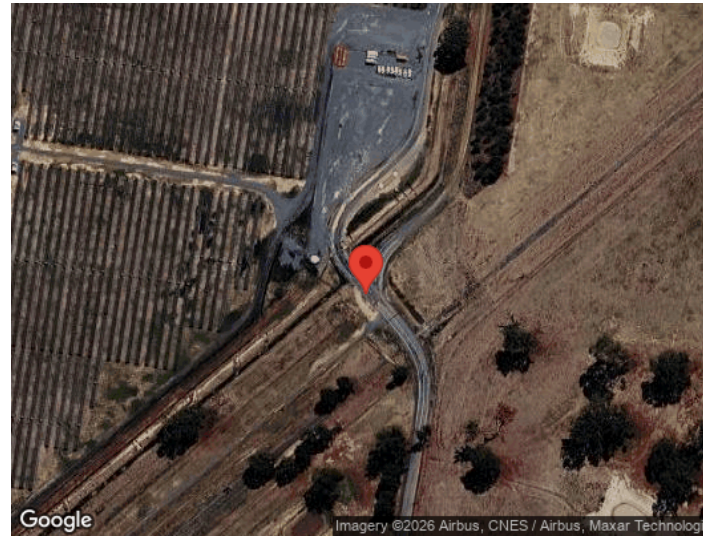
Potholing

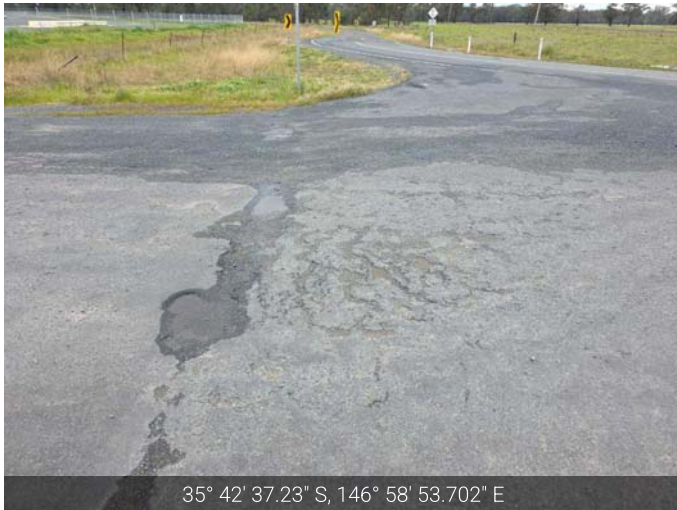
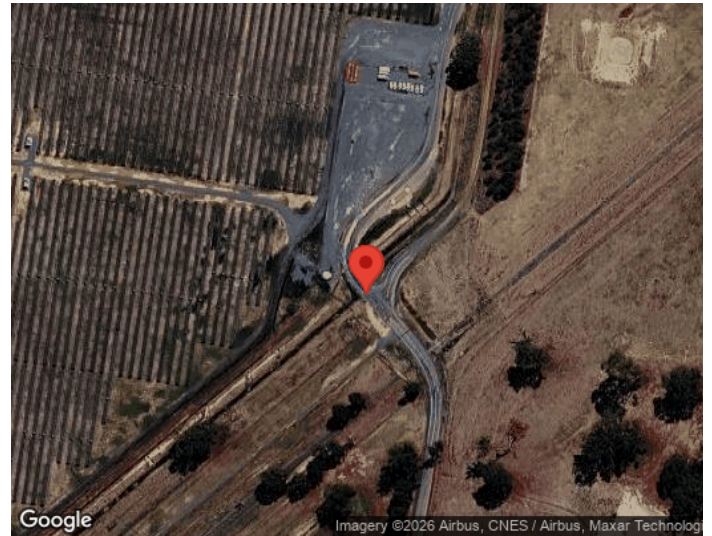
Surface Break-up exposing roadbase at site entry

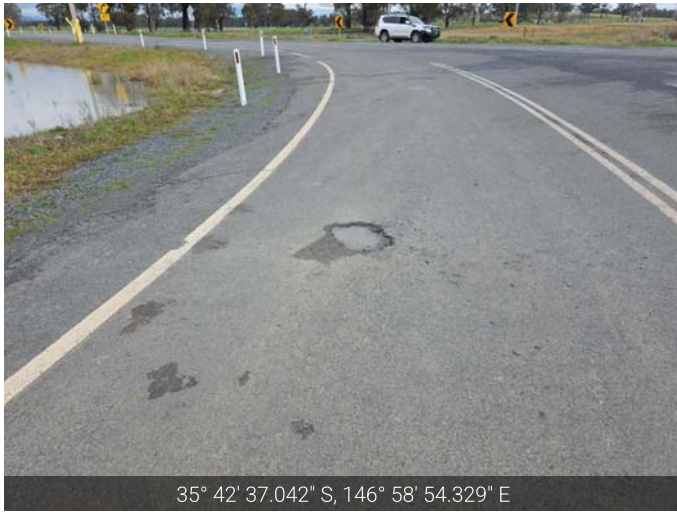
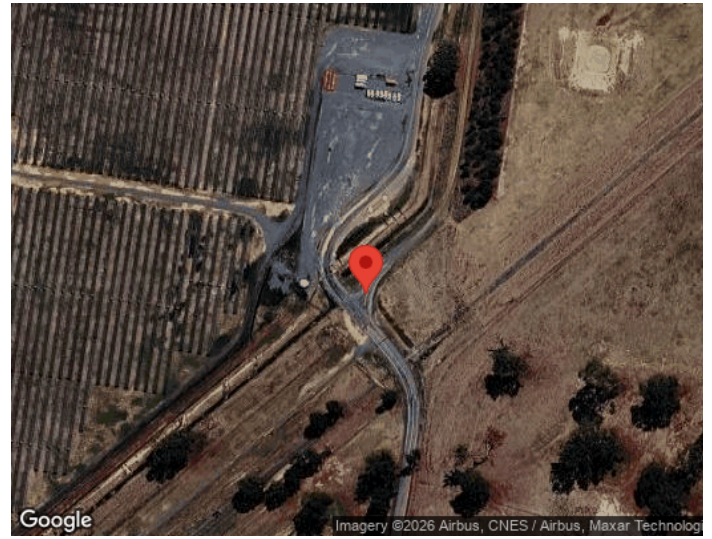
Potholing

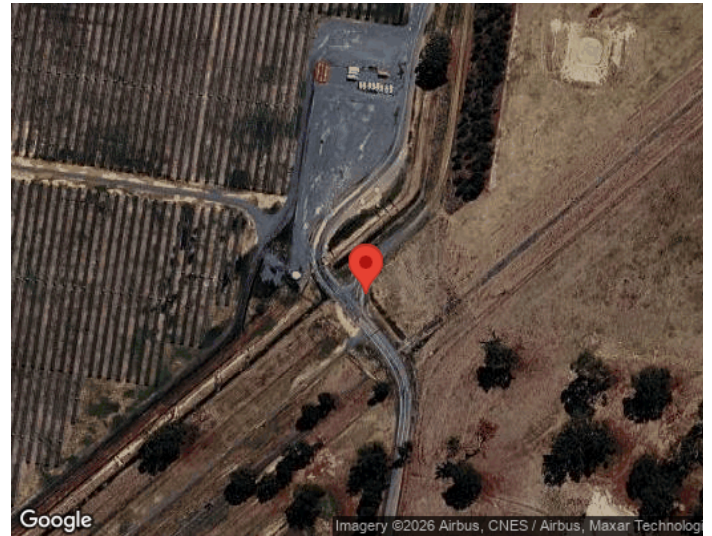
Gouging to Road Surface

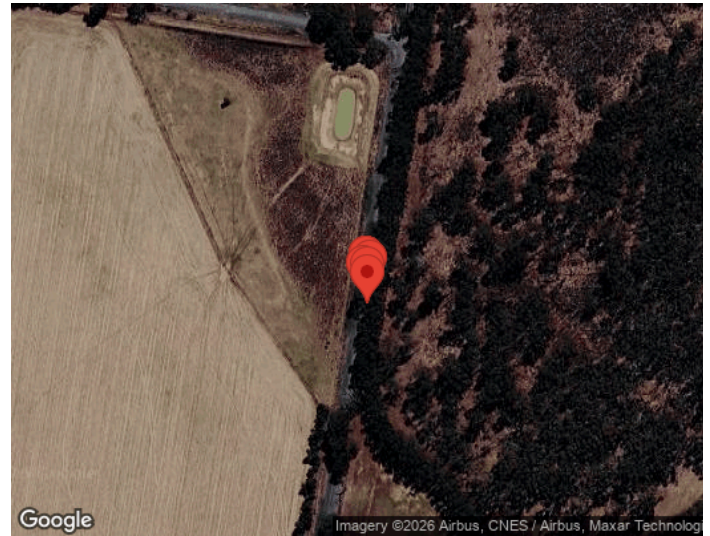
Directional Cracking to road surface

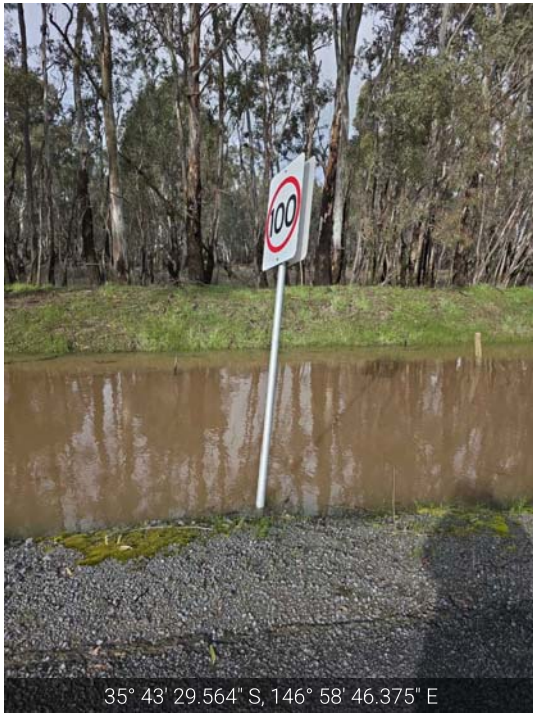
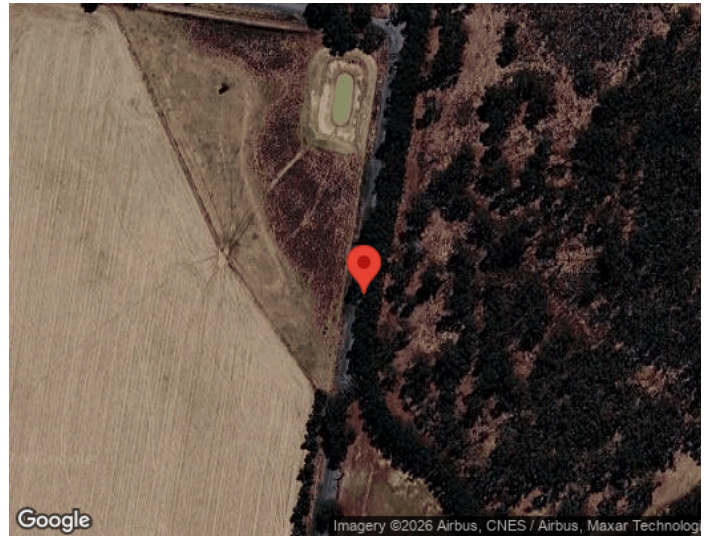
Signage on lean

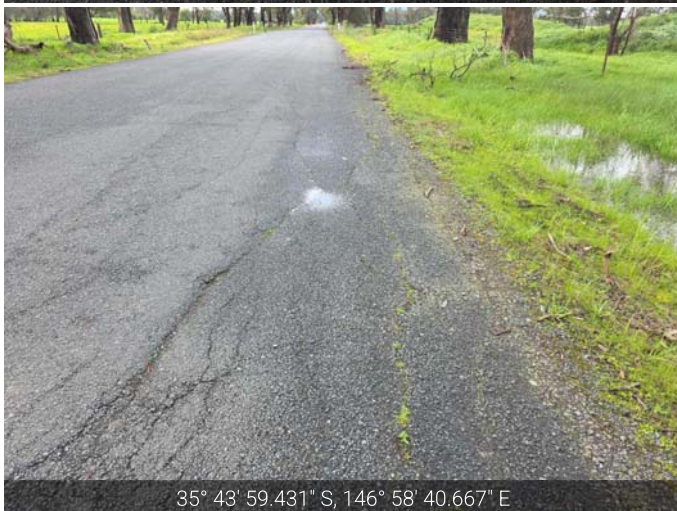
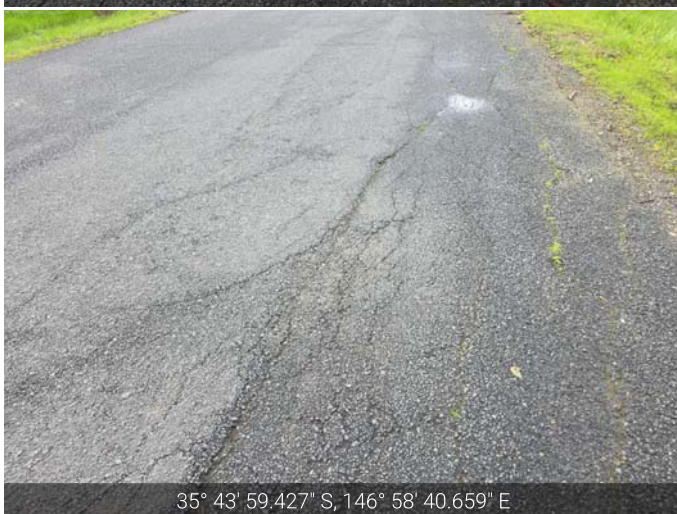
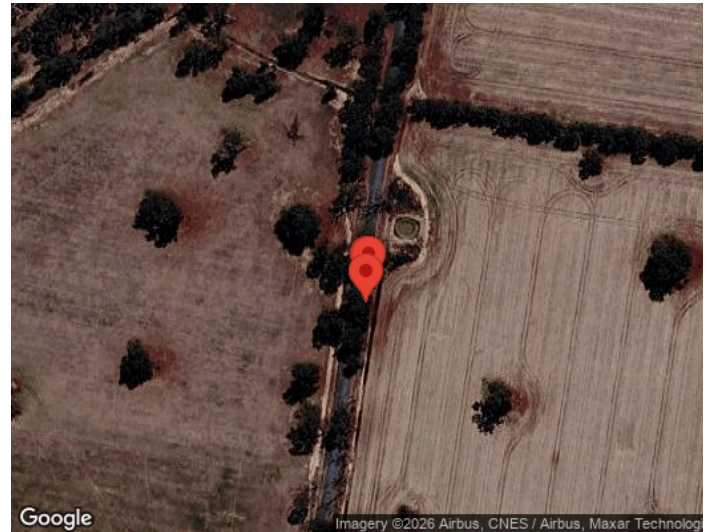
Foliage Growth through road base

Surface Cracking

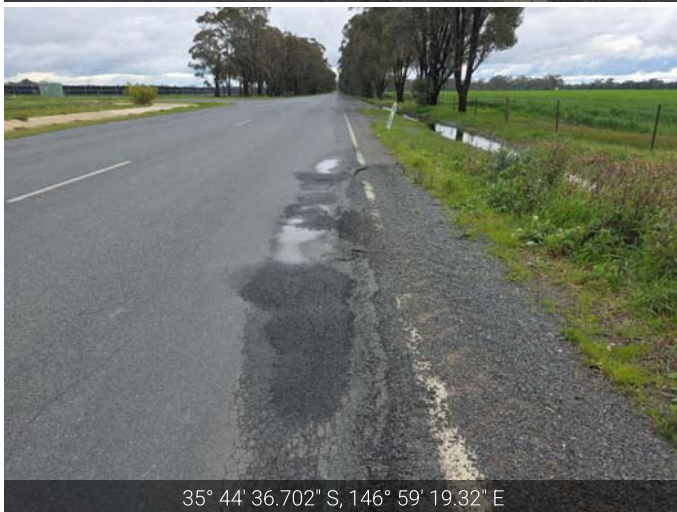
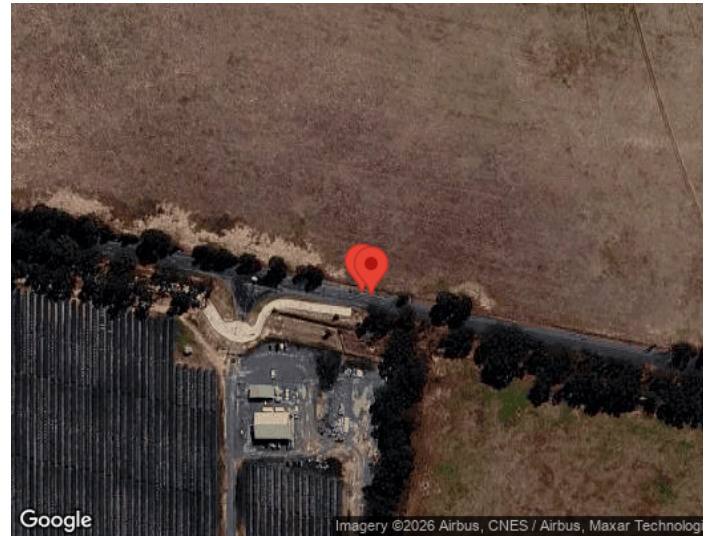
Heaving to road seal

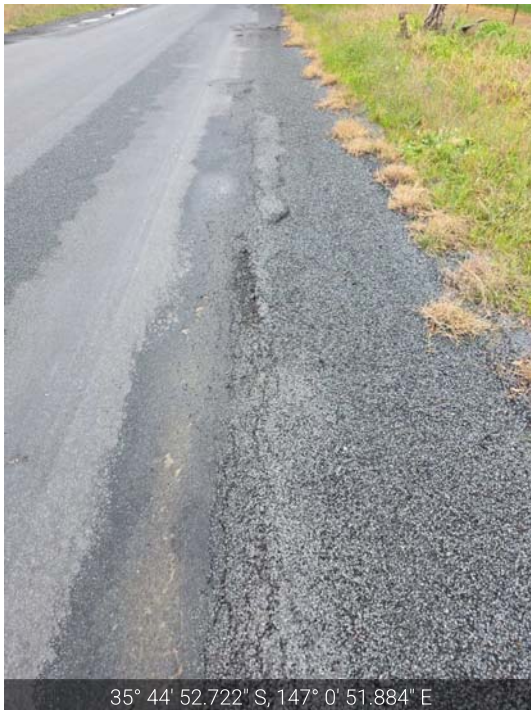
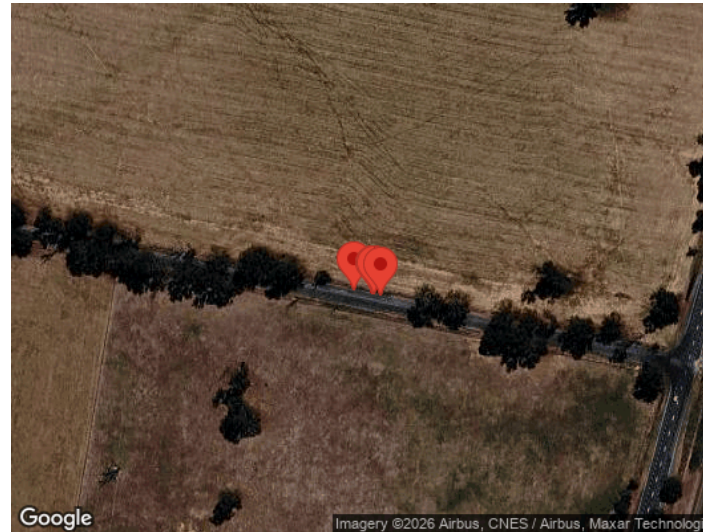
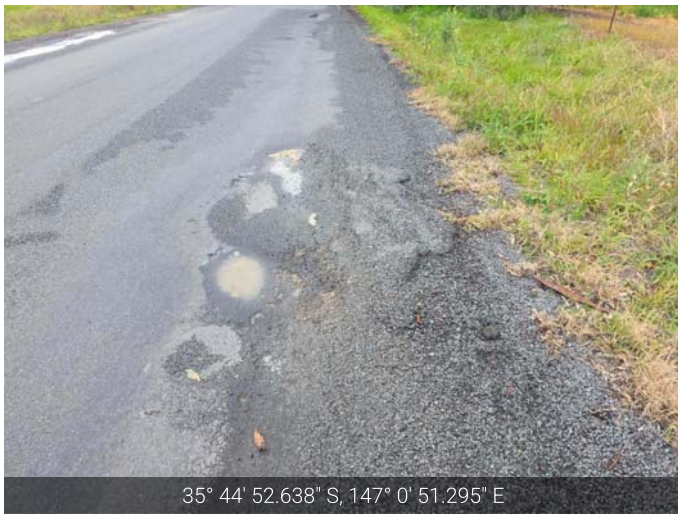
Heaving to edge of road

Spray seal repairs
