## Culcairn Closeout - Dilapidation Report - WSC December - 2025

Re: Dilapidation Inspection and report - Culcairn Solar Farm Surrounding roads:

- Benambra road "A" to "B", 3.8KM
- Weeamera road "B" to "C", 3.5KM

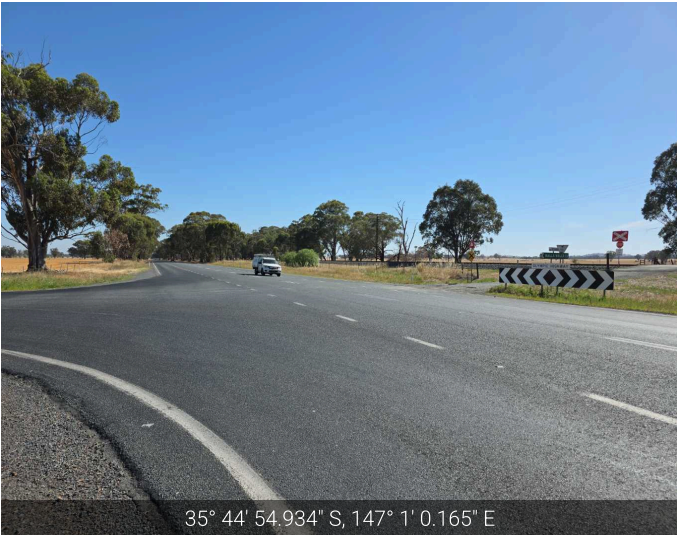
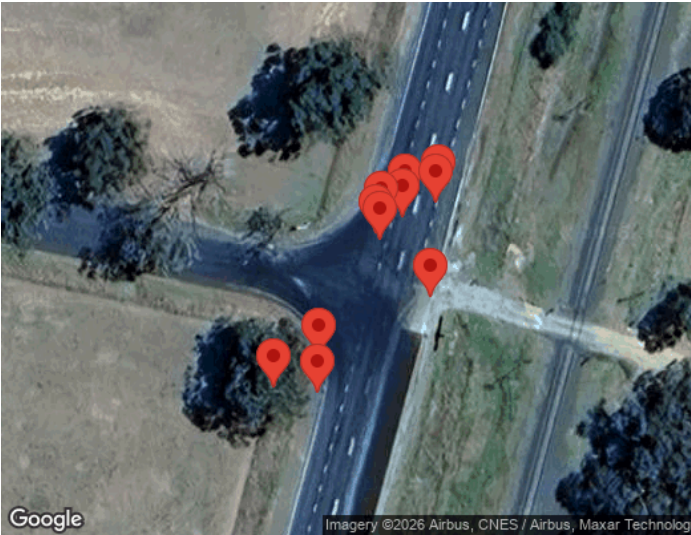
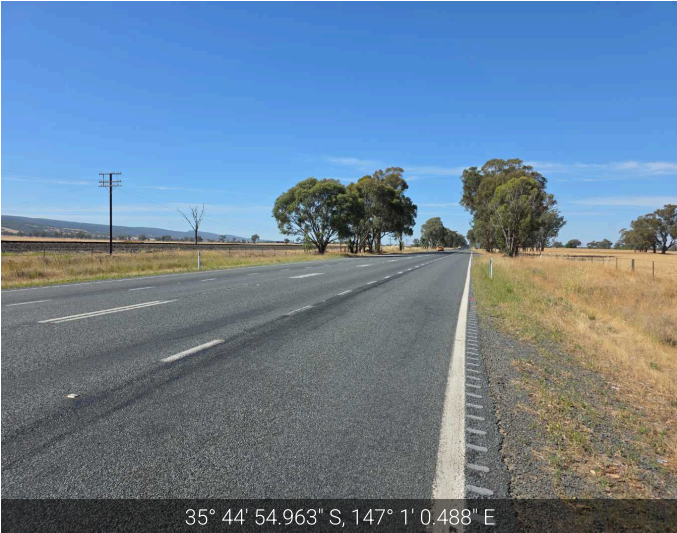
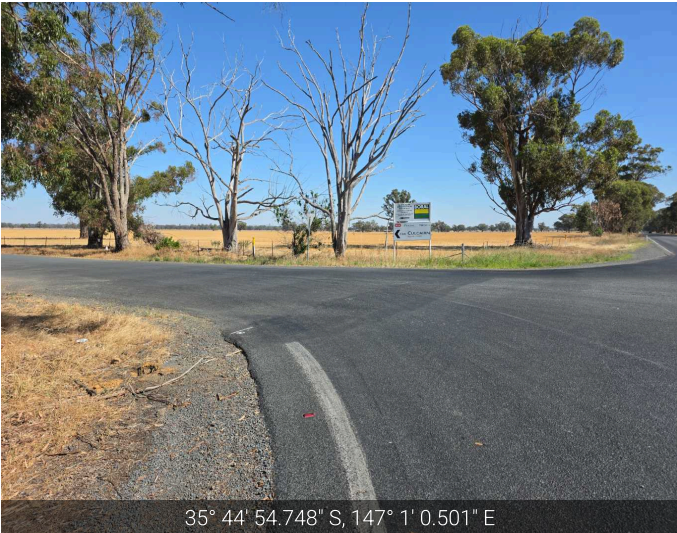
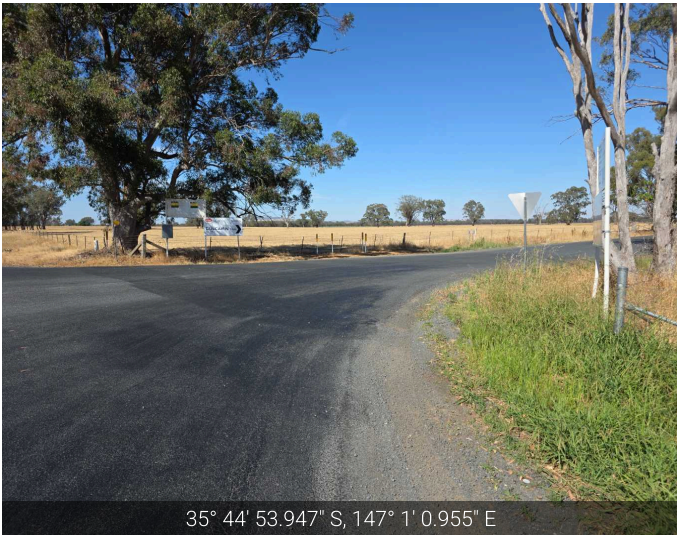
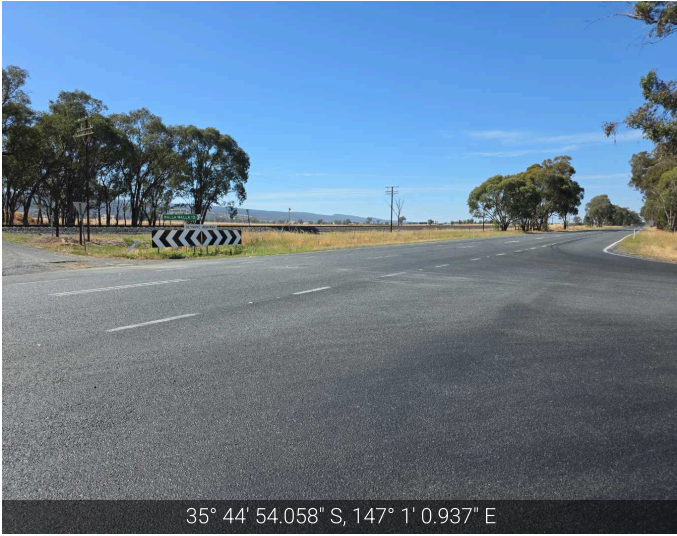
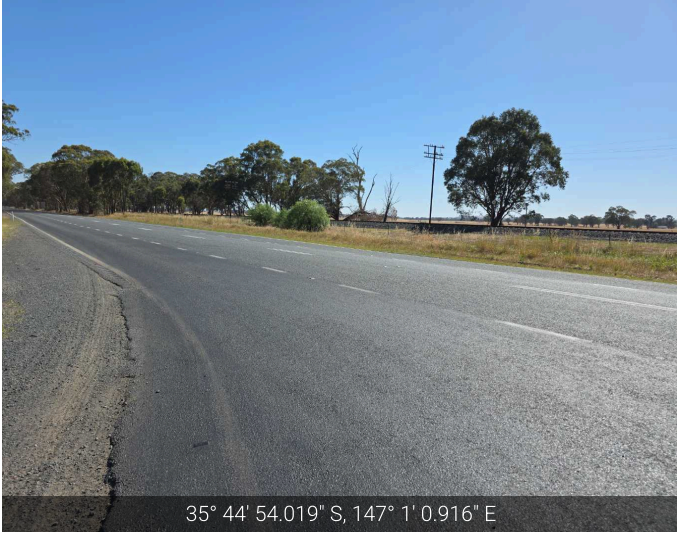
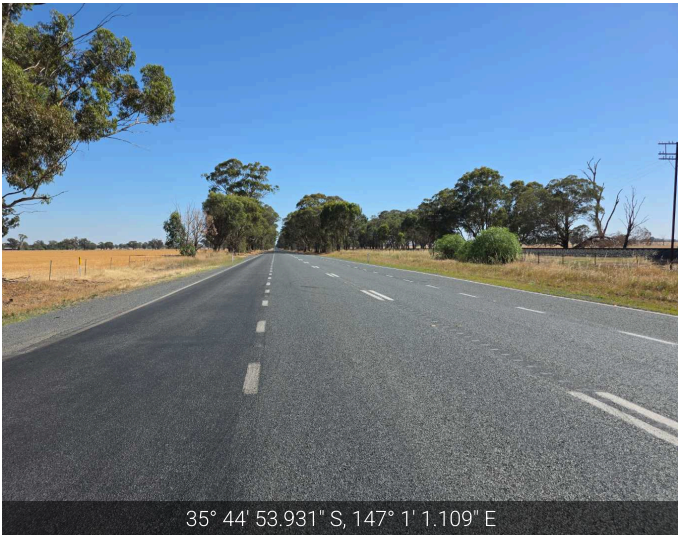
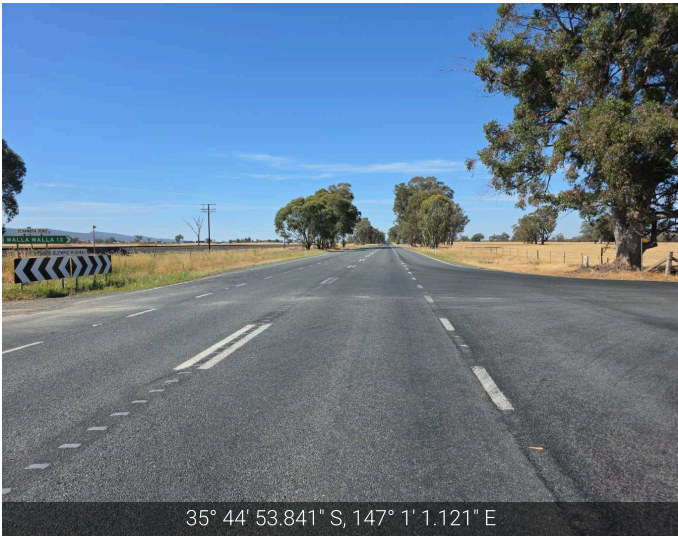
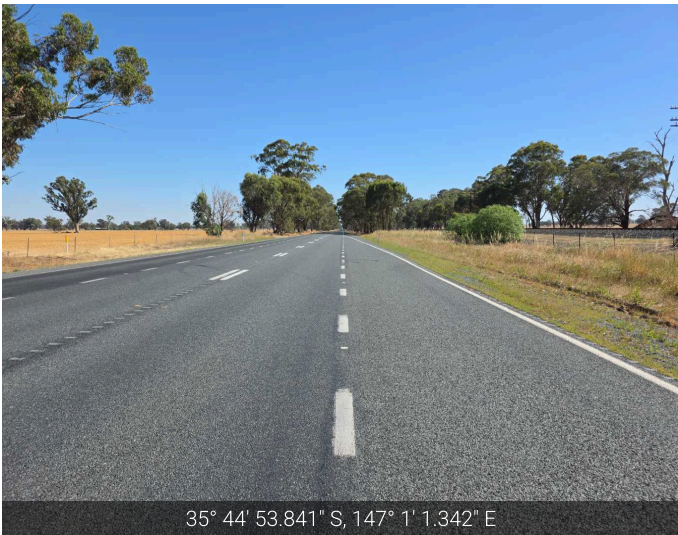
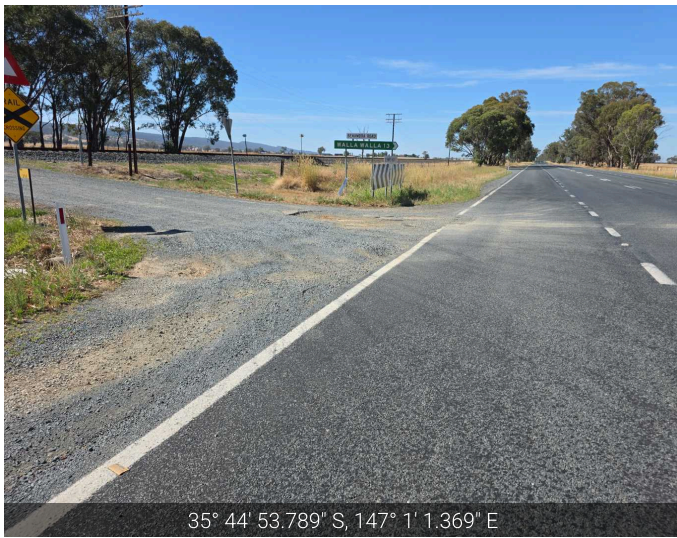
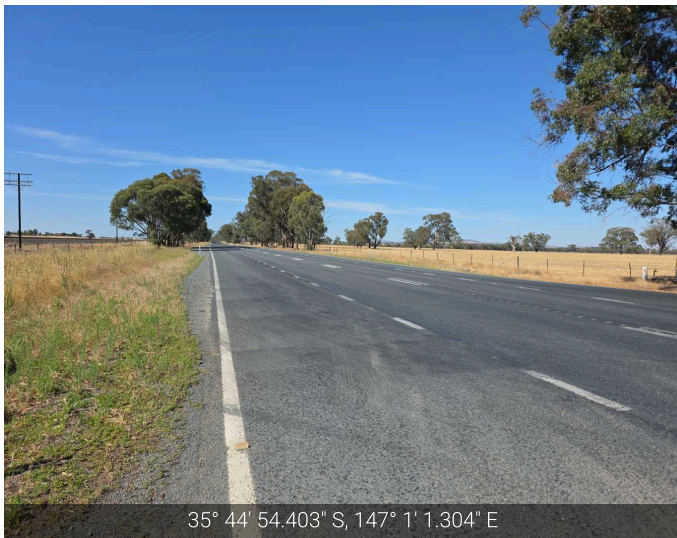
ID: A002

Folder: Intersection - Benambra Rd & Weeamera Rd    Record type: General  
General View - Intersection - Benambra Rd & Weeamera Rd

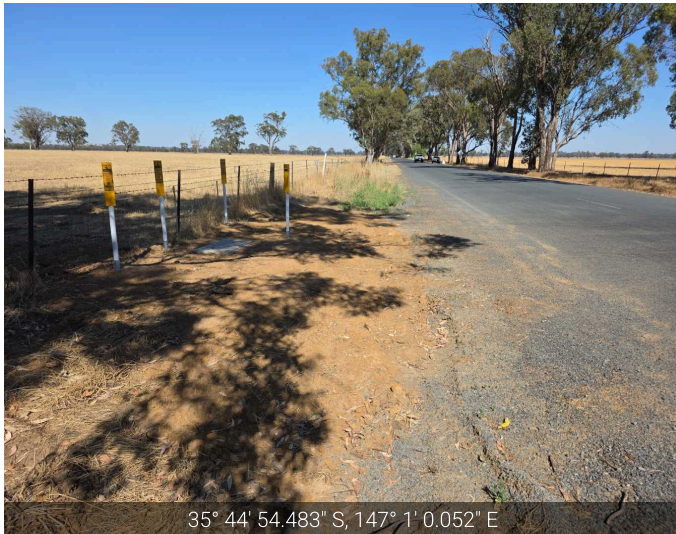
Recent Works to infrastructure

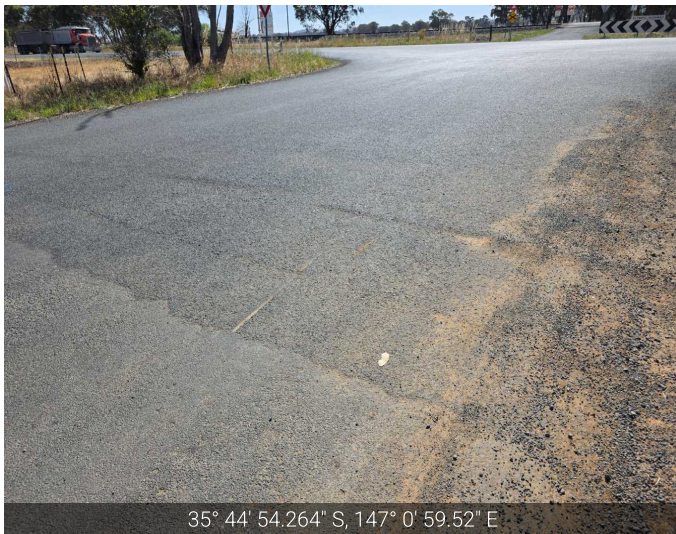
ID: A005

Folder: Benambra Rd    Record type: Dilapidation    Tags: Gouging To Road Surface

Gouging to Road Surface

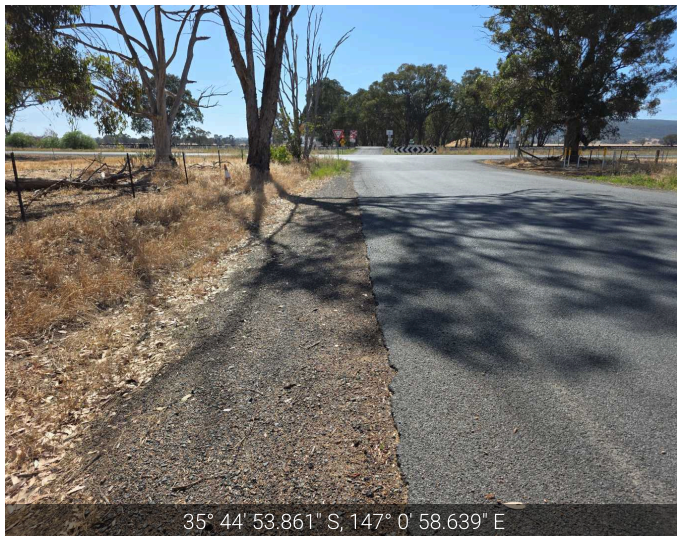
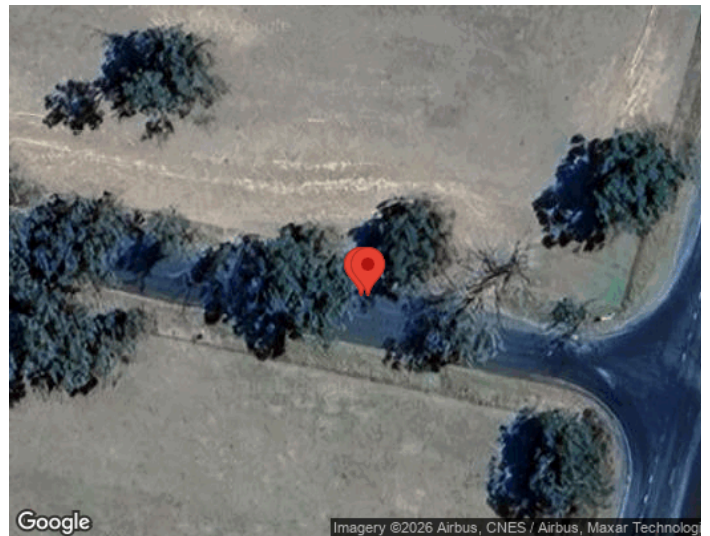
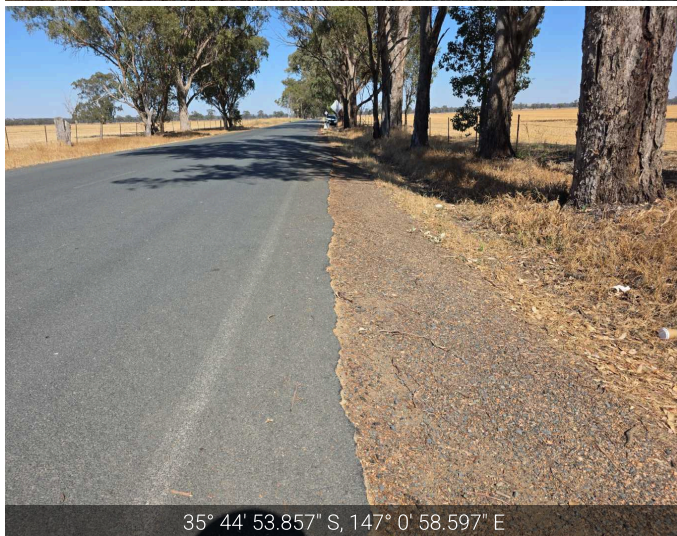
ID: A006

Folder: Benambra Rd    Record type: Dilapidation    Tags: Edge Break-up

Edge Break-up

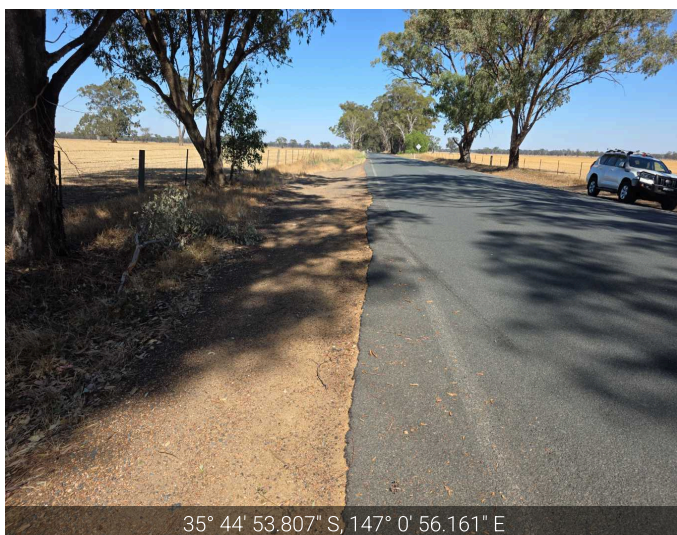
ID: A007

Folder: Benambra Rd    Record type: Dilapidation    Tags: Edge Break-up

Edge Break-up

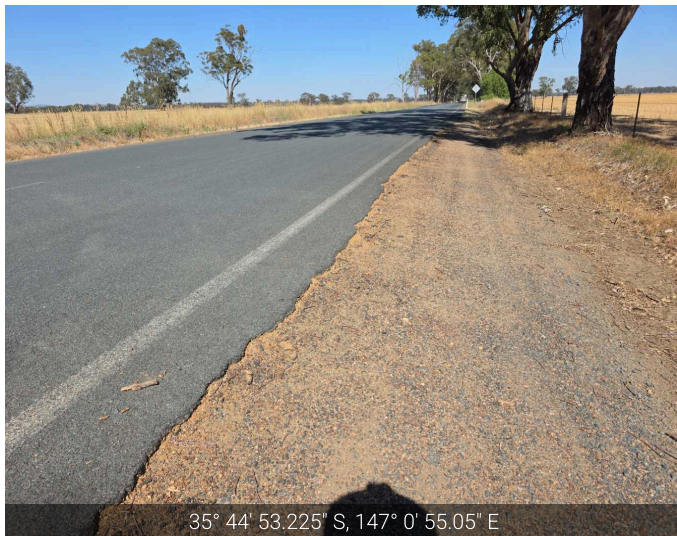
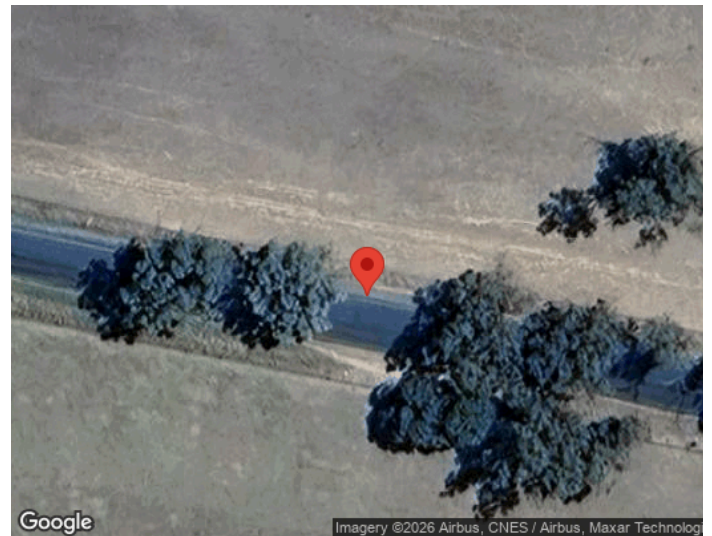
**Item 7****ID: A008****Folder:** Benambra Rd    **Record type:** Dilapidation    **Tags:** Edge Break-up

Edge Break-up

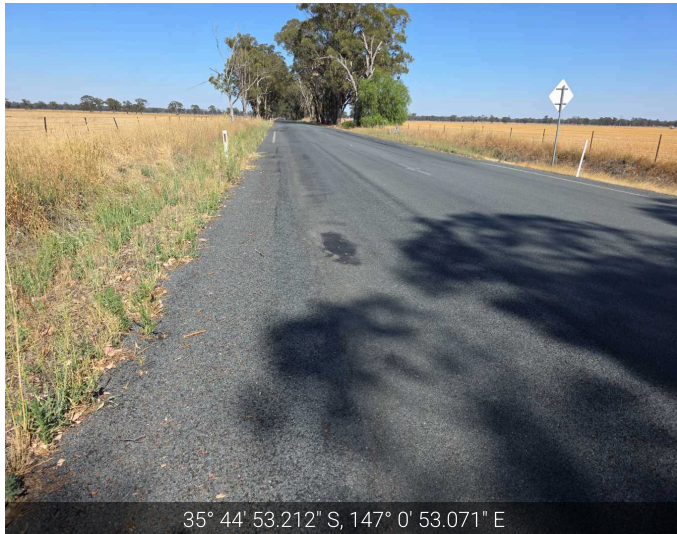
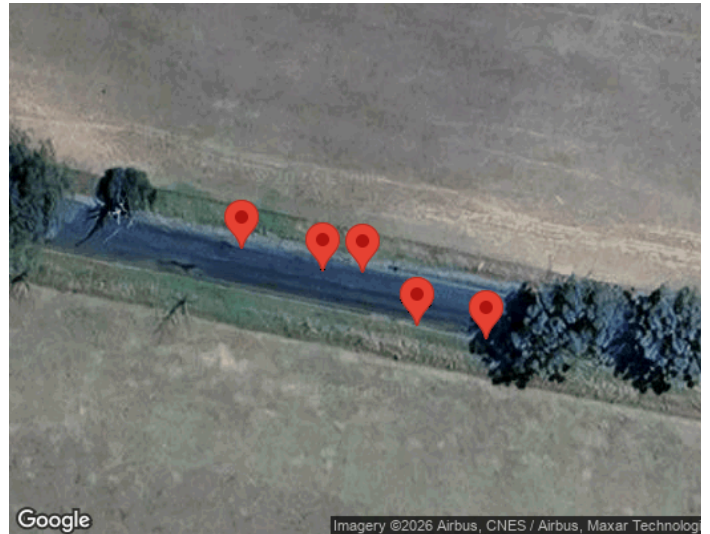
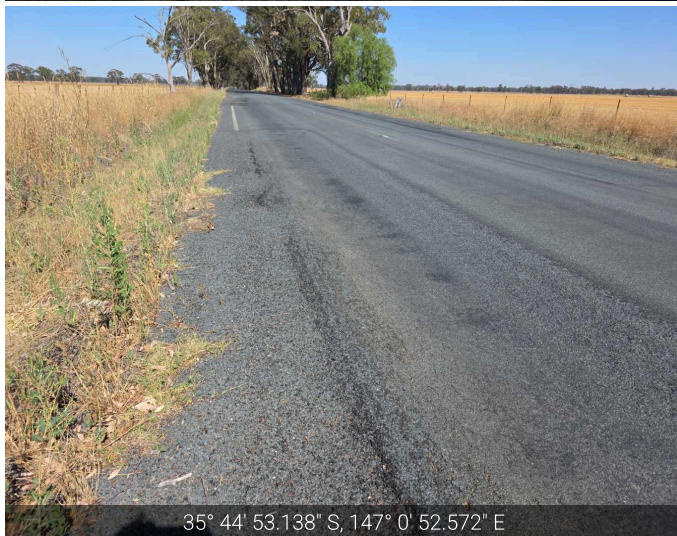
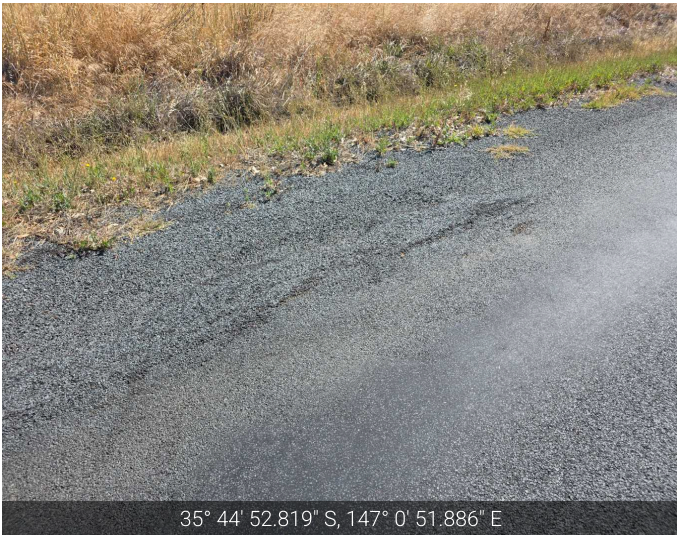
Folder: Benambra Rd    Record type: Dilapidation    Tags: Heaving of the road surface from heavy vehicle access

Patching to road with further heaving

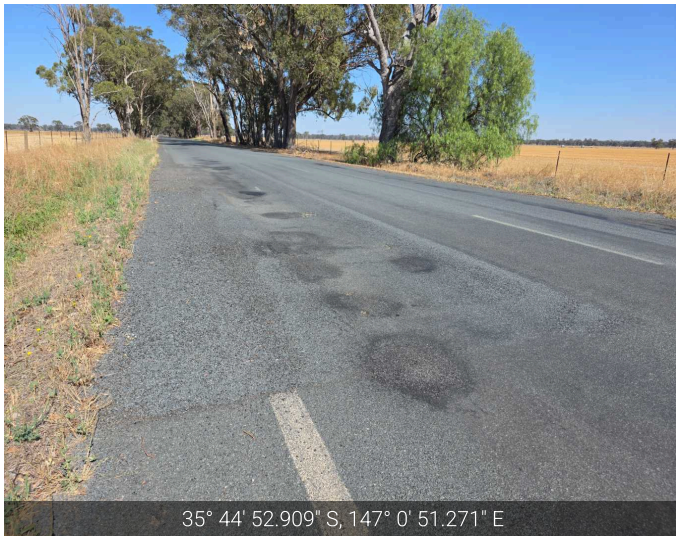
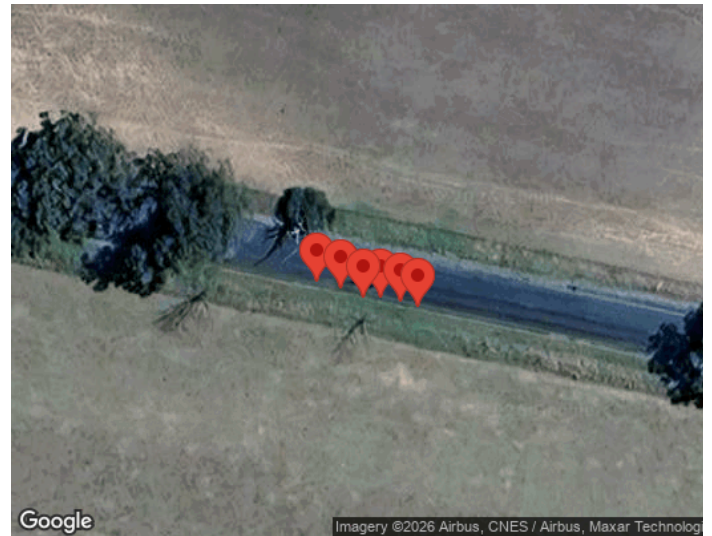
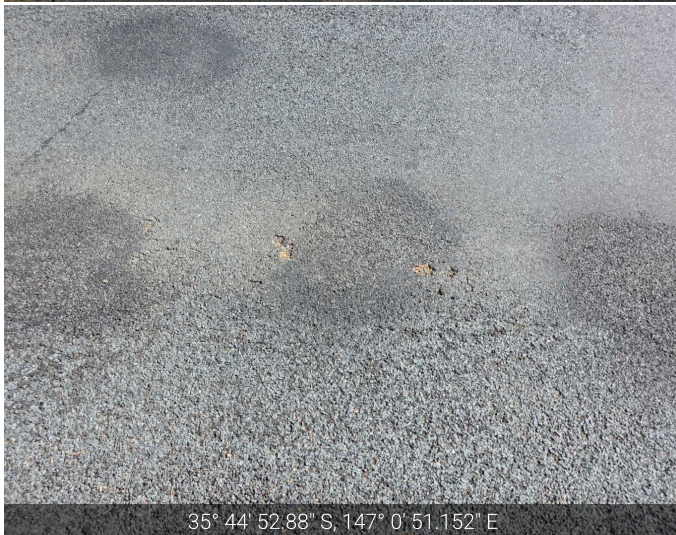
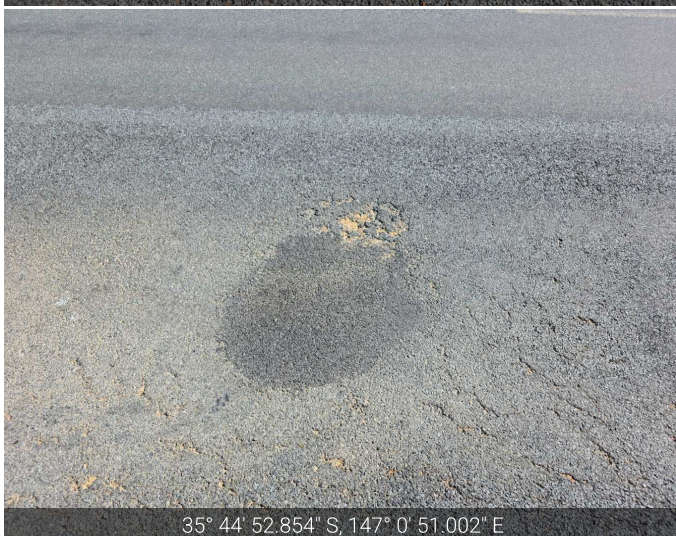
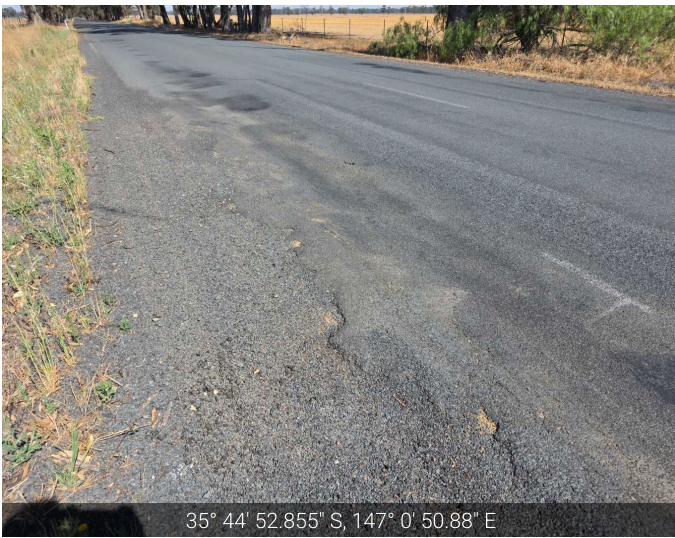
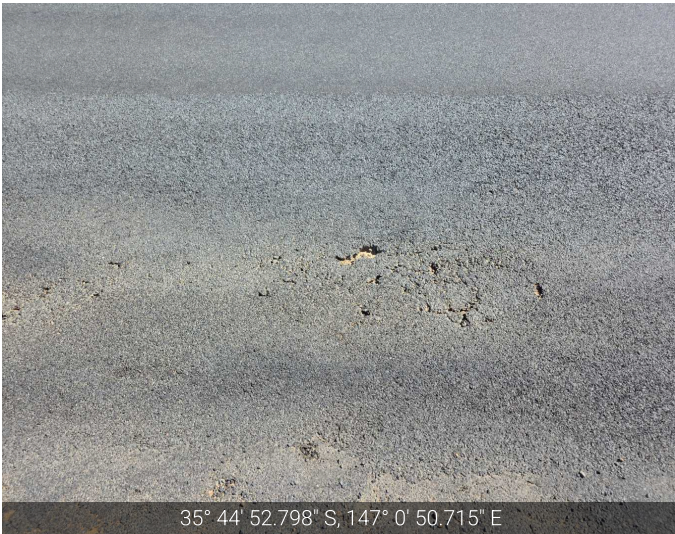
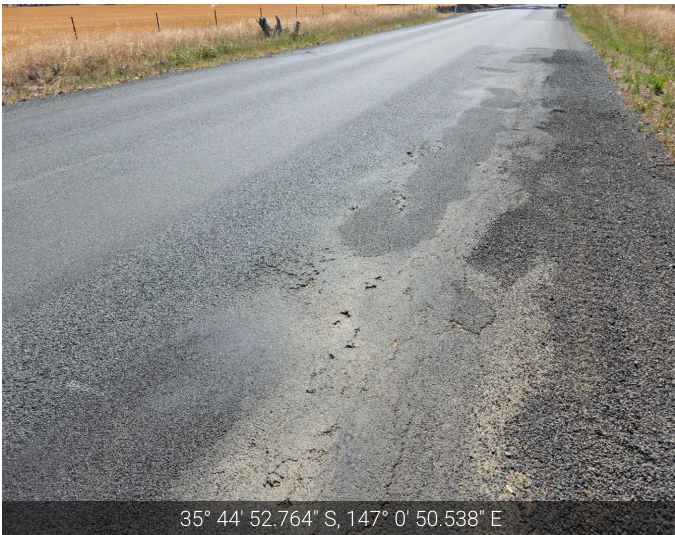
**Folder:** Benambra Rd    **Record type:** Dilapidation    **Tags:** Heaving of the road surface from heavy vehicle access, Cracking and movement – exposing road base

Patching to road with further heaving

Break-up of surface

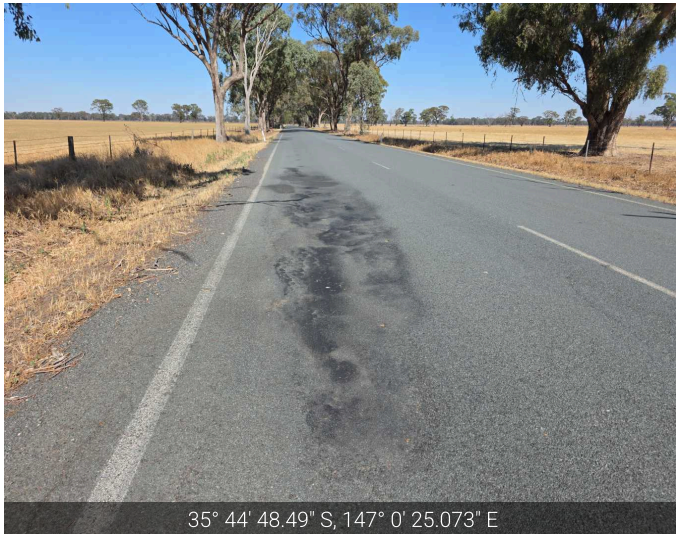
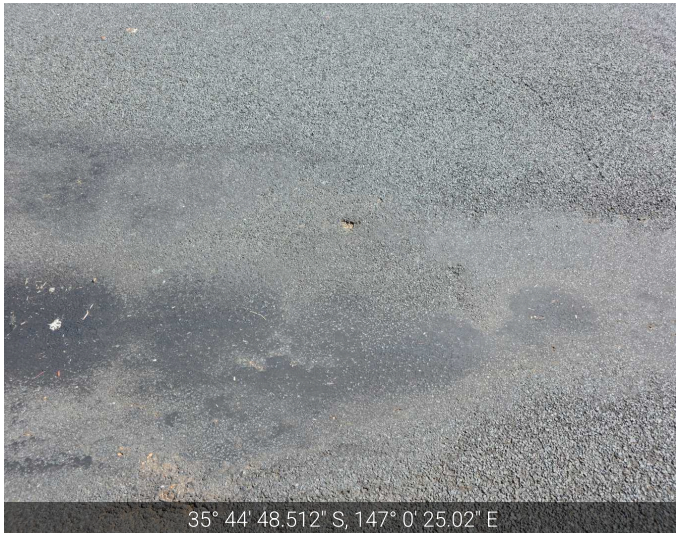
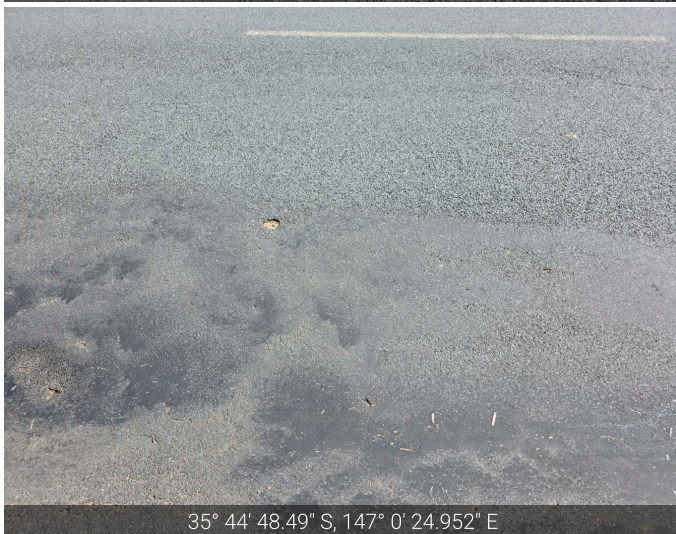
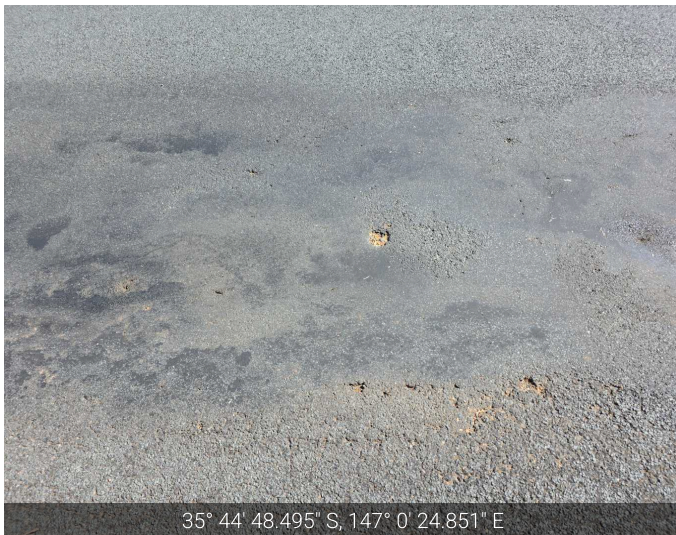
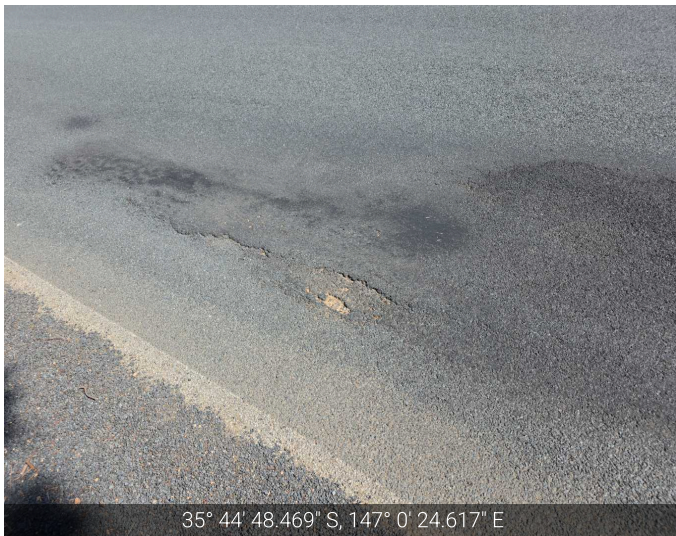
Folder: Benambra Rd    Record type: Dilapidation    Tags: Cracking and movement – exposing road base

Patching with further settlement and surface break-up exposing roadbase

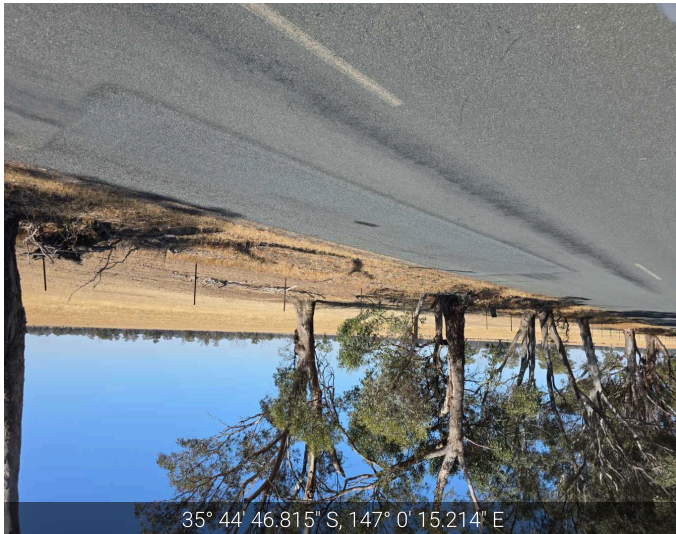
**Item 14****ID: A015**

Folder: Benambra Rd    Record type: Dilapidation    Tags: Repairs  
Repairs to Road

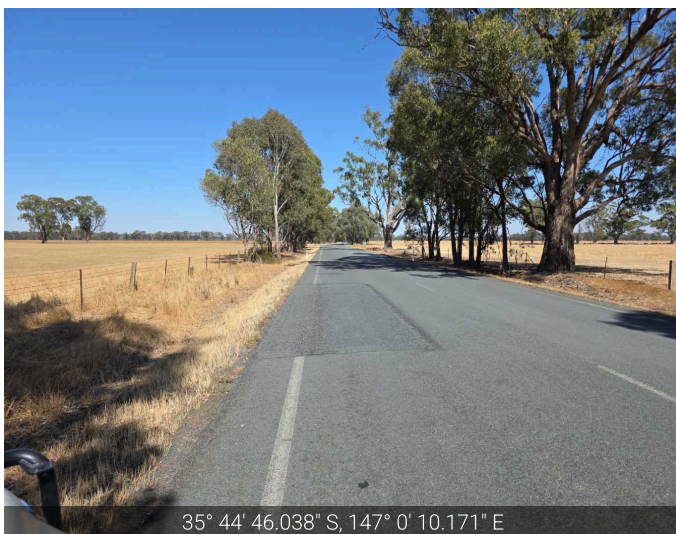
**Item 15****ID: A016**

Folder: Benambra Rd    Record type: Dilapidation    Tags: Repairs  
Repairs to Road

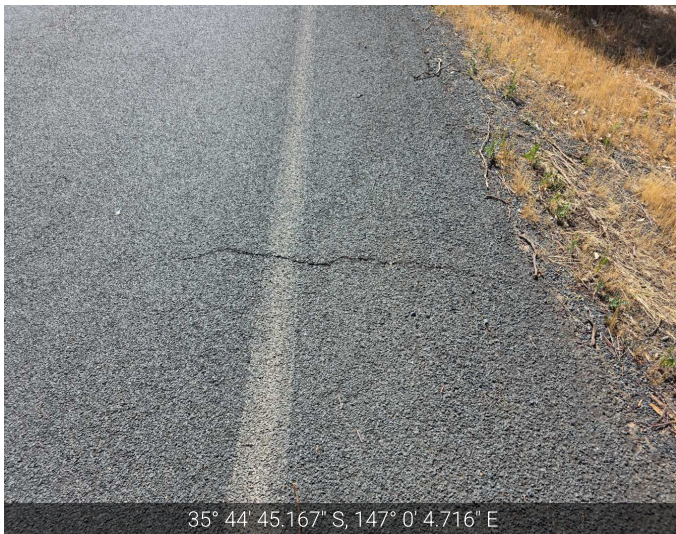
Folder: Benambra Rd    Record type: Dilapidation    Tags: Cracking To Road Surface

Cracking to Road Surface

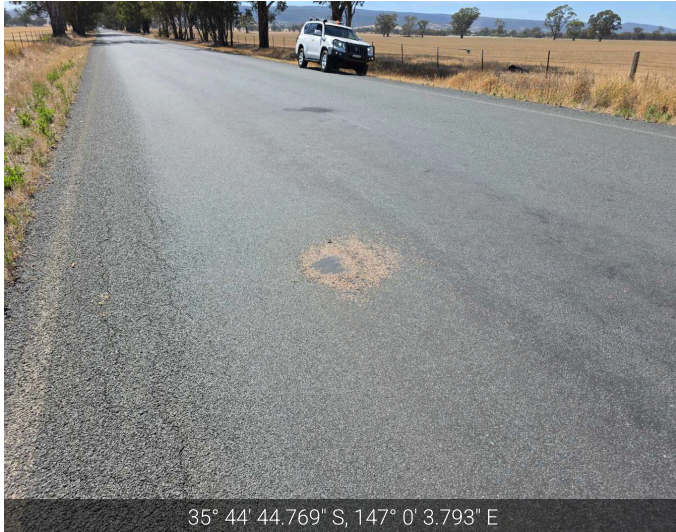
Folder: Benambra Rd    Record type: Dilapidation    Tags: Repairs, Cracking To Road Surface, Cracking and movement – exposing road base

Repairs to Road

Cracking to surface

Exposed road base

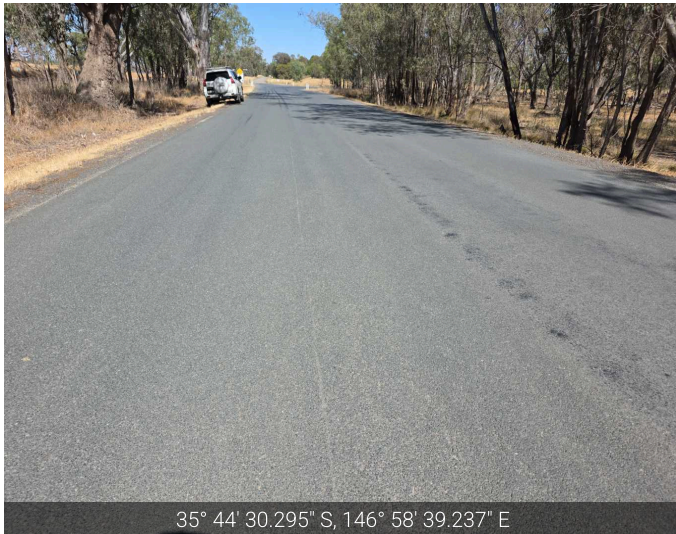
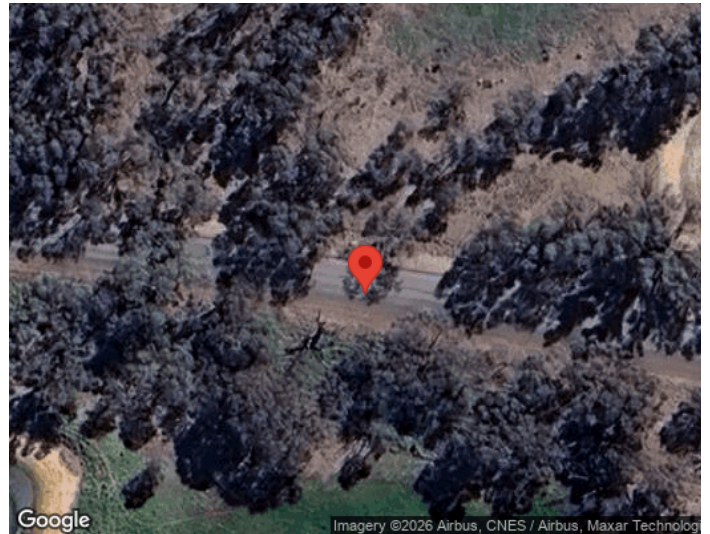
Folder: Benambra Rd    Record type: Dilapidation    Tags: Gouging To Road Surface

Gouging to Road Surface

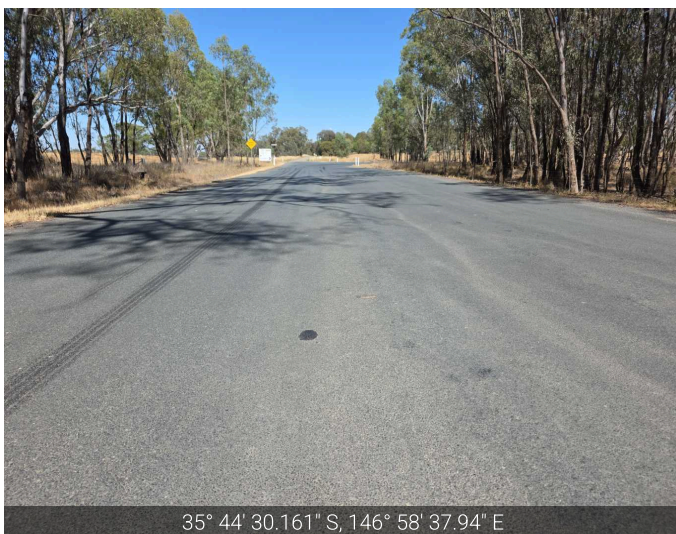
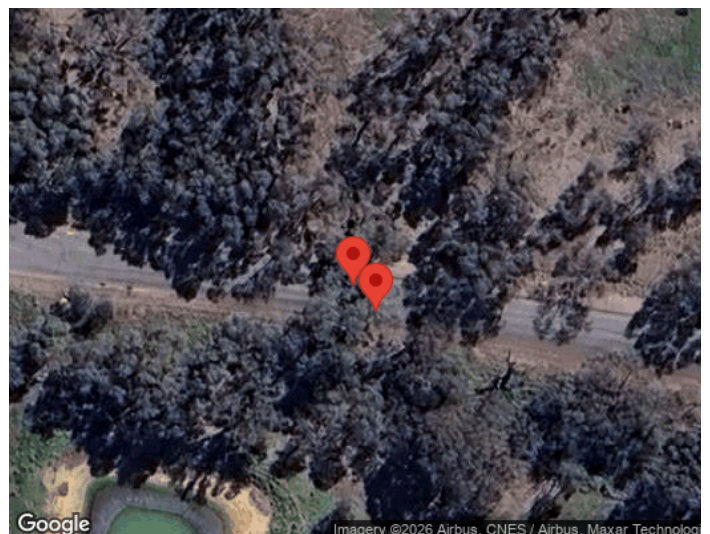
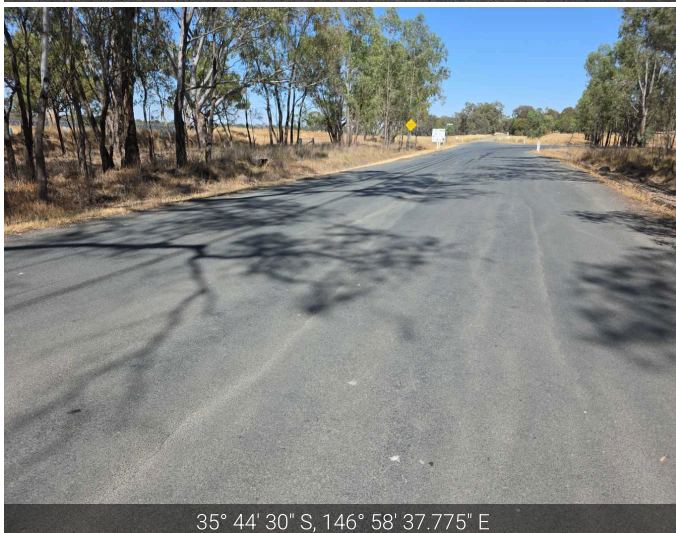
Folder: Benambra Rd    Record type: Dilapidation    Tags: Uneven Finish

Uneven road surface finish from one pass to the next

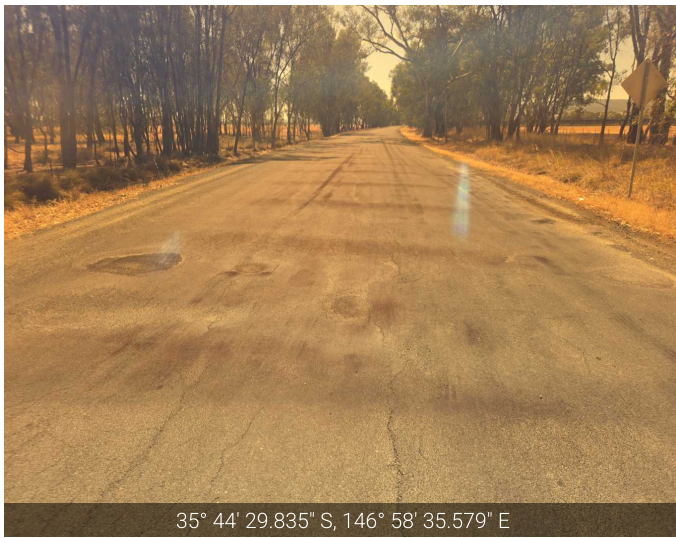
**Folder:** Intersection - Benambra Rd & Weeamera Rd    **Record type:** General    **Tags:** Uneven Finish, Cracking To Road Surface, Heaving of the road surface from heavy vehicle access

Uneven surface to Road finish

Cracking to Road finish

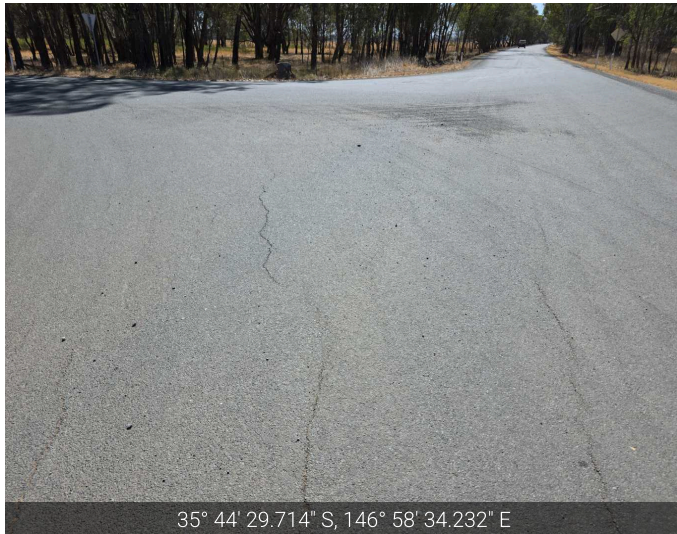
Folder: Intersection - Benambra Rd & Weeamera Rd    Record type: General    Tags: Cracking To Road Surface

Cracking to Road finish

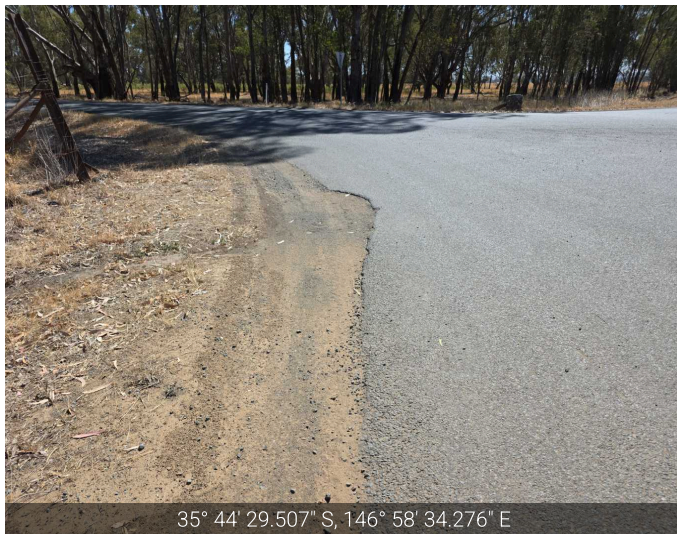
Folder: Intersection - Benambra Rd & Weeamera Rd    Record type: General    Tags: Edge Break-up

Break-up to edge

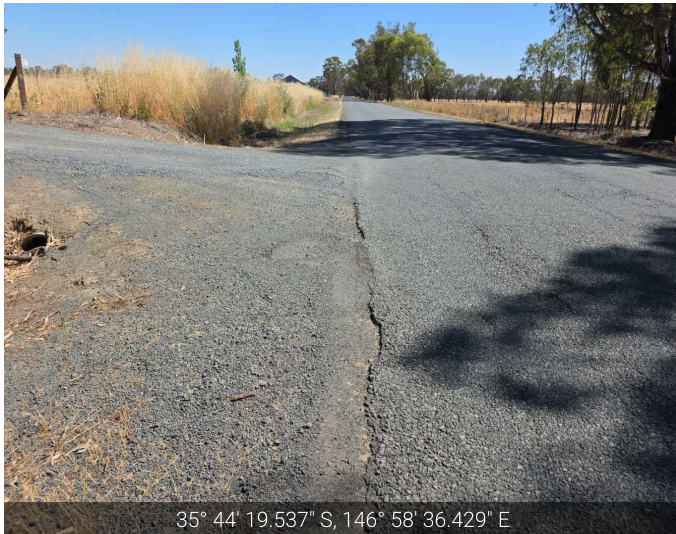
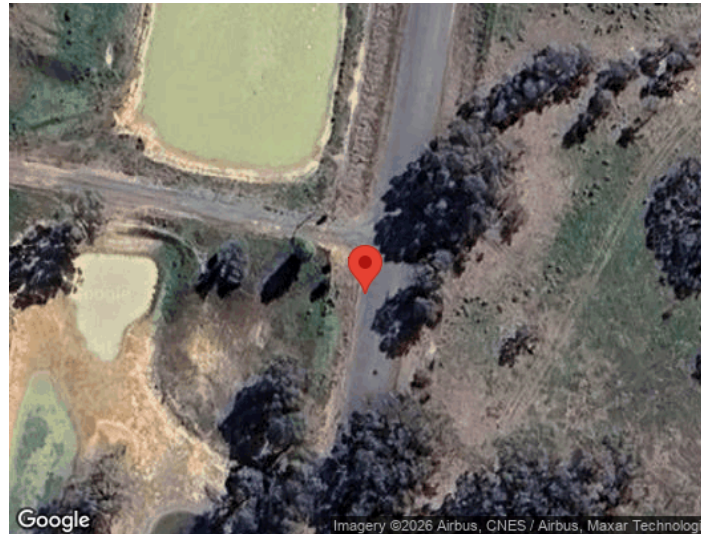
**Item 29**

Folder: Weeamera Rd    Record type: Dilapidation    Tags: Edge Break-up

Edge breakup along private entry

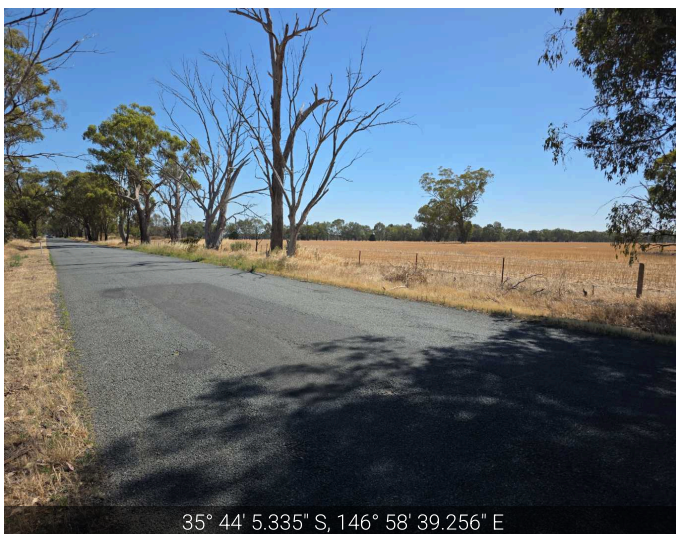
**Item 30**

Repairs to Road

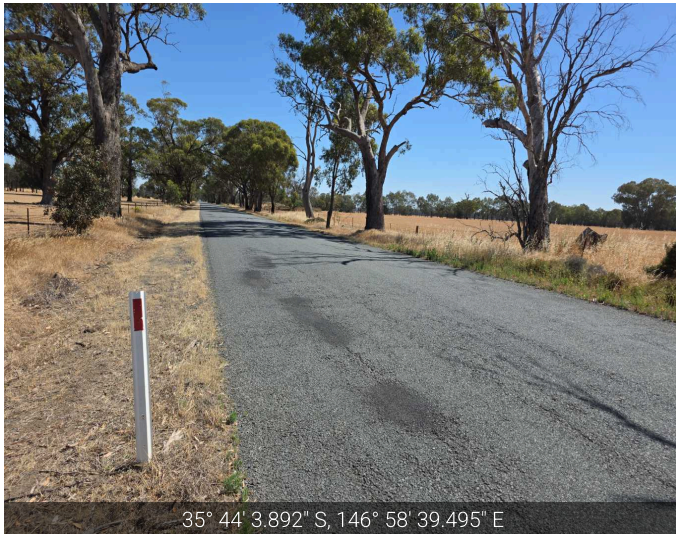
**Item 31**

Repairs to Road

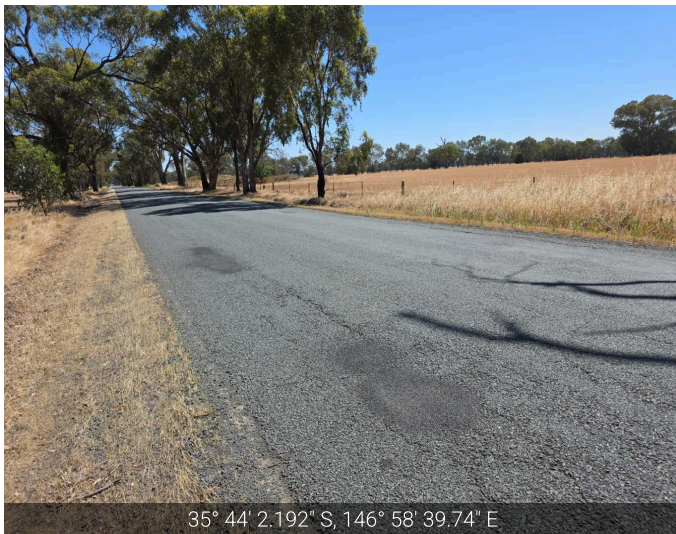
**Item 32**

Repairs to Road

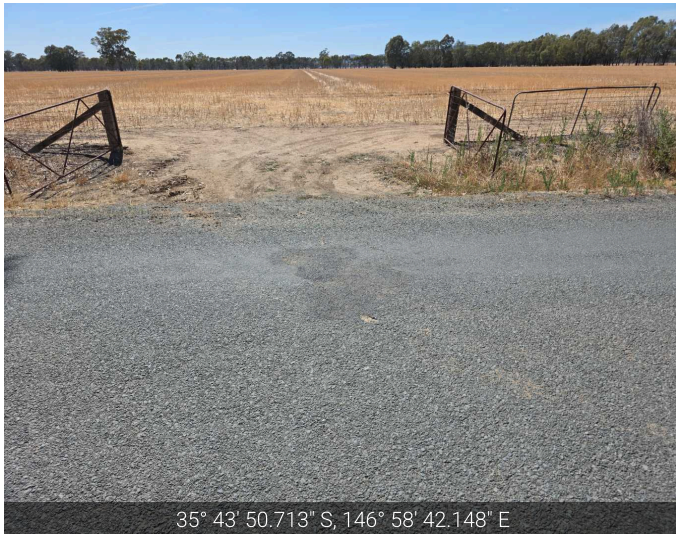
**Item 33**

Folder: Weeamera Rd    Record type: Dilapidation    Tags: Repairs, Gouging To Road Surface

Patching and Gouging to Road at private entry

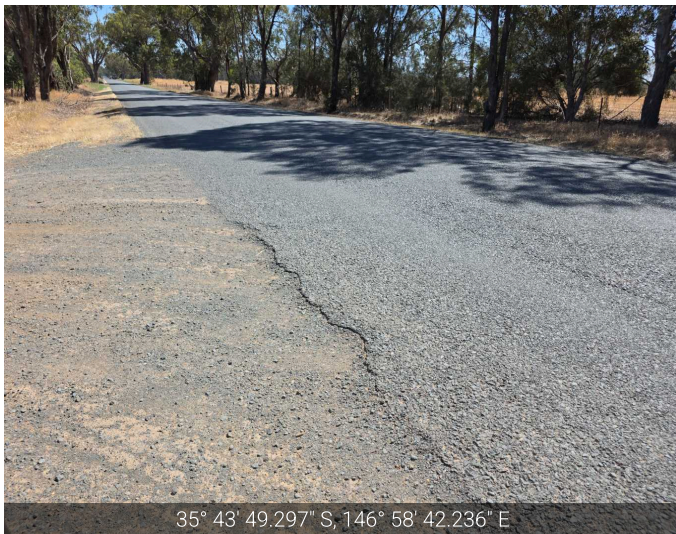
**Item 34**

Folder: Weeamera Rd    Record type: Dilapidation    Tags: Edge Break-up

Edge Break-up at private entry

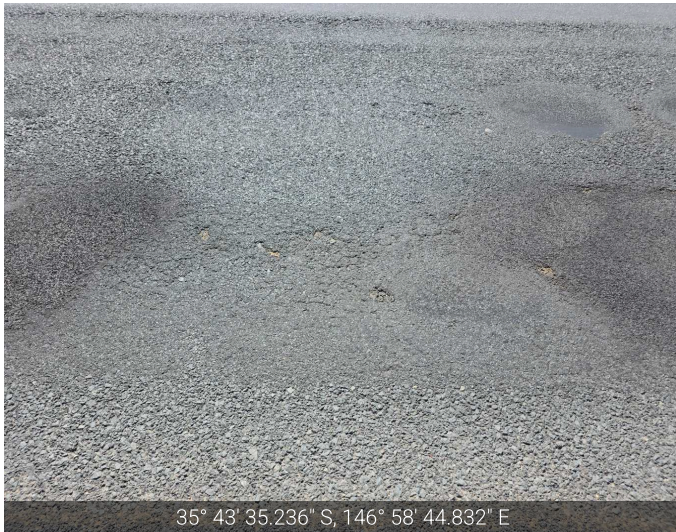
Folder: Weeamera Rd    Record type: Dilapidation    Tags: Repairs, Cracking and movement – exposing road base

Repairs to Road

Cracking to Surface exposing roadbase

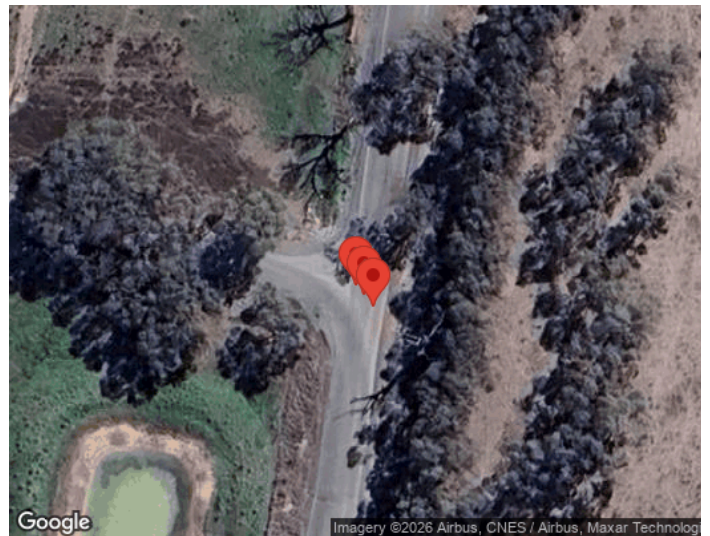
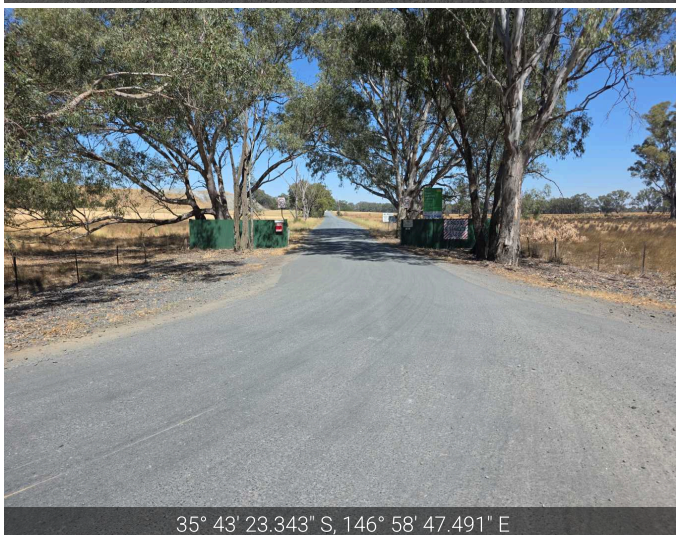
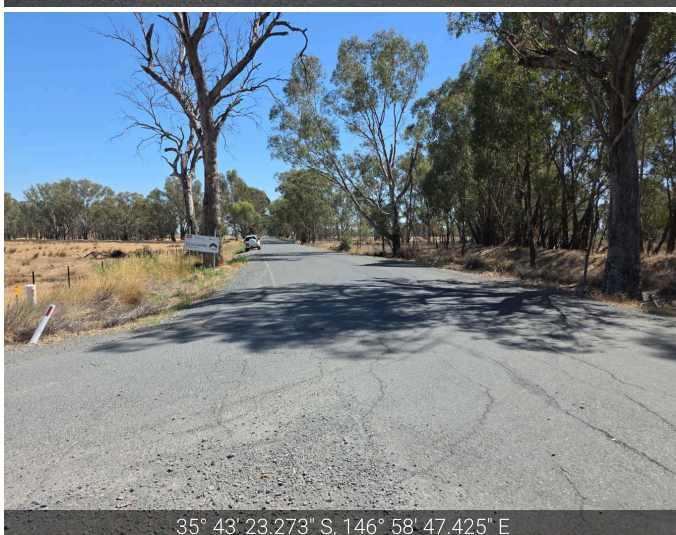
General view of entry to quarry

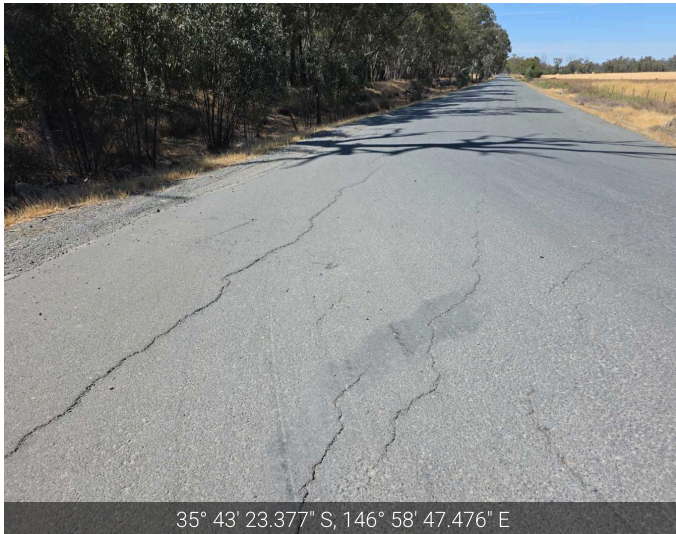
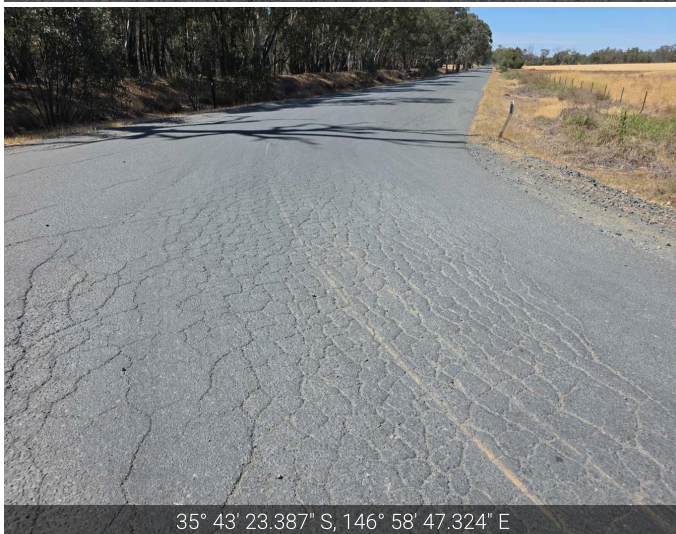
Folder: Weeamera Rd Record type: General Tags: Crack patterns running in all directions, Cracking To Road Surface

Cracking to Road Surface
