## Culcairn Closeout - Dilapidation Report - WSC December - 2025

Re: Dilapidation Inspection and report - Culcairn Solar Farm Surrounding roads:

- Benambra road "A" to "B", 3.8KM
- Weeamera road "B" to "C", 3.5KM

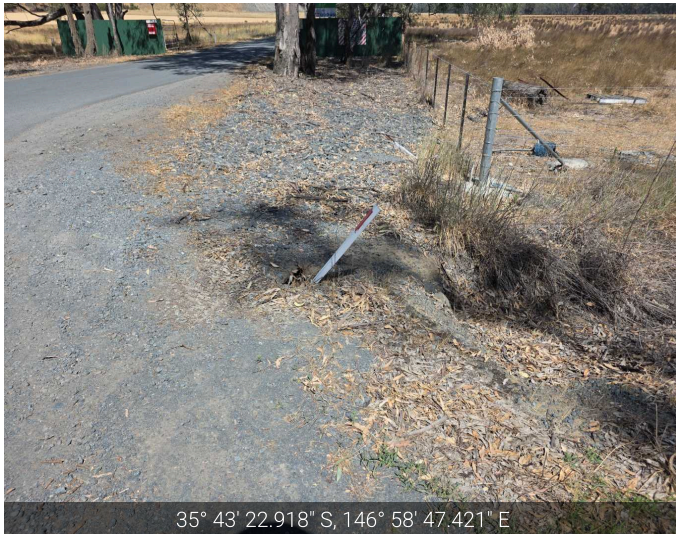
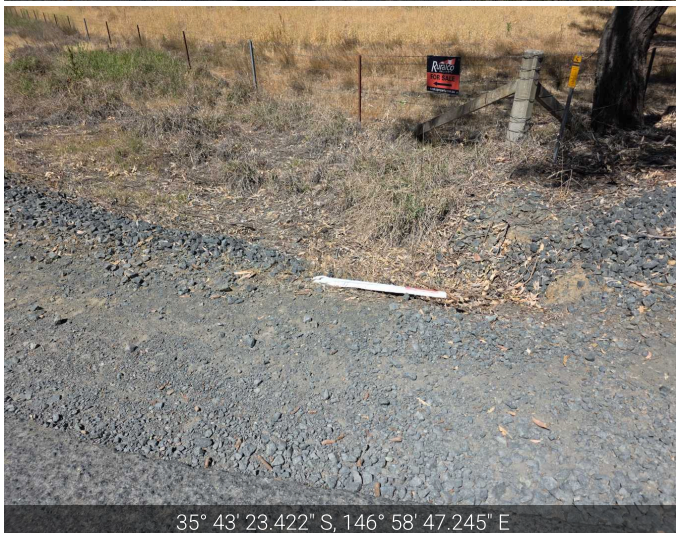
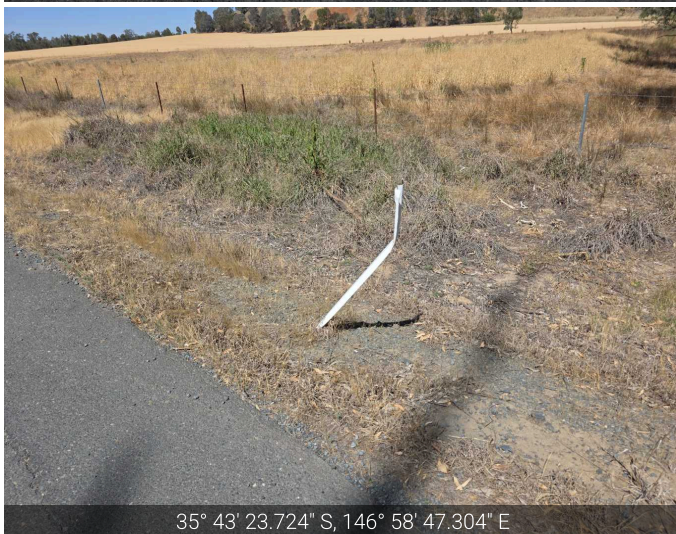
Folder: Weeamera Rd    Record type: Dilapidation    Tags: Damage To Signage

Damage to Road Markers

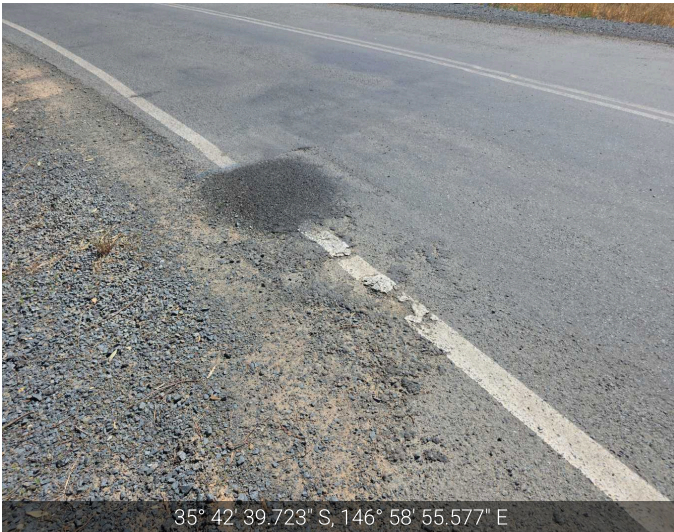
Repairs to Road

Uneven finish to Road

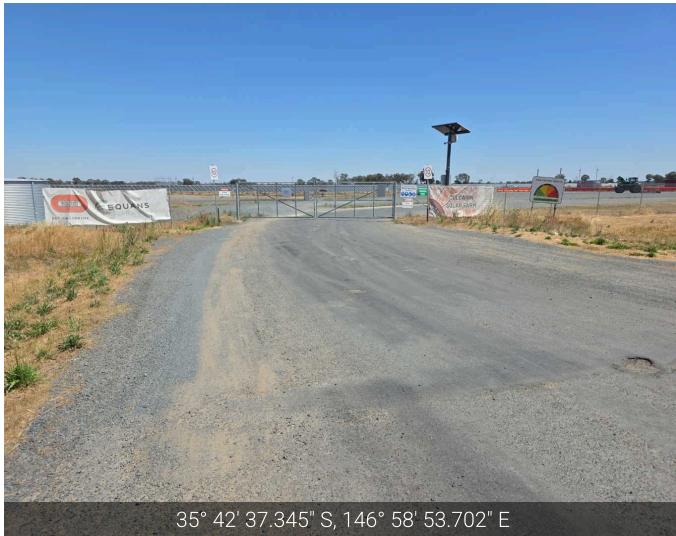
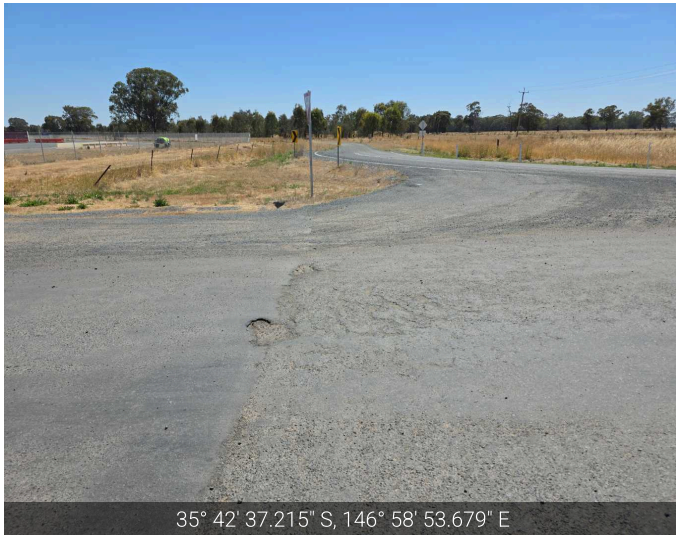
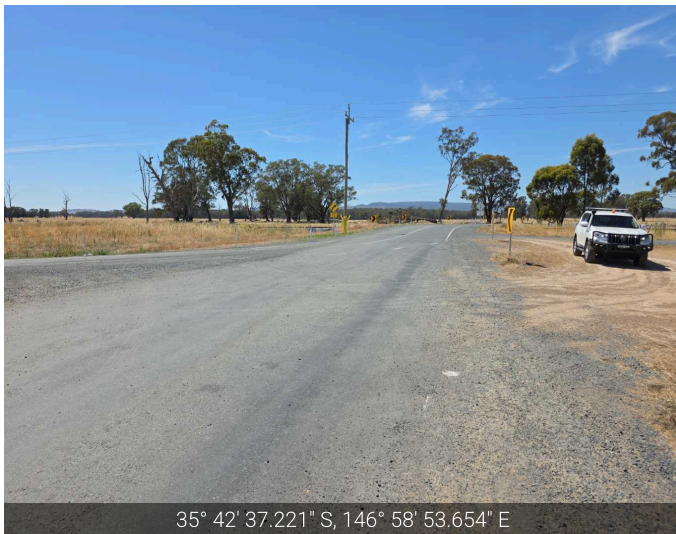
General view of Site Entrance

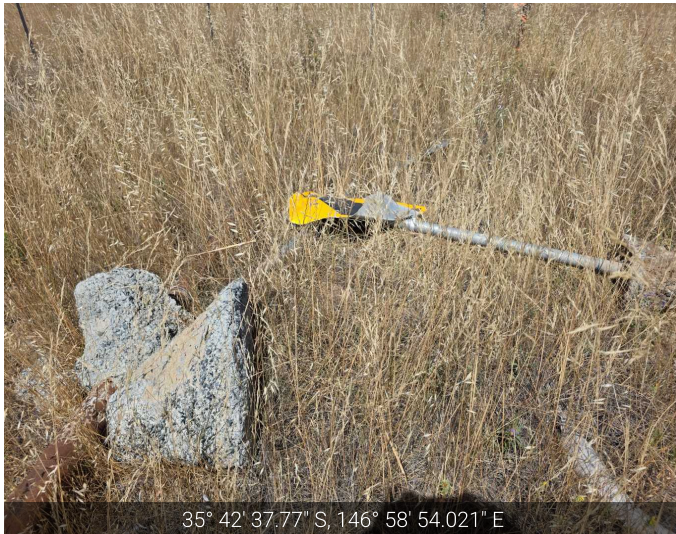
**Item 44**

Folder: Weeamera Rd    Record type: Dilapidation  
Rubbish to edge of intersection upgrade of 2024/2025

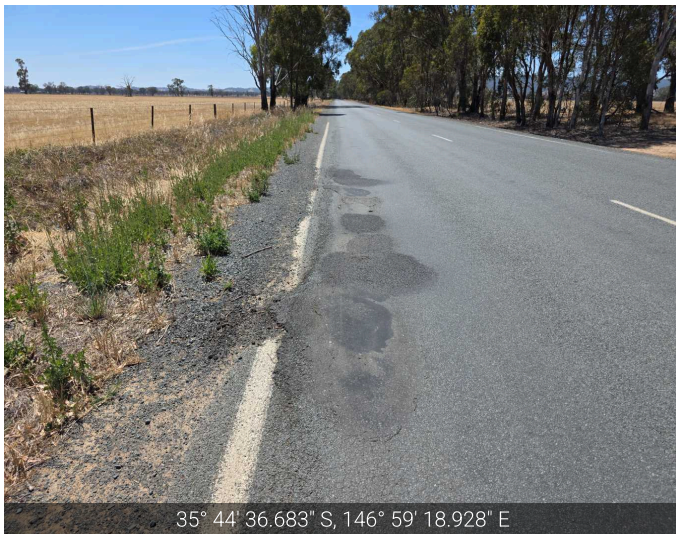
**Item 45**

Folder: Benambra Rd    Record type: Dilapidation    Tags: Heaving of the road surface from heavy vehicle access, Repairs  
Patching and Heaving to Road finish

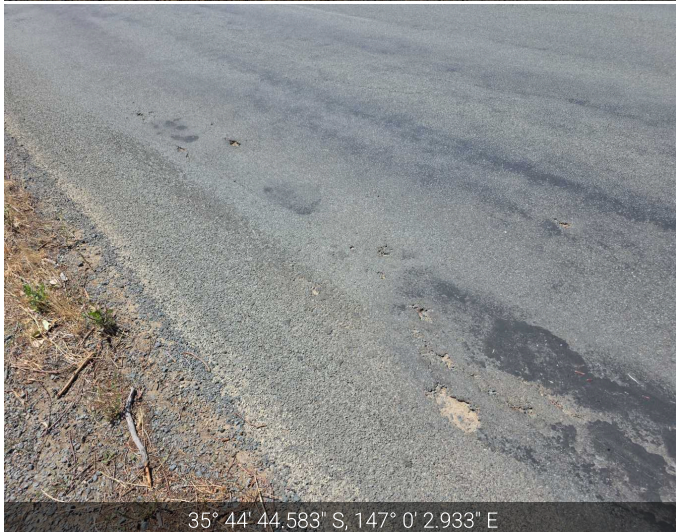
Patching to Road Surface

Exposed Road Base

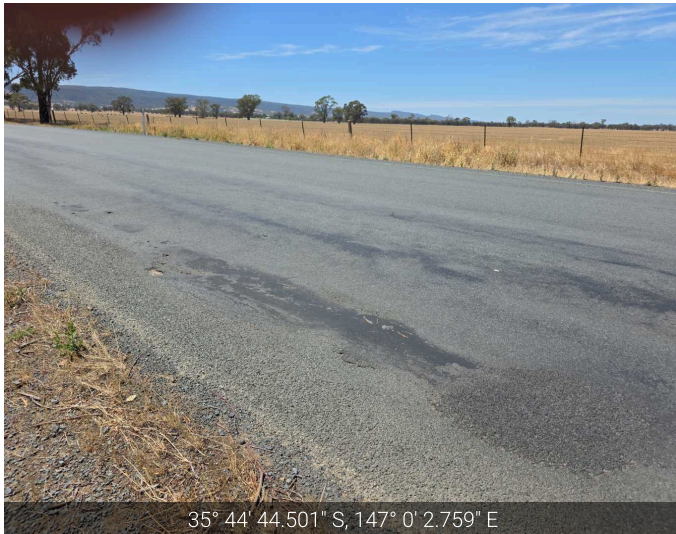
Patching to Road Surface
