# CULCAIRN BESS

## Access Road Dilapidation report August 2026

| Design Phase : N/A | | Document no: NEO-CUBS-CV-REP-2707 | Number of pages : 43 | | |

### RE: Dilapidation Inspection and report - Culcairn BESS Solar Farm Surrounding roads:

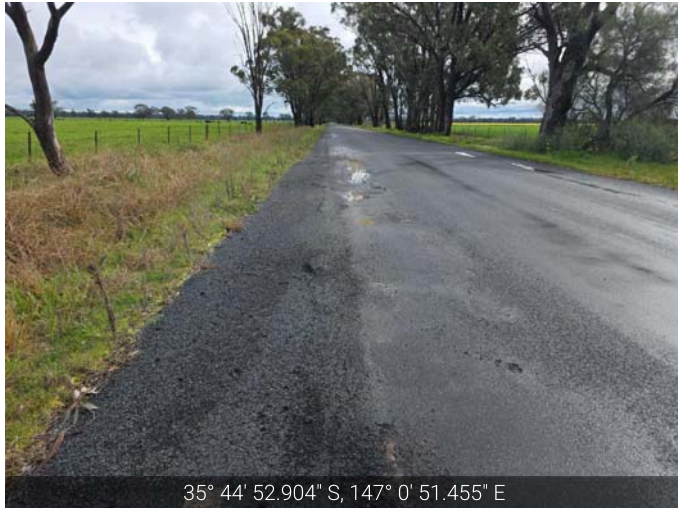
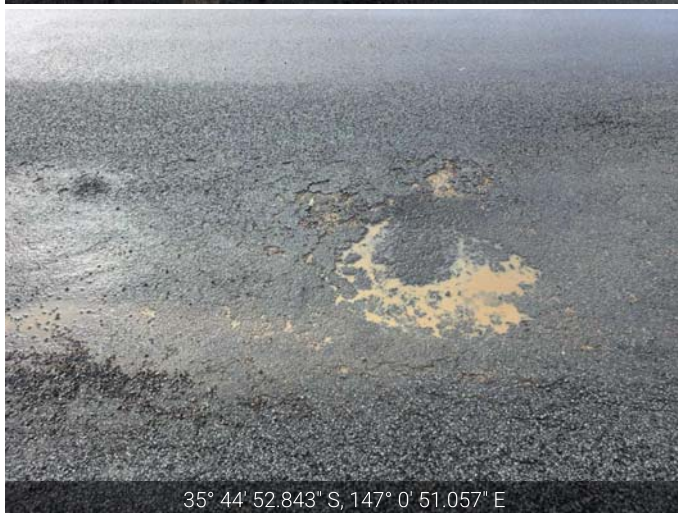
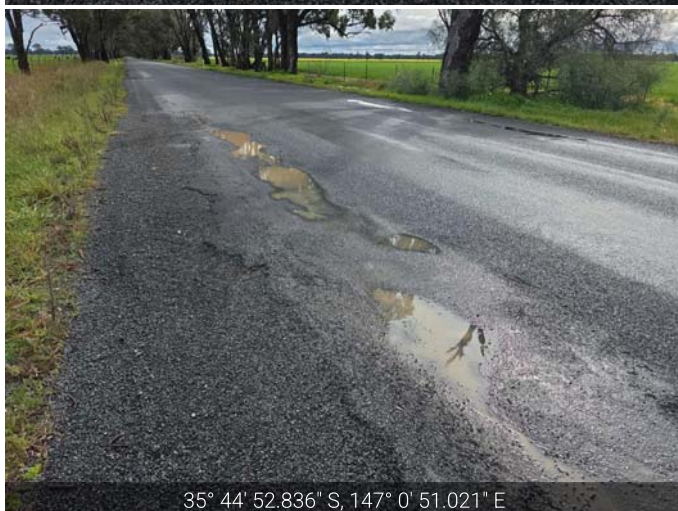
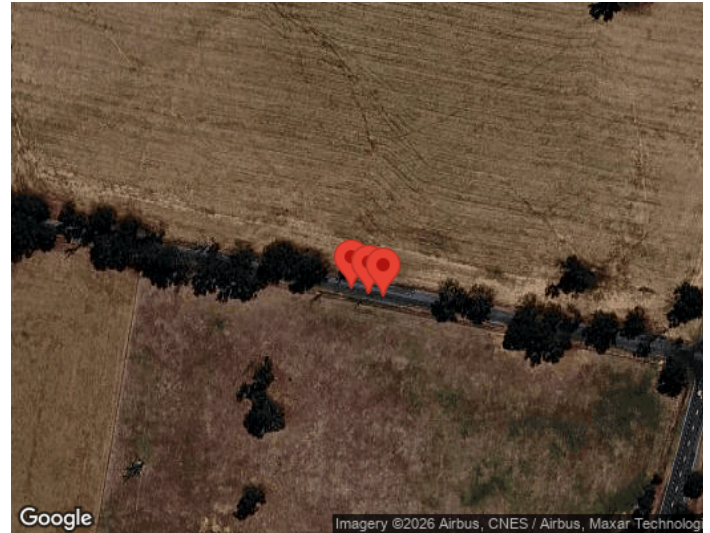
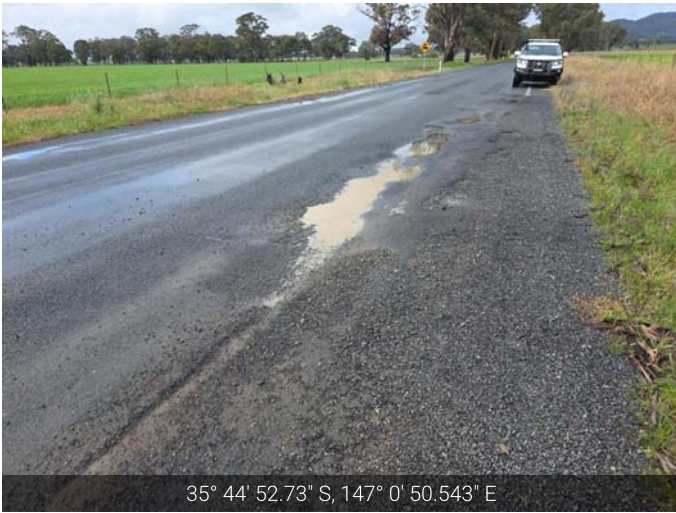
Heaving

Surface break-up exposing roadbase

Standing water

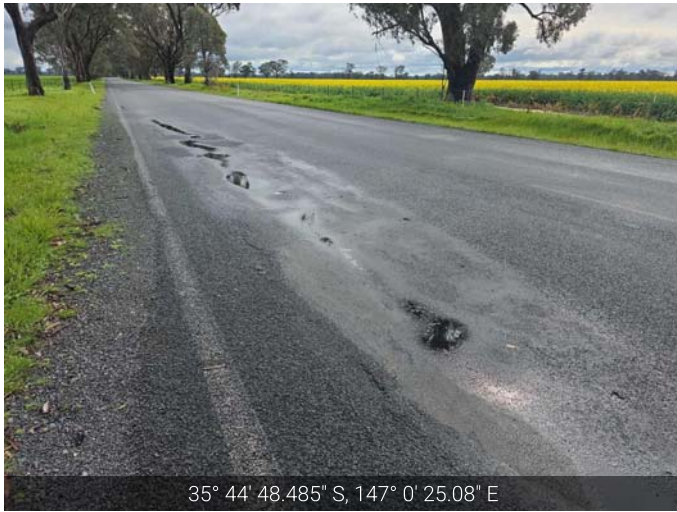
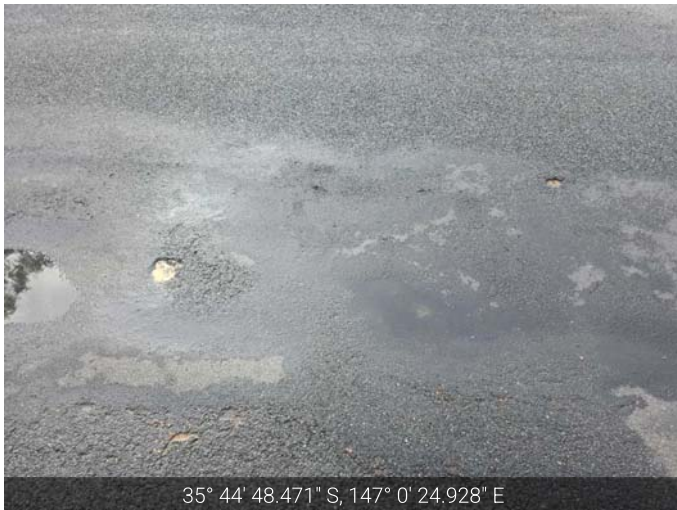
Heaving to road surface

Small break-up to road surface

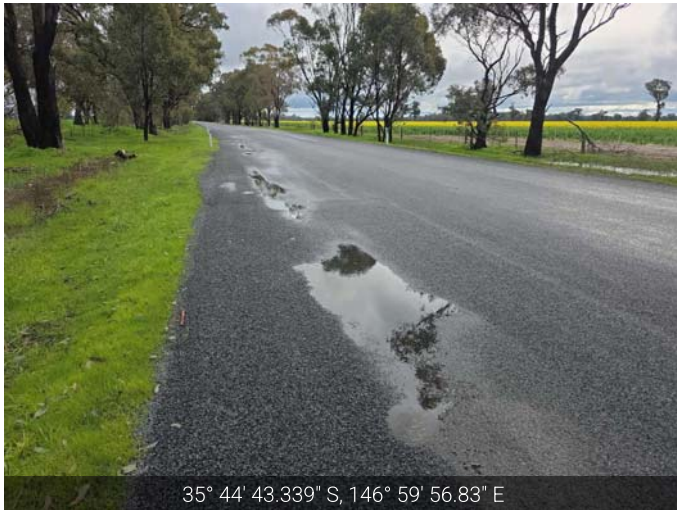
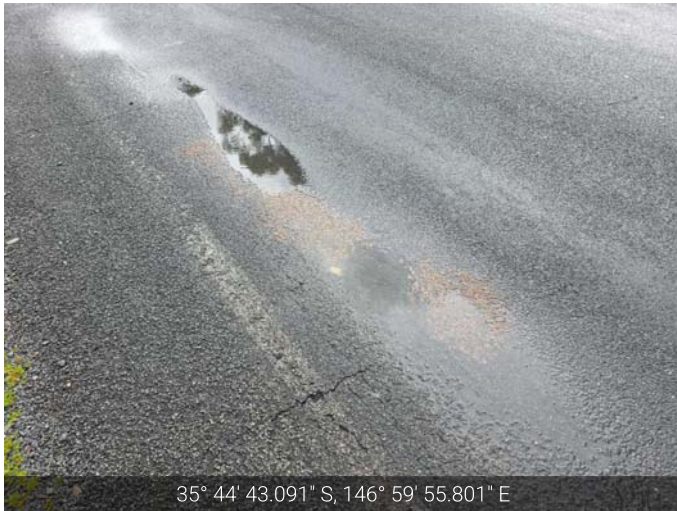
Water on road over surface break-up

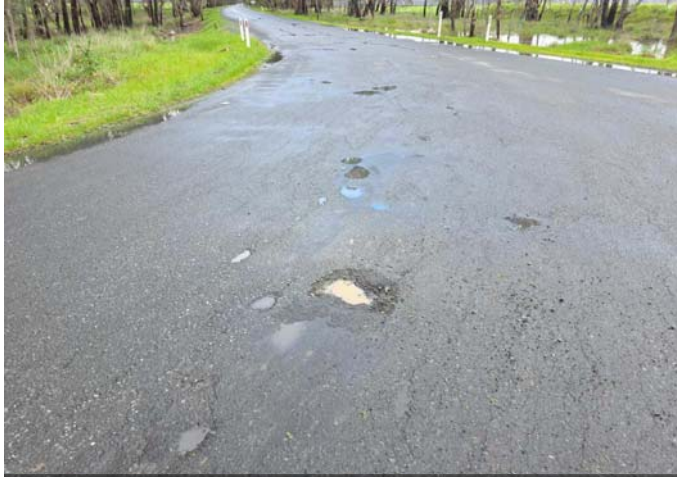
35° 44' 29.563" S, 146° 58' 34.985" E

Potholing

Crocodile Cracking

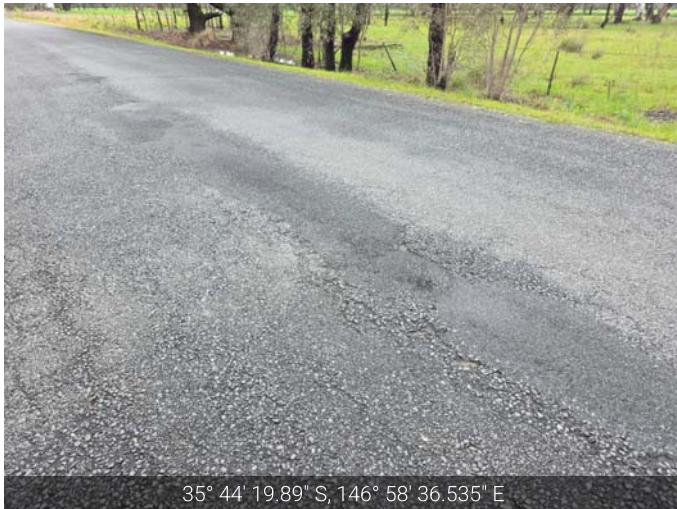
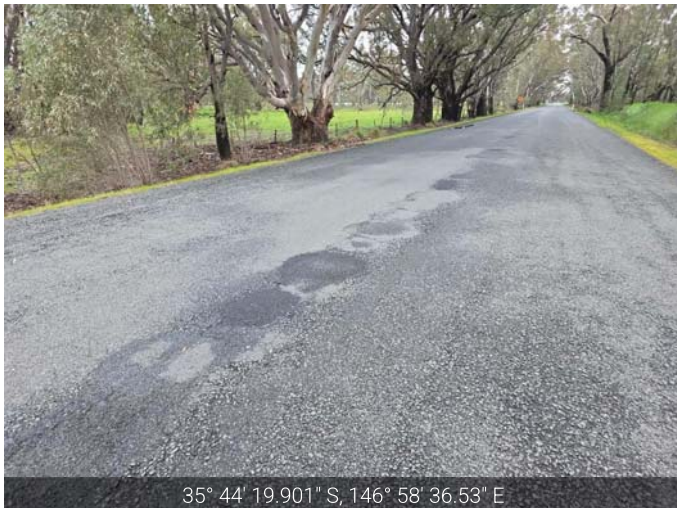
Surface Break-up

Patch sealing Repairs

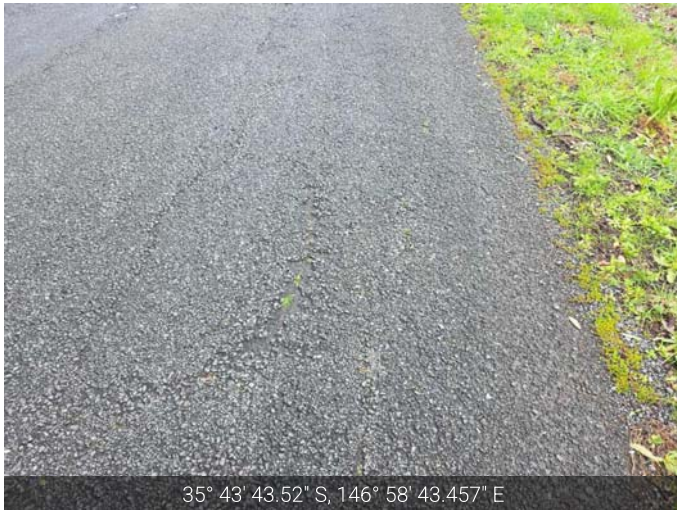
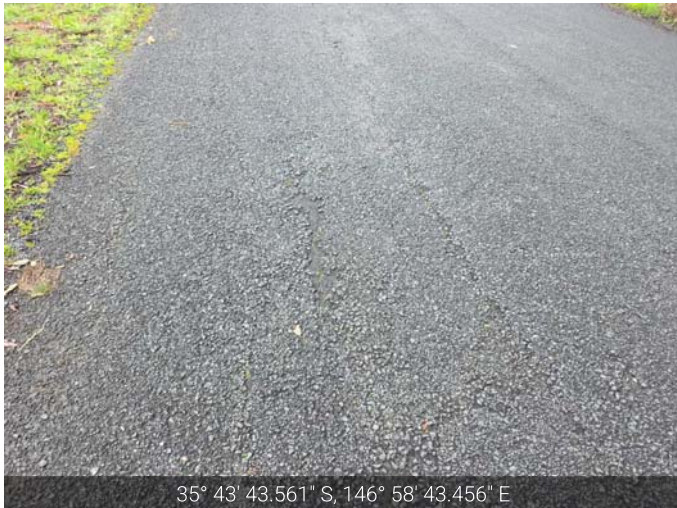
Foliage Growth through road base

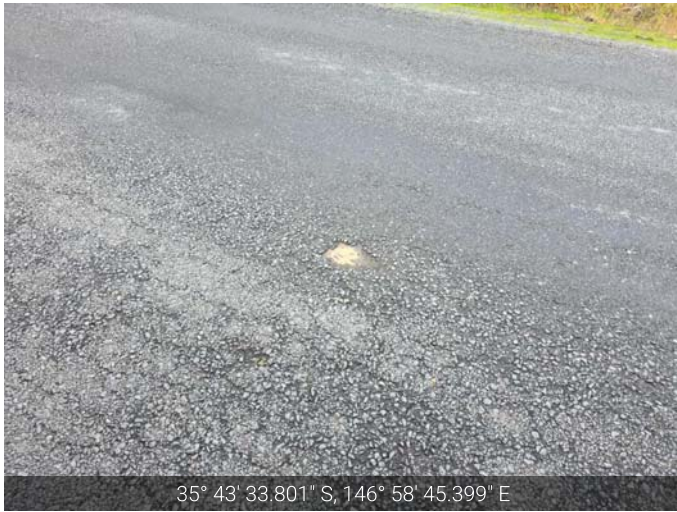
Surface Break-up

Potholing

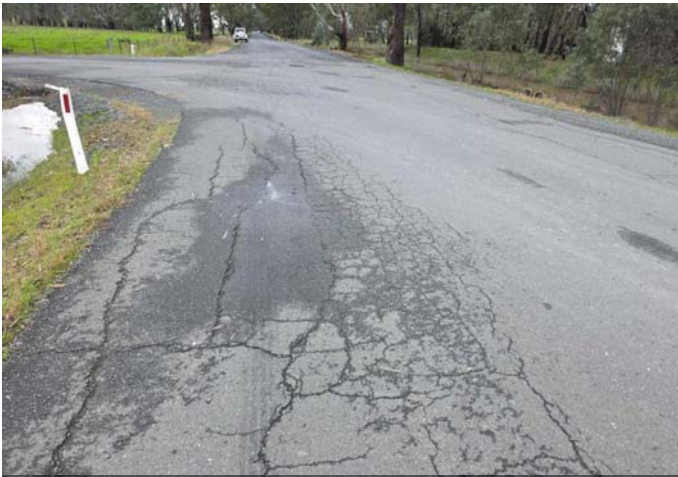
35° 43' 23.921" S, 146° 58' 47.273" E

Longitudinal Cracking

Crocodile Cracking

Damage to Road Markers

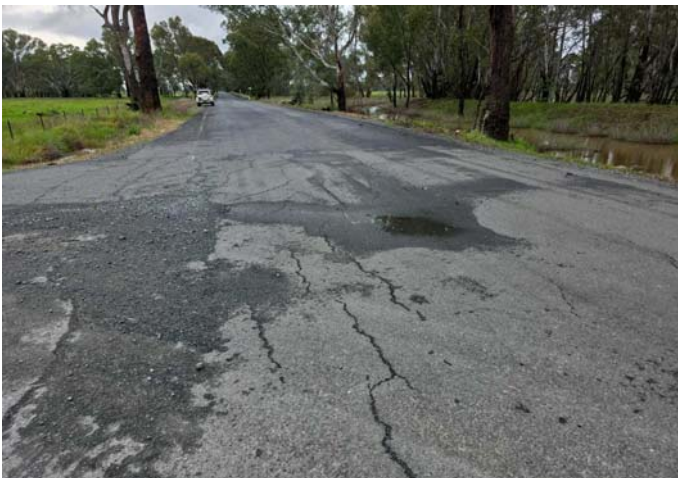
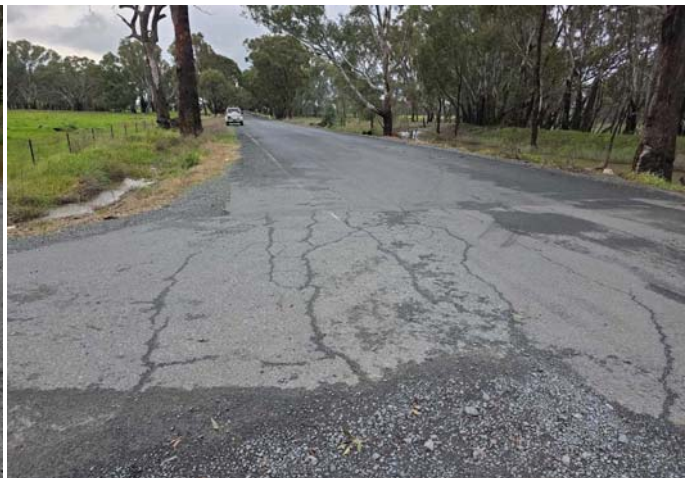
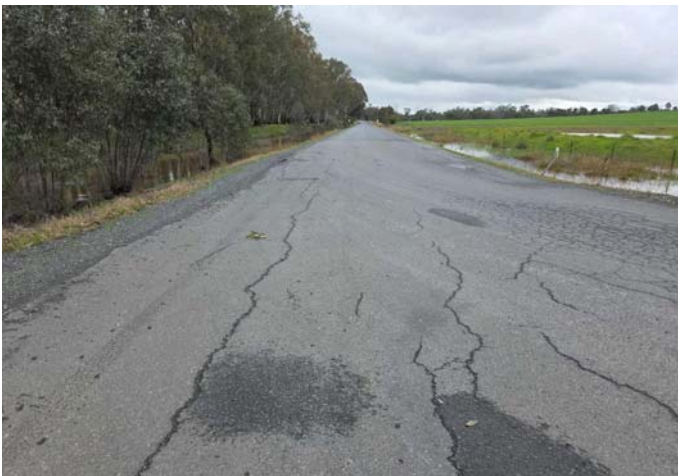
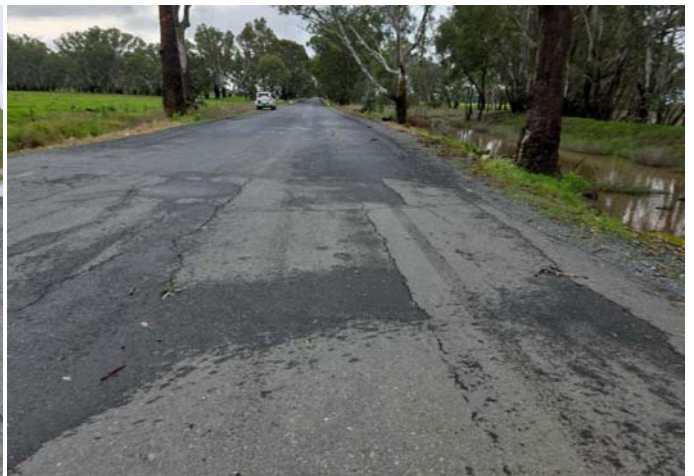
10 Aug 2026  
Damage to Road Marker

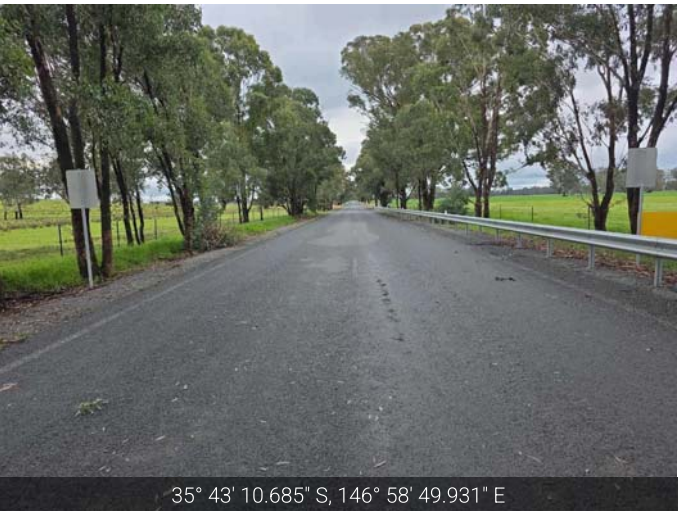
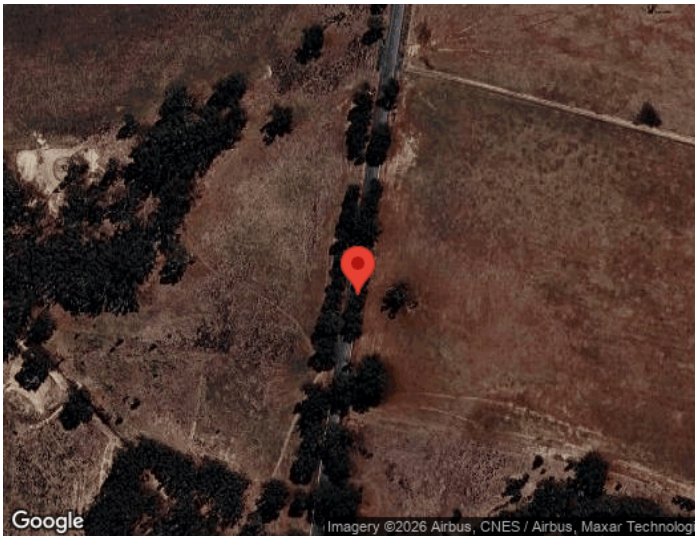
Damage to Guardrail

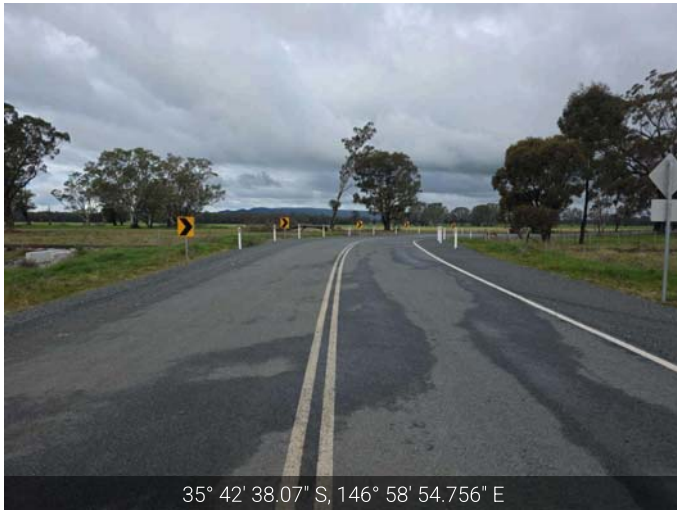
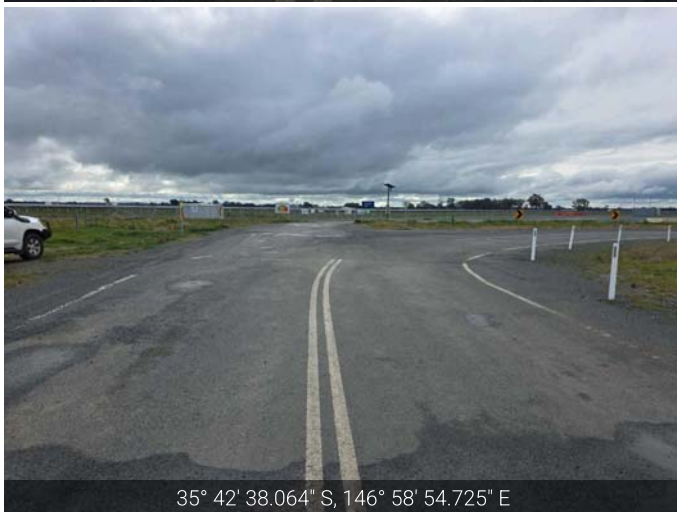
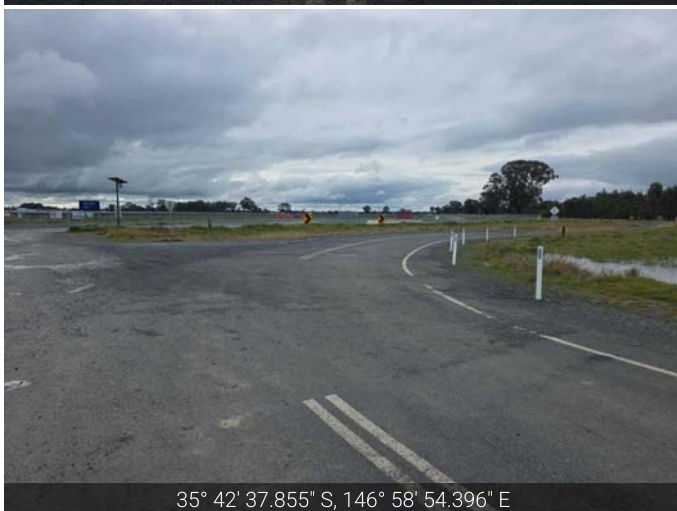
Slight Heaving to surface

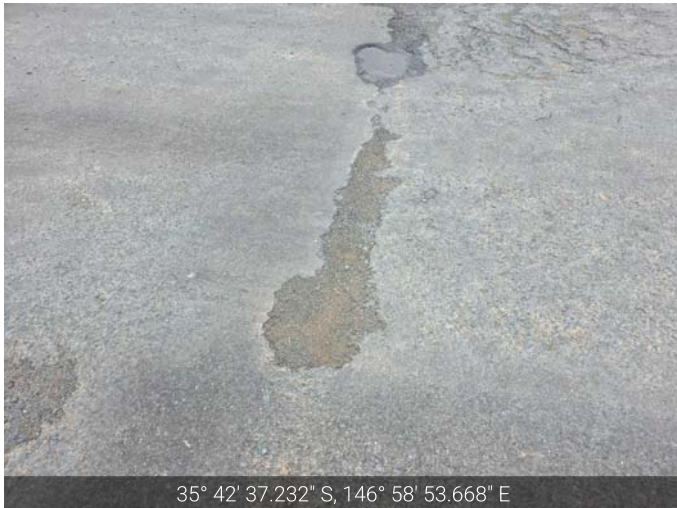
Surface Break-up exposing roadbase at site entry

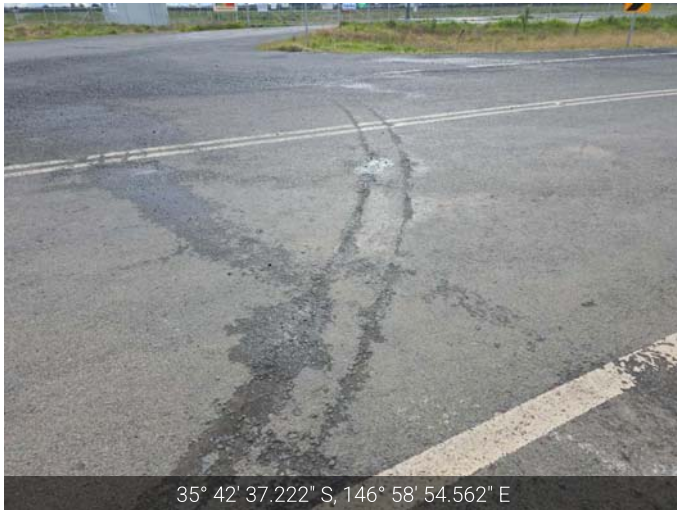
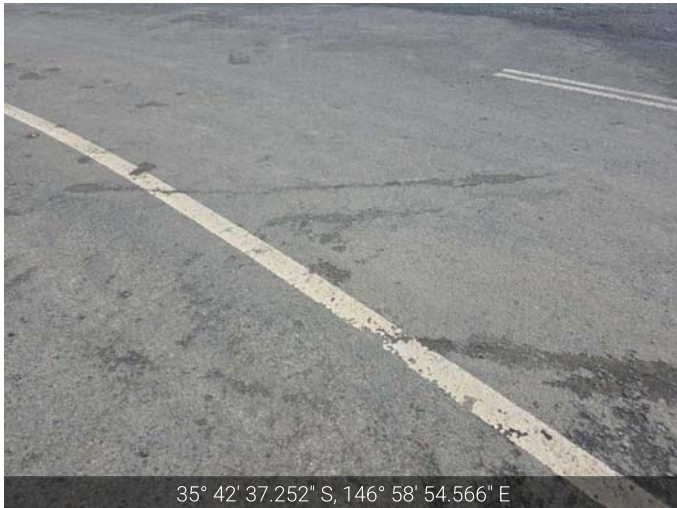
Gouging to Road Surface

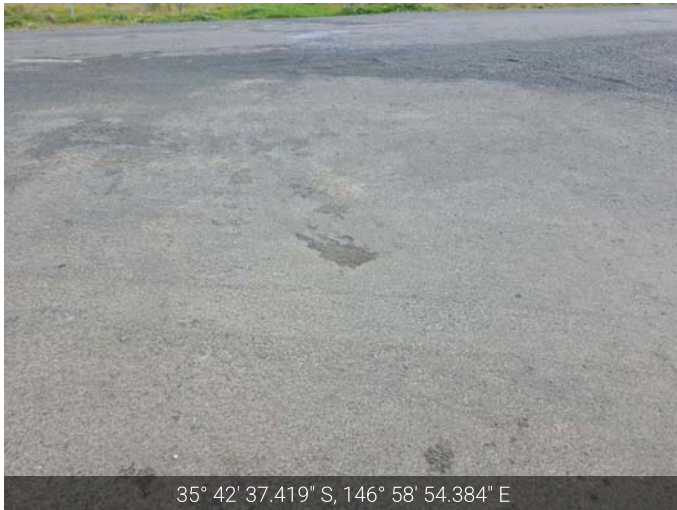
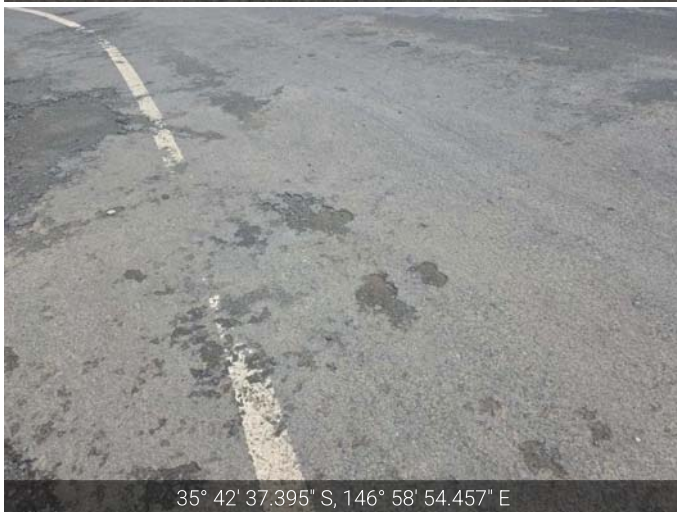
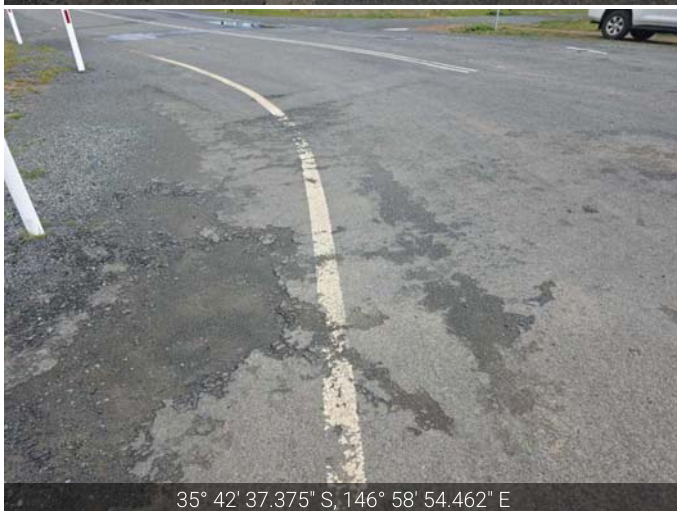
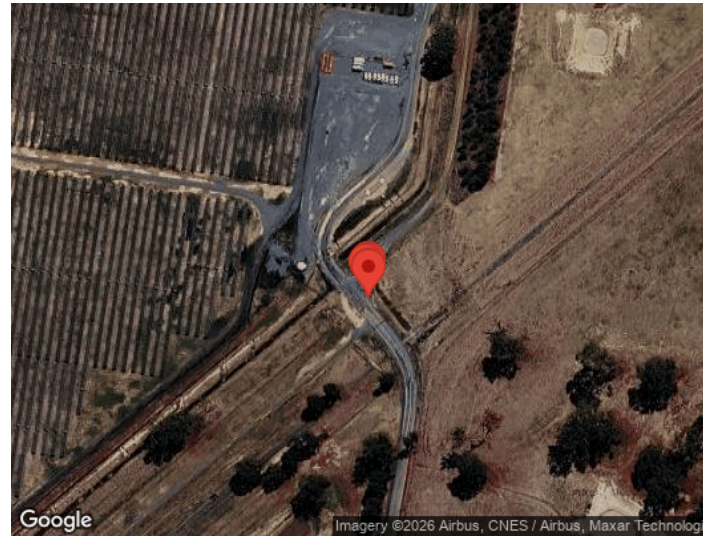
Surface Break-up exposing roadbase

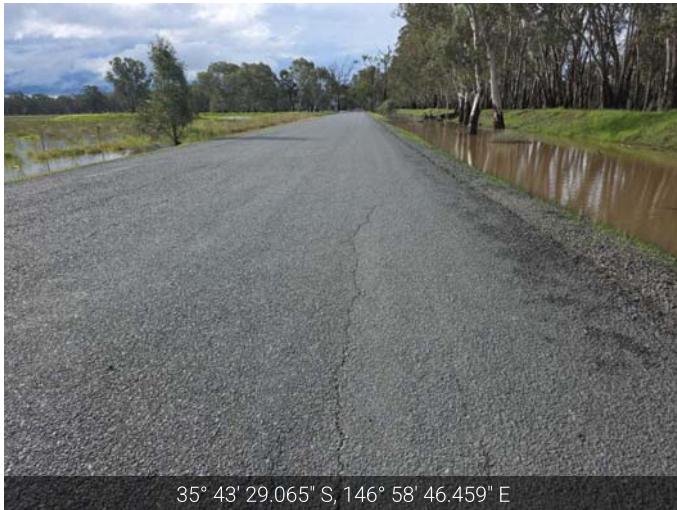
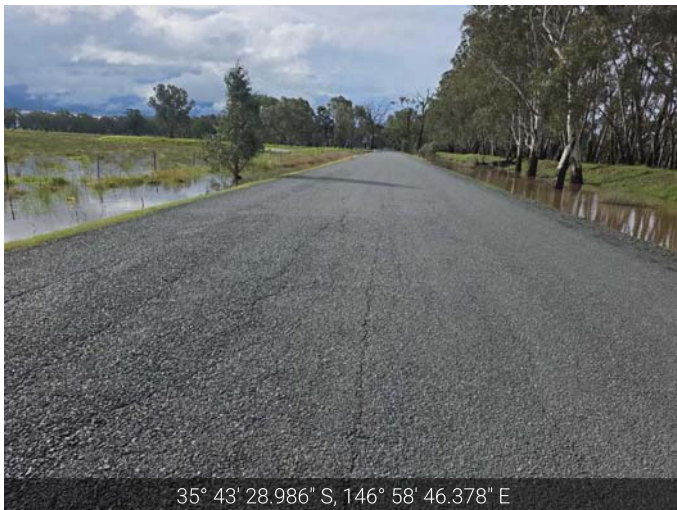
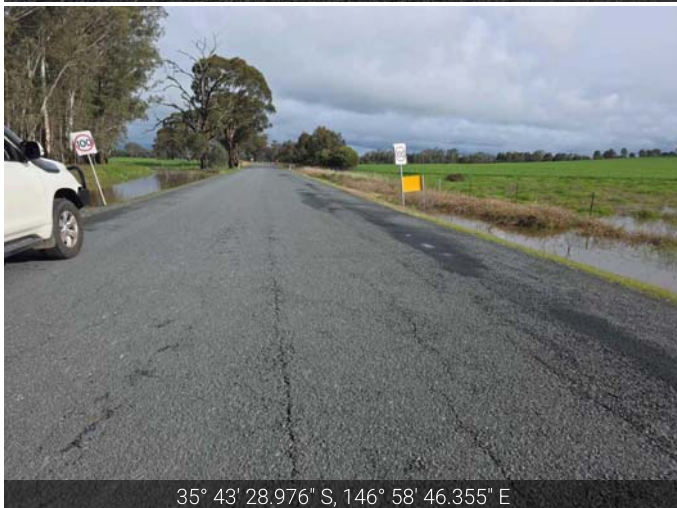
Directional Cracking to road surface

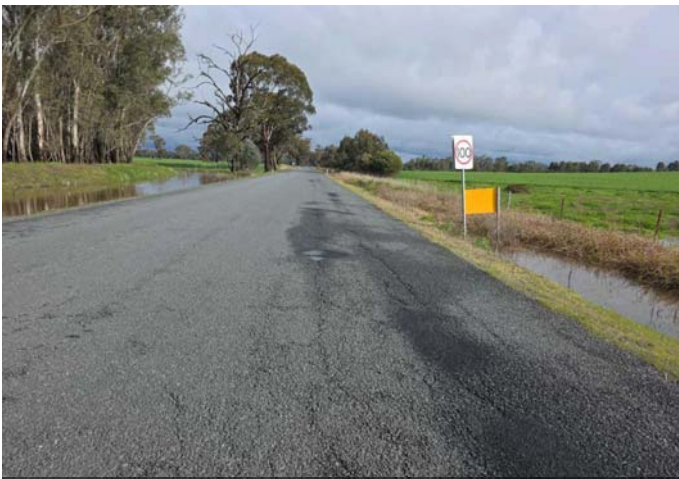
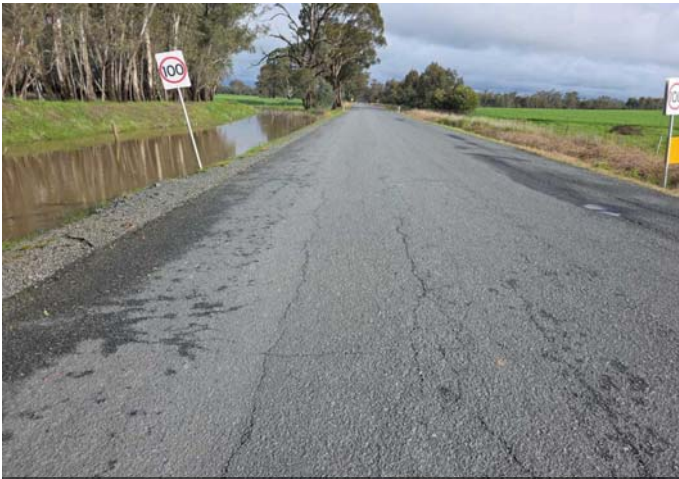
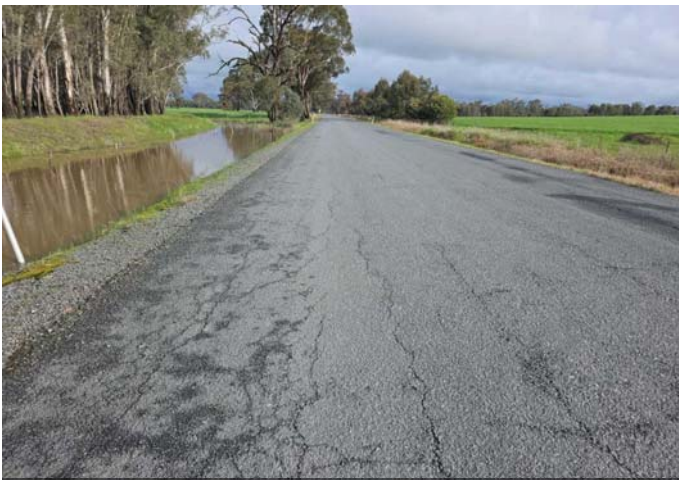
Signage on lean

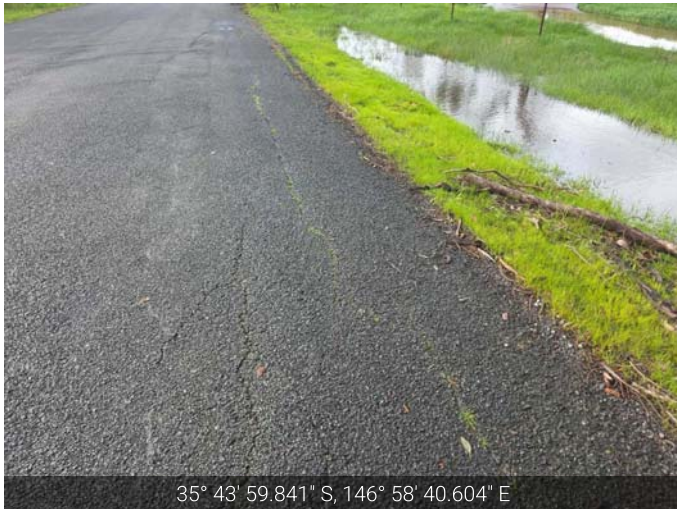
Foliage Growth through road base

Surface Cracking

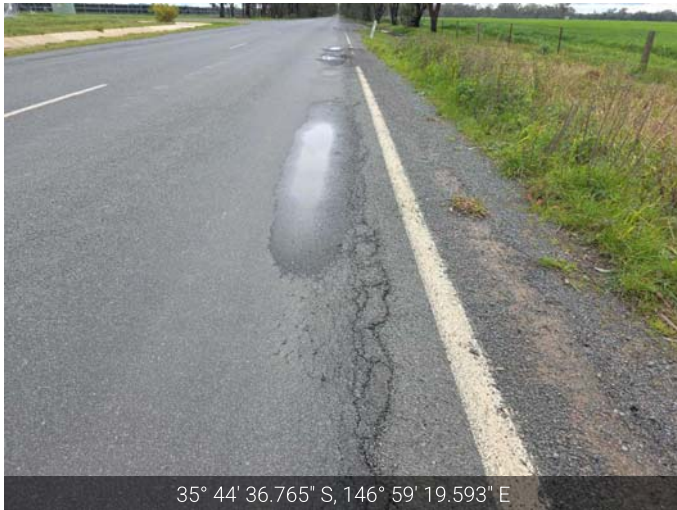
Heaving to road seal

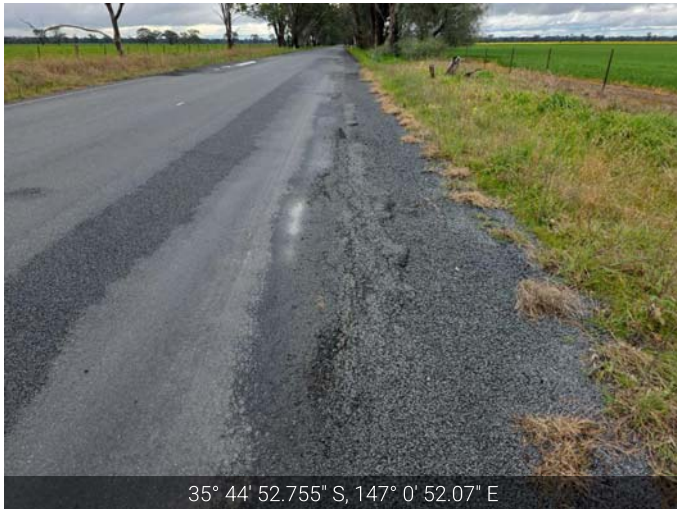
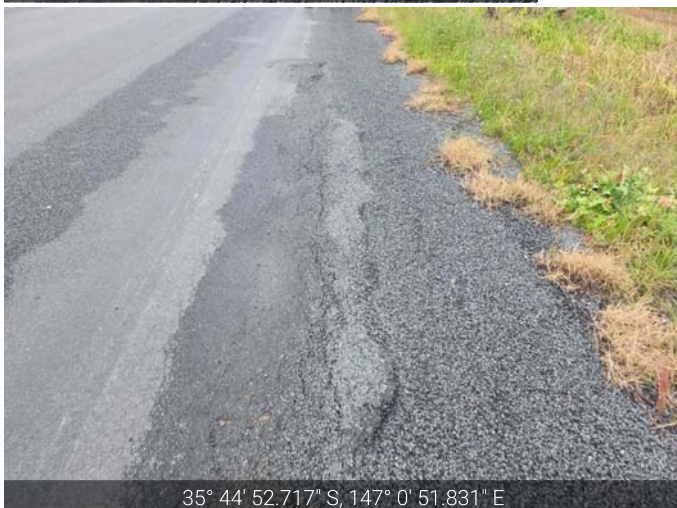
Heaving to edge of road

Spray seal repairs

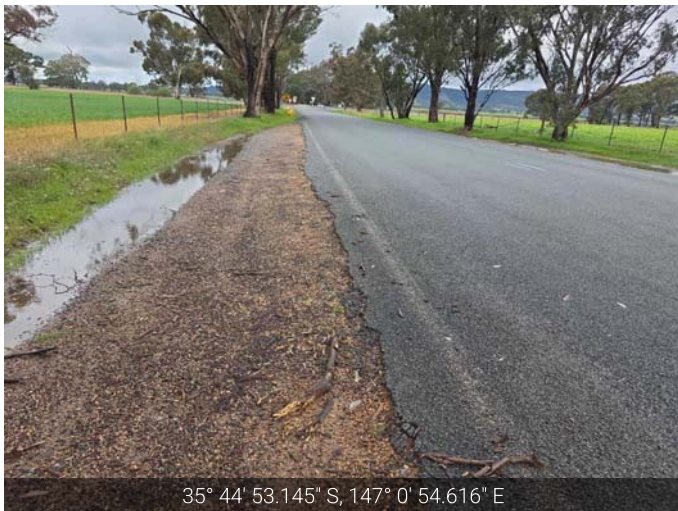
Item 40

Typical edge Break-up
